# Innovation for Fukushima-Daiichi Decommissioning

Future Challenges and Expectations

International Research Institute for Nuclear Decommissioning (IRID)

2023

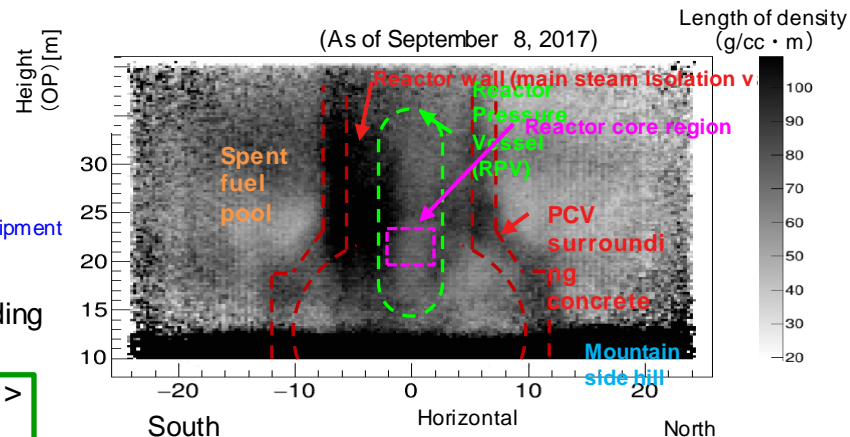
Measurement image of inside the unit 3

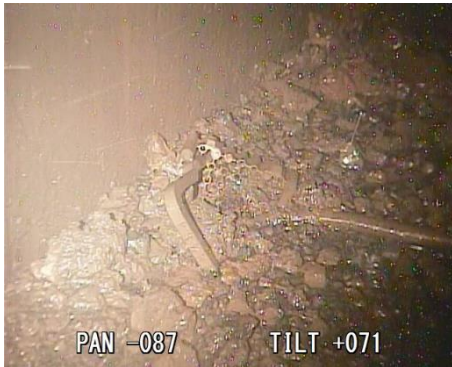
- The robot investigated the inside of the Units 1-3 PCVs by using cameras.
- There are large differences in state of the damaged reactor cores depending on each Unit.
- The severity of damage is estimated in order of No. 1, No. 3 and No. 2.
- In Unit 2, part of fuel assembly ( a handle) that has fallen on the floor outside of the reactor was observed.

Photo: Near the pedestal inner wall at the Unit 2 PCV bottom

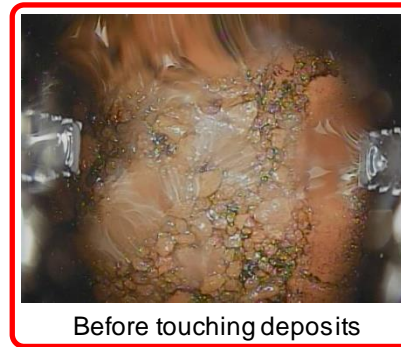
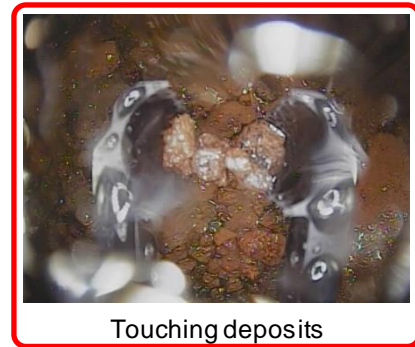
Before touching deposits

Touching deposits

Photo: Touching pebble-like deposits by tool at the Unit 2 PCV bottom

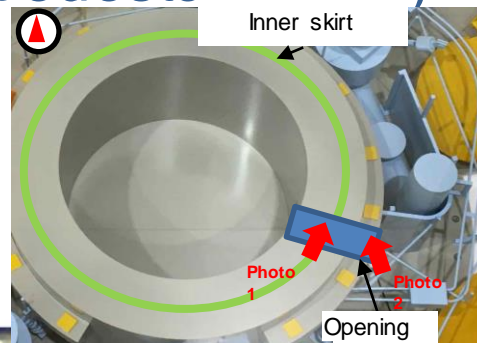
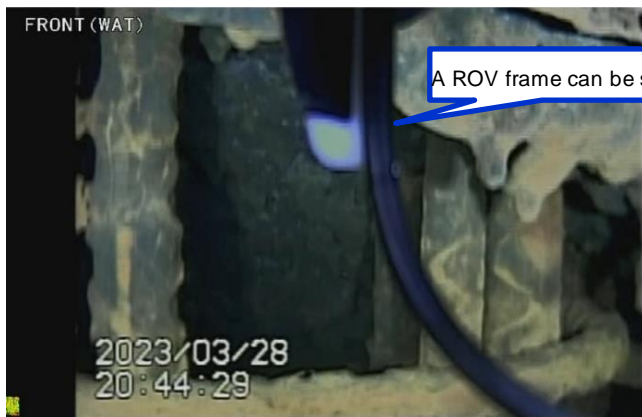
- The Unit 1 pedestal wall on inner and opening were damaged and remained only iron rebar.
- The lost concrete area of the pedestal inner wall (only rebar remains) is approximately 1meter in height and 50cm in depth. The lost of the pedestal outer wall opening would be limited.

Photo 1: Concrete wall seen from the pedestal opening

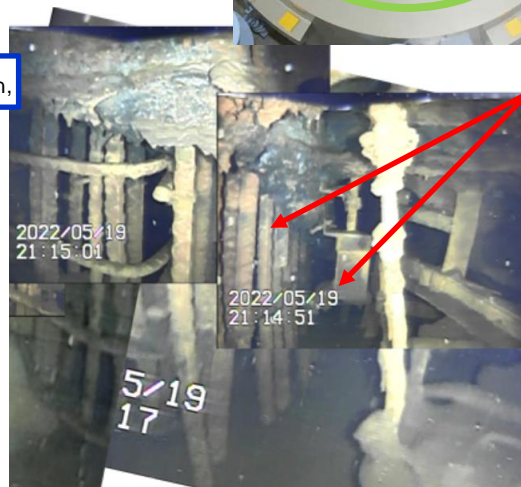
Remains of concrete walls ?

Photo 2: Concrete wall seen from the pedestal outside

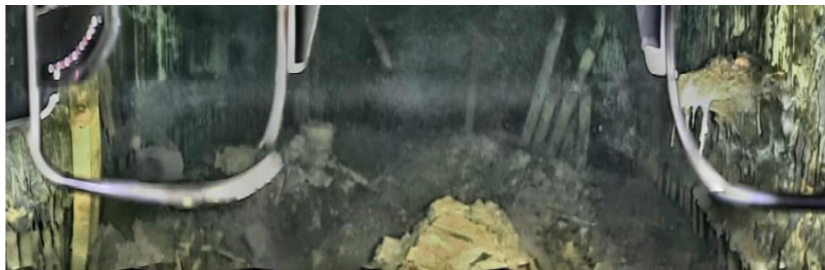
- The Unit 1 reactor core was damaged about eight hours after the loss of power.
  - Unit 1 has almost no fuel in the RPV, and deposits have spread outside the pedestal.
- The inner walls of the pedestal were also damaged.

Composite image of the Unit 1 entire pedestal floor  
(Reference: the TEPCO Holdings website)

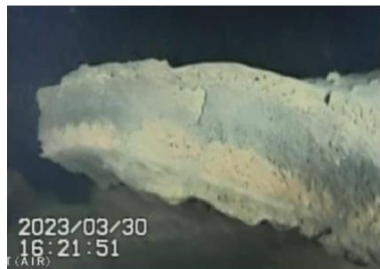
Shelf-shaped deposit  
outside the Unit 1 pedestal  
(Reference: TEPCO Holdings  
website)

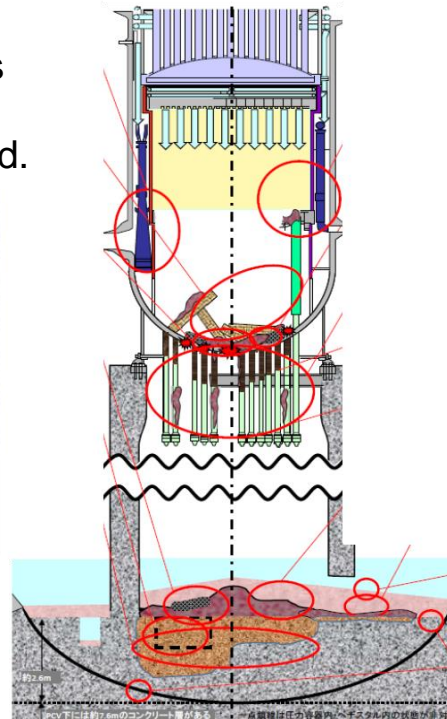
Damage estimation of the Unit 1 RPV/PCV  
(From TEPCO website)

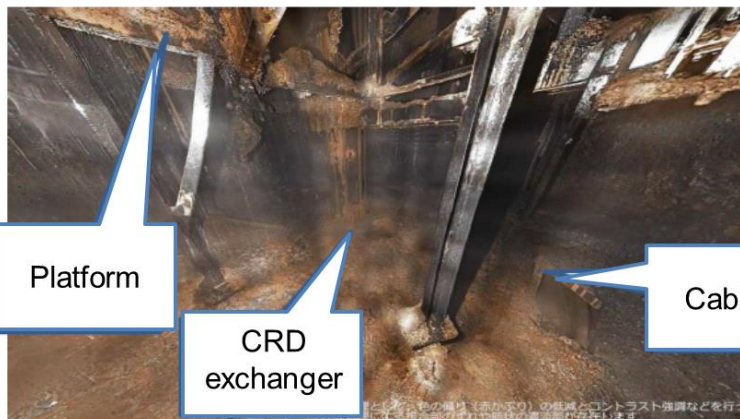
- The Unit 2 reactor core was damaged about 3 days after the loss of power.
- Unit 2 has a lot of fuel left in the RPV. Although there is 1 meter-deposit on the pedestal floor. The RPV substructure retains its original form.

Wide angle photo of the Unit 2 entire pedestal floor  
(Reference: the TEPCO Holdings website)

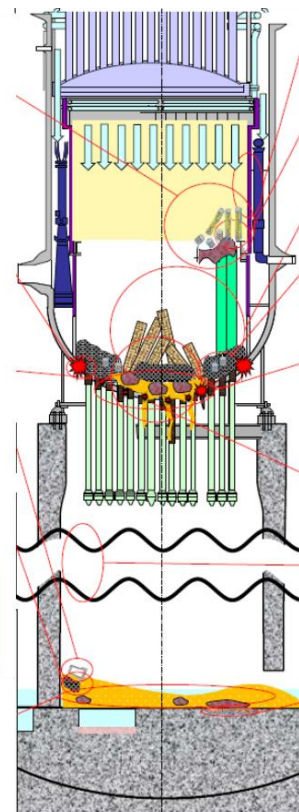
Damage estimation of the Unit 2 RPV/PCV  
(From TEPCO HP)

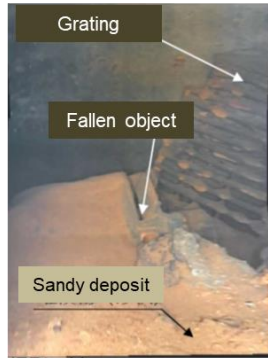
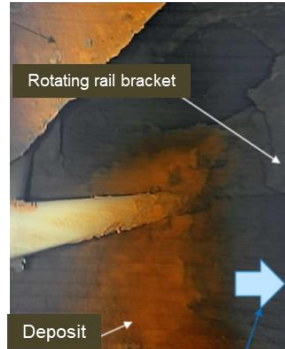
- The Unit 3 reactor core was damaged about one and half day after the loss of power.
- Unit 3 have some fuel left in the RPV.  
There is 2-3 meters of deposits on the pedestal floor.

Photos taken from investigation inside the Unit 3 pedestal

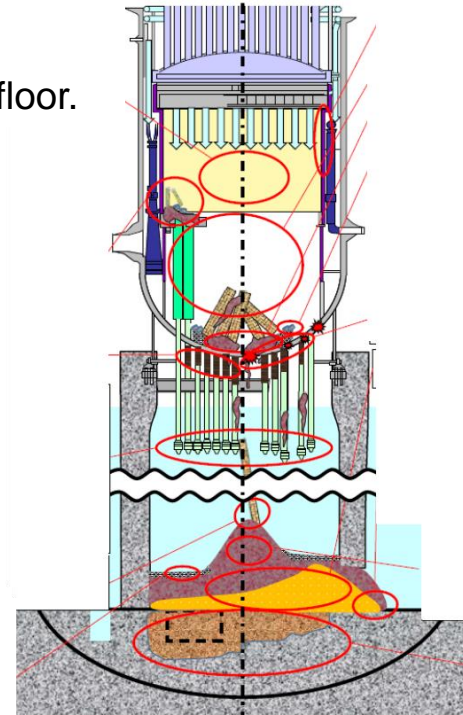
Damage estimation of the Unit 3 RPV/PCV  
(From TEPCO HP)
