Flow Accelerated Corrosion Programme in Angra NPP Units 1 and Angra 2

April / 2009

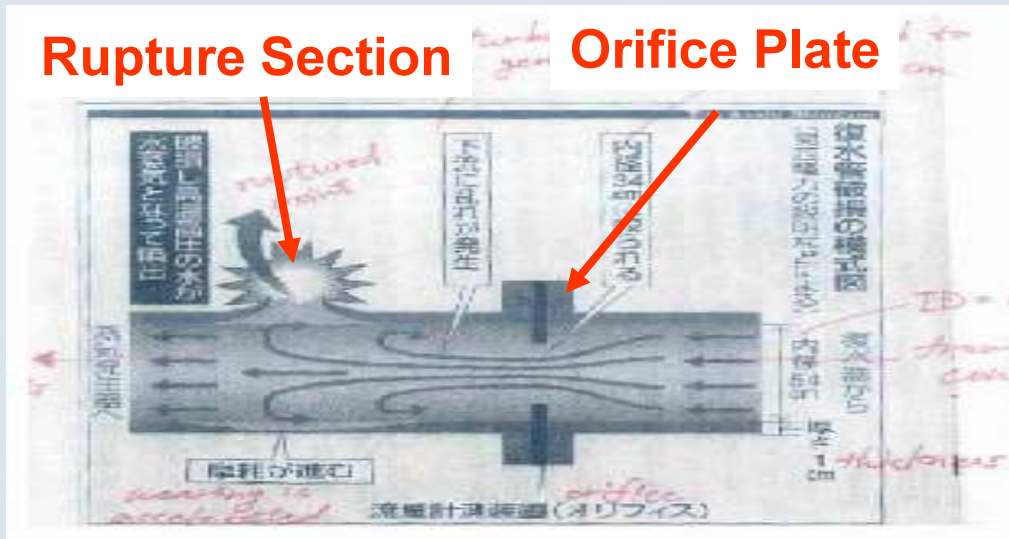
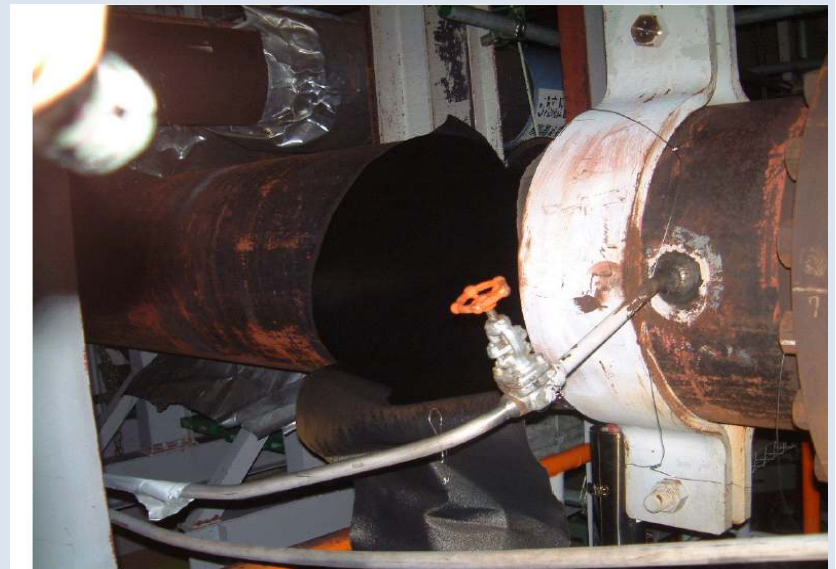
2004 → Mihama 3 → Rupture of a condensate pipe downstream of a flow orifice.
Five workers died.

Minimum wall thickness of the ruptured area: 0.4 mm (0.02 in)
