Flow accelerated corrosion in cooper-nickel 90-10 in sea water

Carlos R. Arganis-J. (1), Miguel Gachuz M.(1) and Veronica Vergara(2)

(1) Instituto Nacional de Investigaciones Nucleares. Mexico
carlos.arganis@inin.gob.mx

(2) Comisión Federal de Electricidad. Mexico.

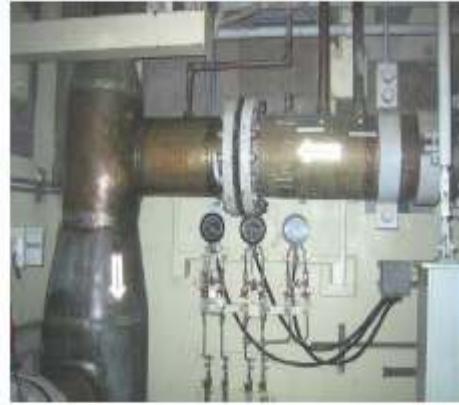
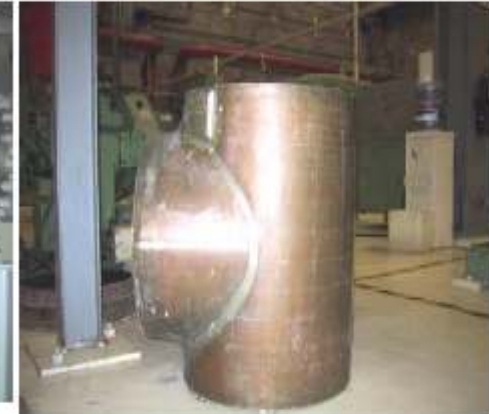
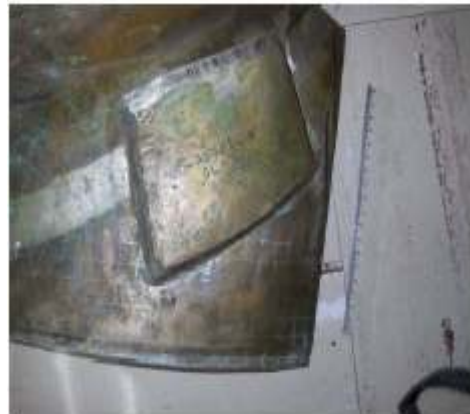
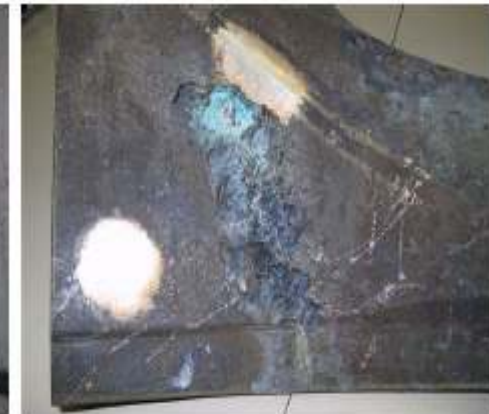
Case 1. Tee's

- Tee of 8X16X24 inches presented loss of thickness
- Tee of 24x24x24 presented a leak in the union of the two fluxes. In this case, the leak was repaired with a stick wood and with a welded patched

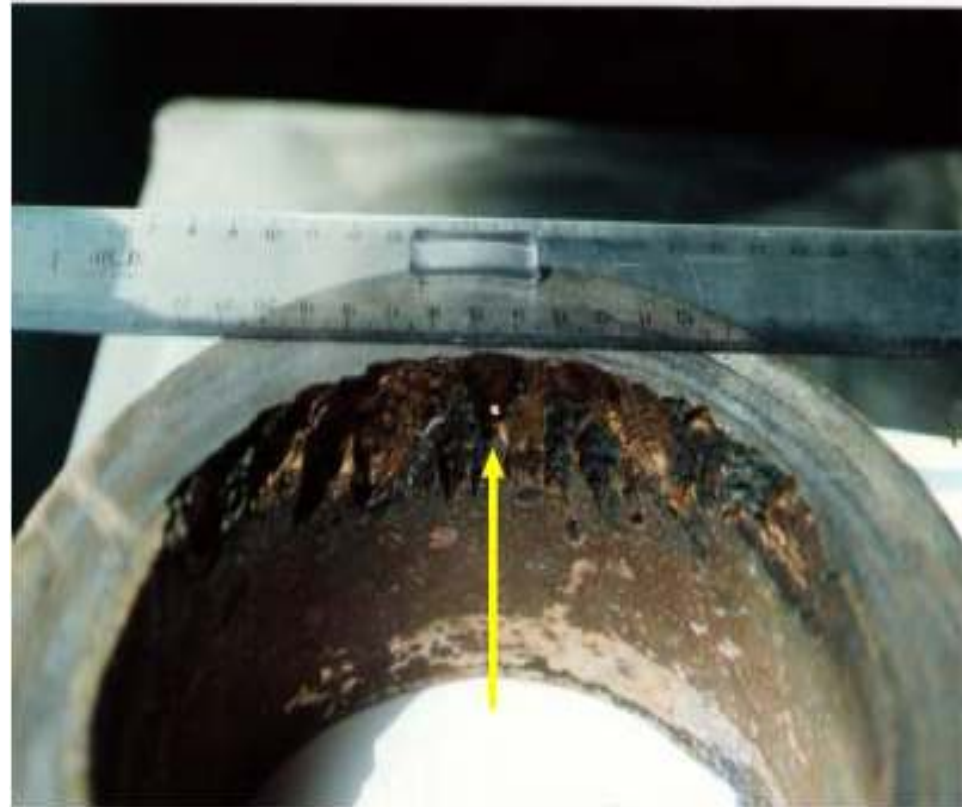
Case 2 medium Pipes

- This pipe presents a leak, caused by damage that reach the total thickness
- "The Balance of plant" velocity was of 2.19 m/s.
- **15.5 cm diameter pipe**

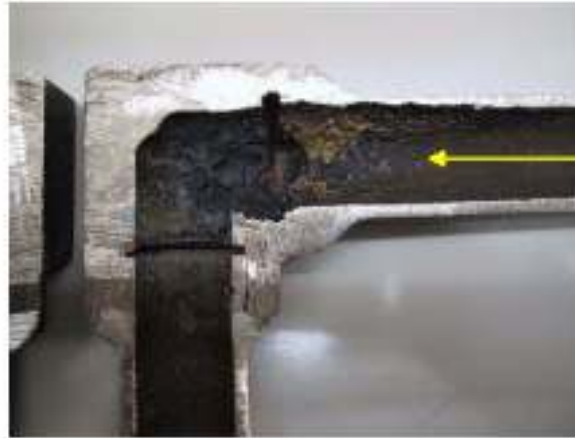
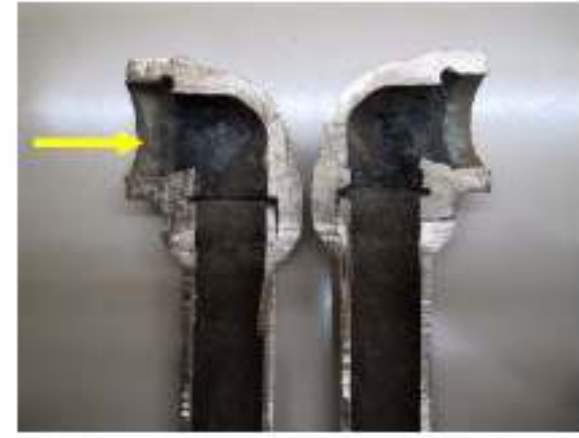
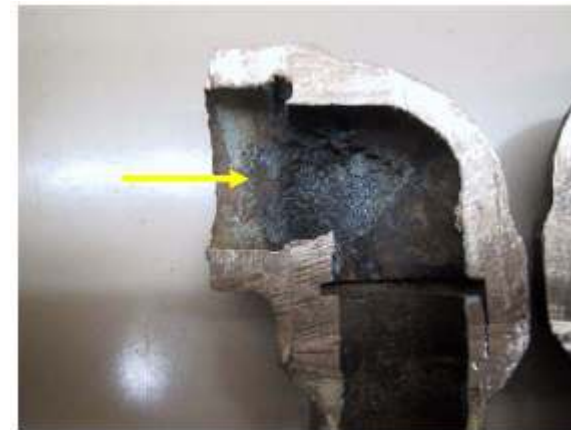
Case 3 small pipes

- Those pipes presents damage in the elbows and in strain lines after the gaps of bad weld unions

- b) Square elbow of $\frac{3}{4}$ inches (1.8 cm diameter pipes and elbows.
 - c) Details of the damage I a elbow.
 - d) General view of the damage.
- Flow 0.06 m³ per minute

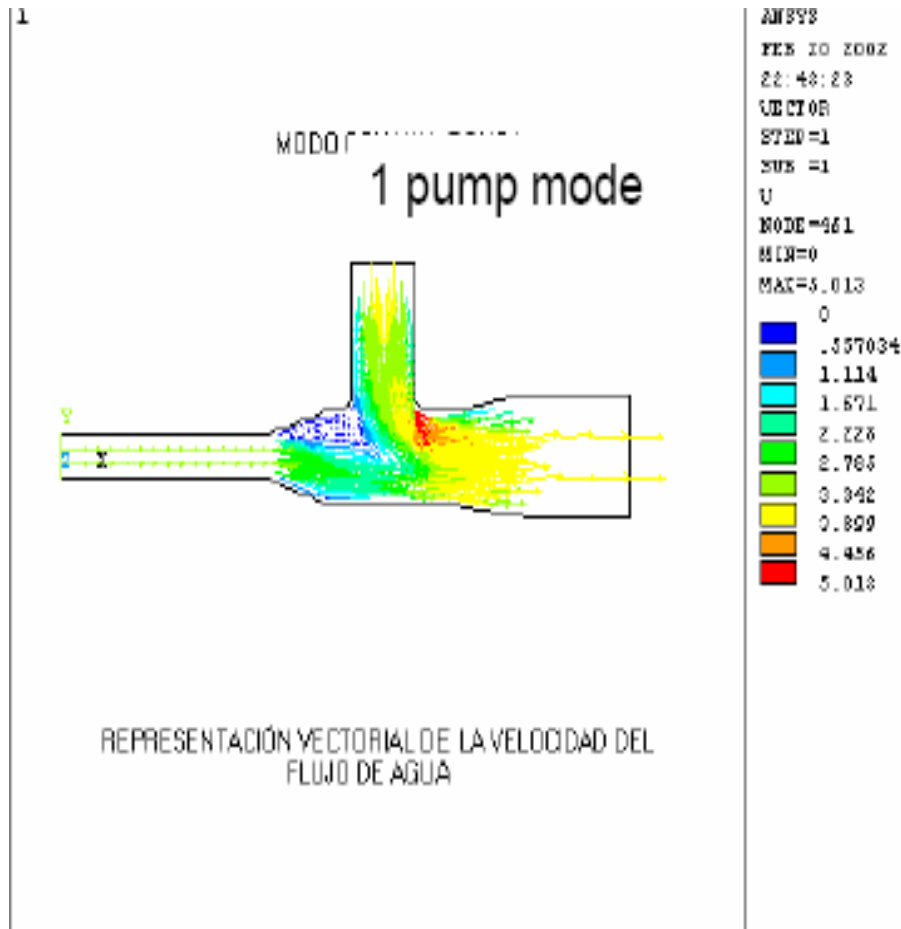
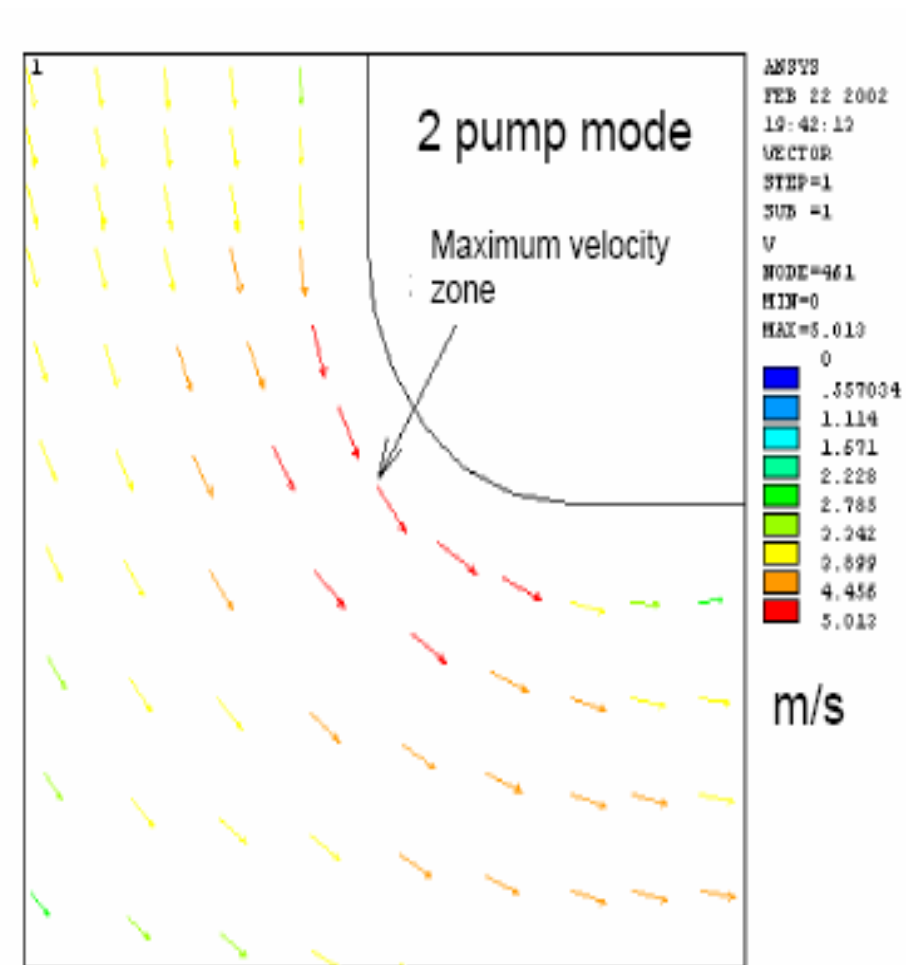
The flow velocity exceed the maximum designed flow rate in the zone of the damage

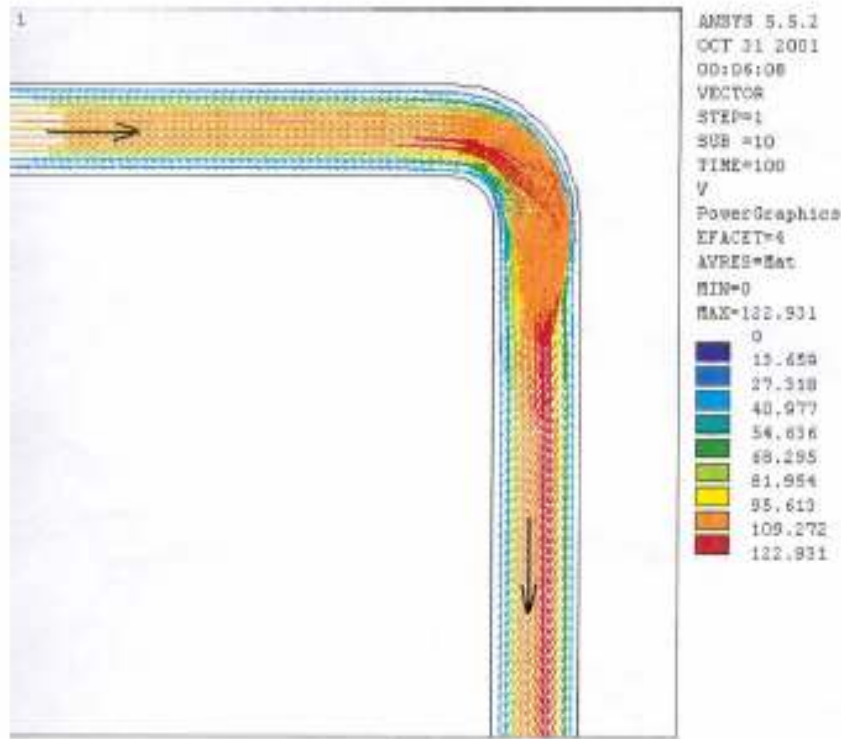
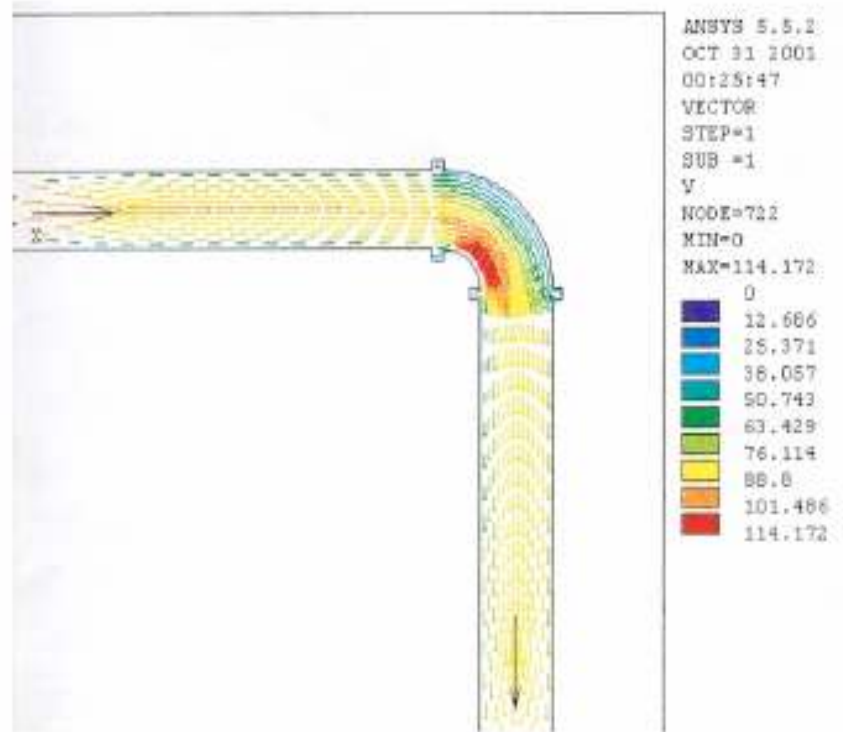
Figures 8. a) 1.8 cm diameter pipe and elbow flow profile with a 0.06 m³ per minute with a good union and b) The same pipe and elbow with a bad union with a gap of 3 mm. Velocities are in inches per second.

The changes in the profile flow is in agree with the geometry of the real damage in the elbows

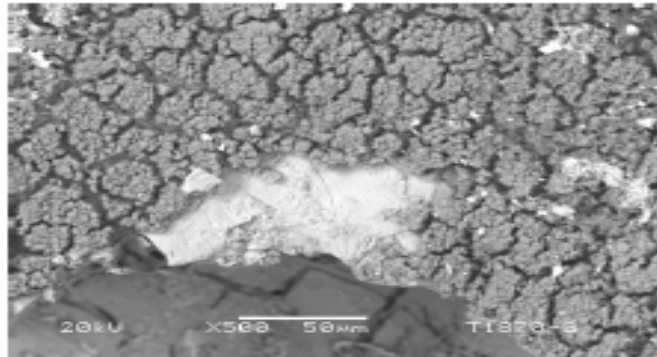
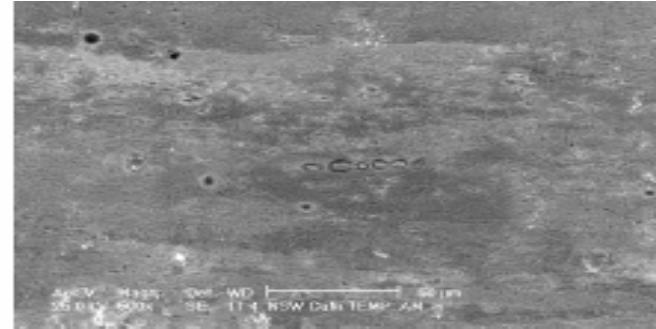
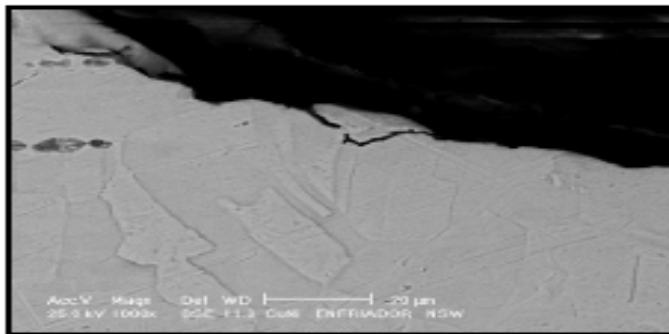
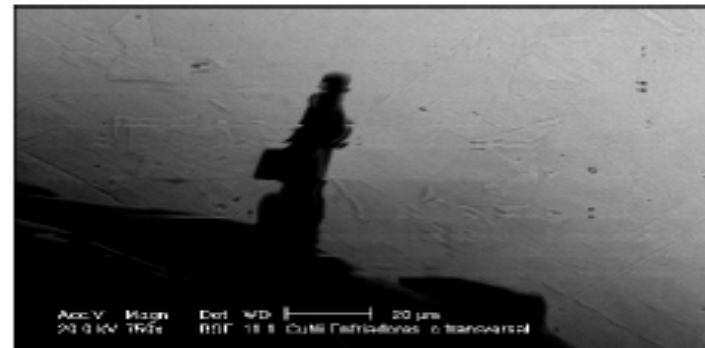
Figures 9. a) CuNi retired from the Tee, showing a porous layer and IGA in the bare metal. b) Polished CuNi after 24 hours in natural sea water showing attack around the precipitates. c) Intergranular attack surrounding a grain. d) IGA penetrating and loss of completed grains

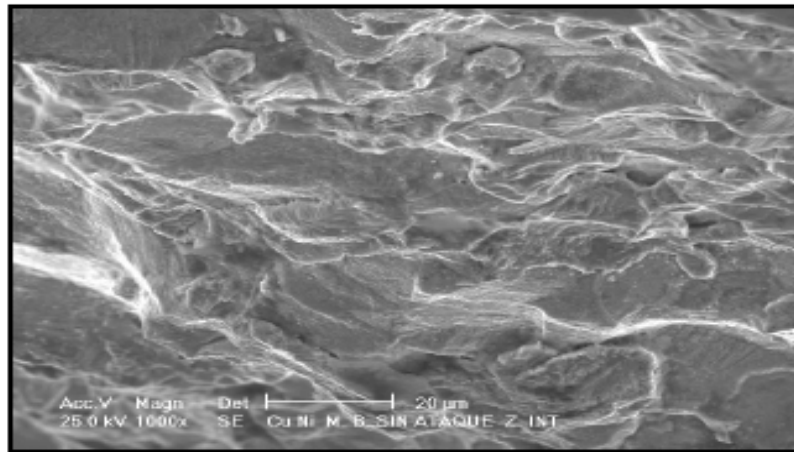
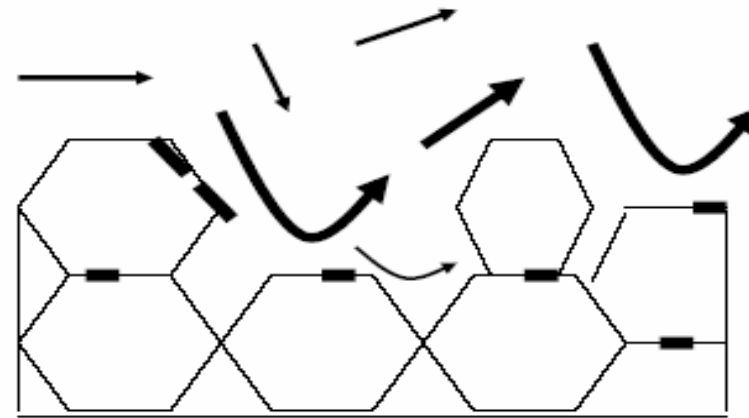
cavities produces microvortex and mechanical damage

This also explain way the model of the corrosion accelerated by flow not work so well in this case, due to the nature intergranular of this attack. There is a part of the loss of materials that are related with the loss of completed grains.

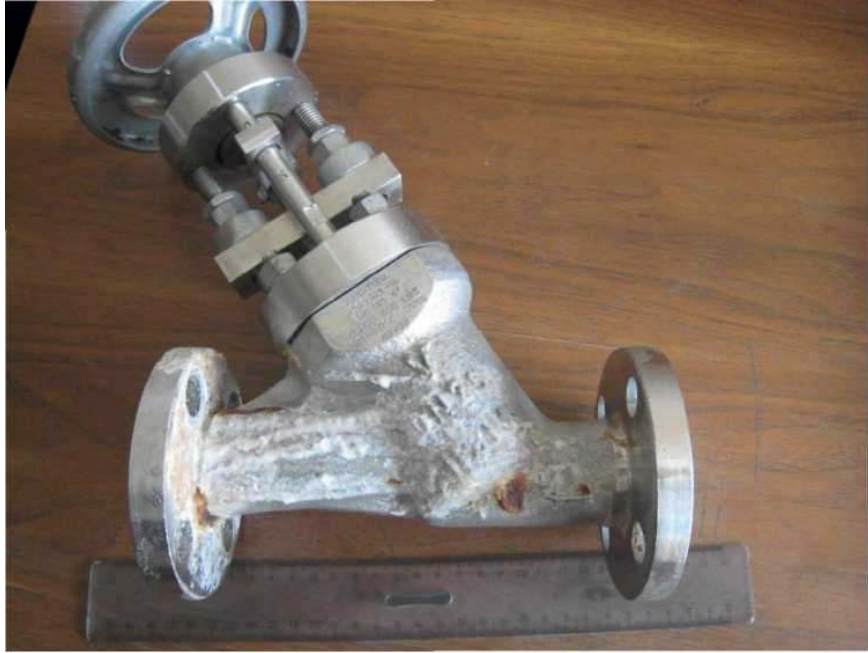
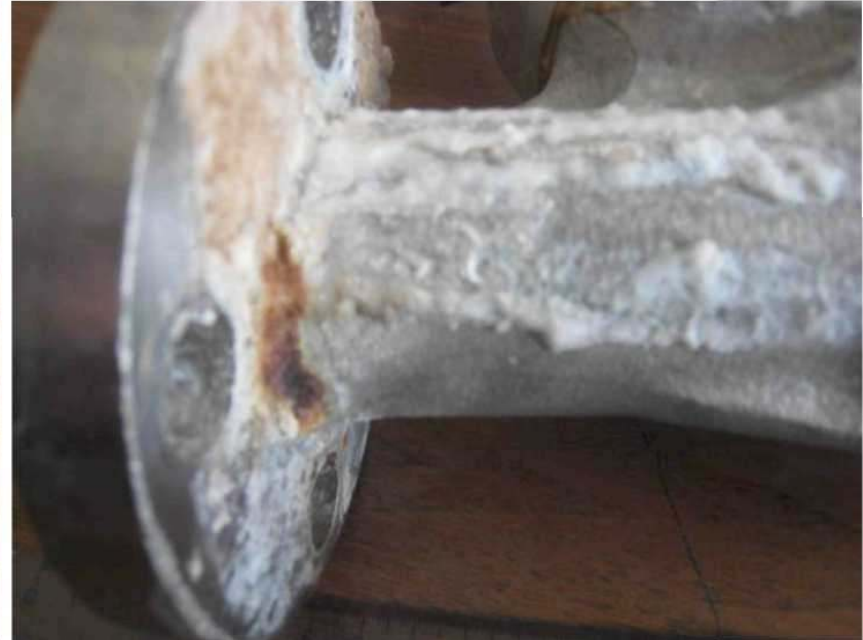
ALX65 valve with a Leak after 9 months in service
