# MEXICAN EXPERIENCES ON RPV SURVEILLANCE MATERIALS

Ing. Magdalena Griz Cruz. (CFE)  
M. Sc. Carlos Arganis ININ. (ININ).  
M. Sc. Eduardo F. Robles P. (ININ)  
Eng. Francisco J. Merino C. (ININ)  
M. Sc. Rogelio Hernandez C. (ININ)

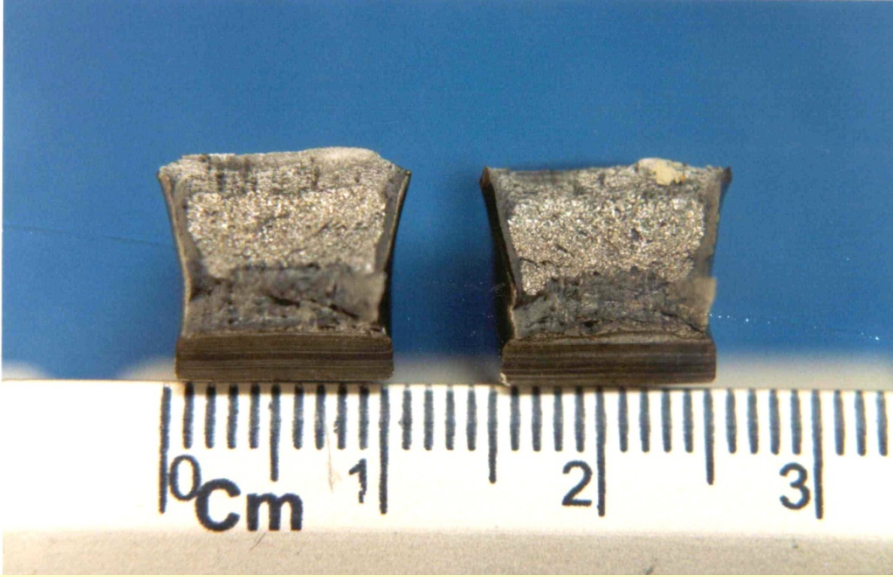
CHARPY SAMPLE	PICTURE
<p data-bbox="498 715 697 743">BASE METAL</p> <p data-bbox="465 786 730 815">LCCC93P1-POS9</p> <p data-bbox="510 858 685 886">TEMP: 55 °f</p> <p data-bbox="446 929 749 958">ENERGY: 116.4 ft-lbf</p> <p data-bbox="417 1001 778 1029">LATERAL EXP. 70.9 mils</p> <p data-bbox="401 1072 794 1100">DUCTIL FRACTURE : 45%</p>

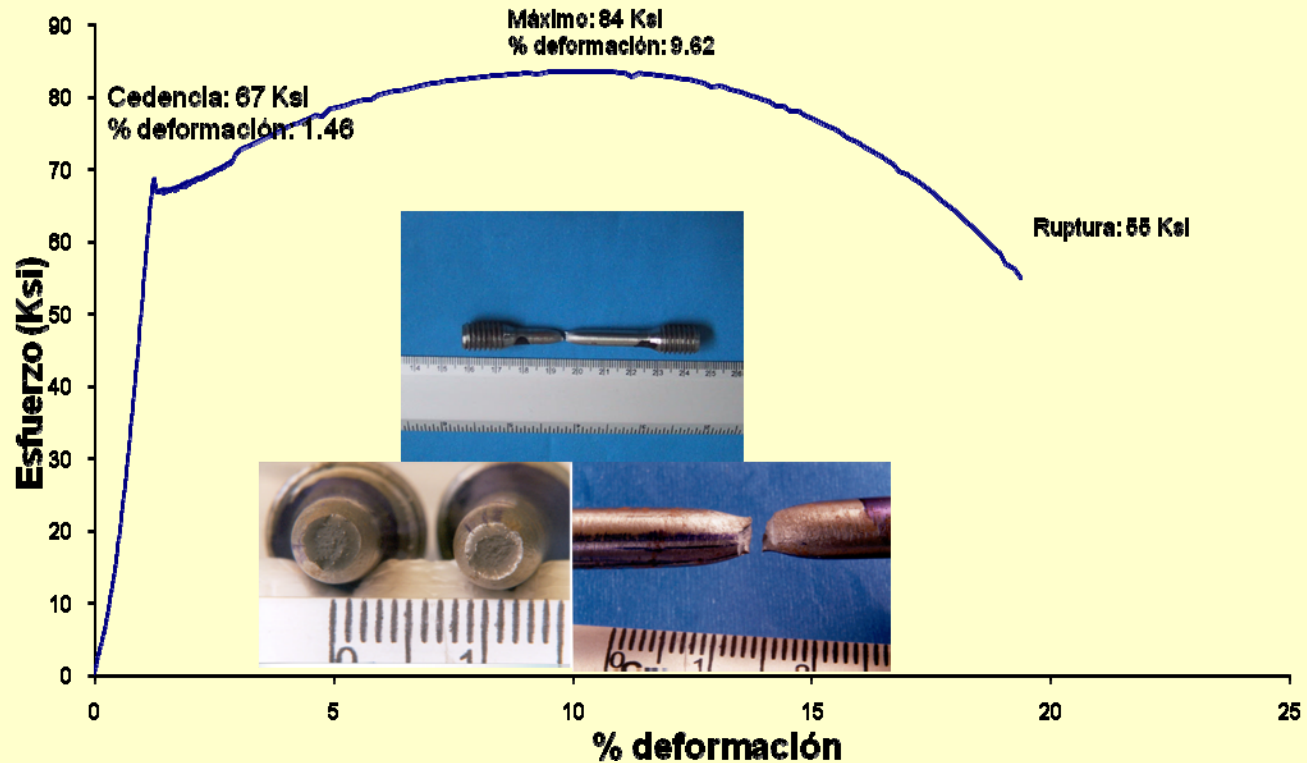
**Esfuerzo vs Deformación, 21/10/03, Probeta 93 P2,  
Posición 10, Soldadura, T = 74.5 °F**
