II. Further developments of the nuclear accident since that time

1. The Tohoku District-Off the Pacific Ocean Earthquake and the resulting tsunamis

(1) Investigation of the causes due to the occurrence of the earthquake and tsunamis

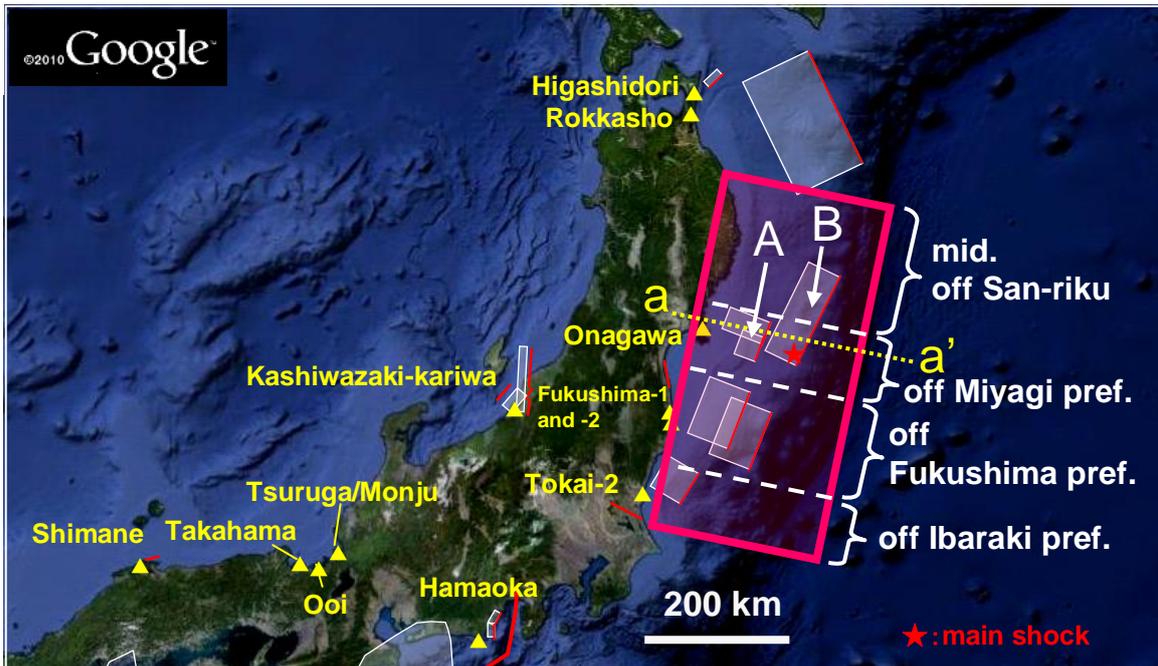
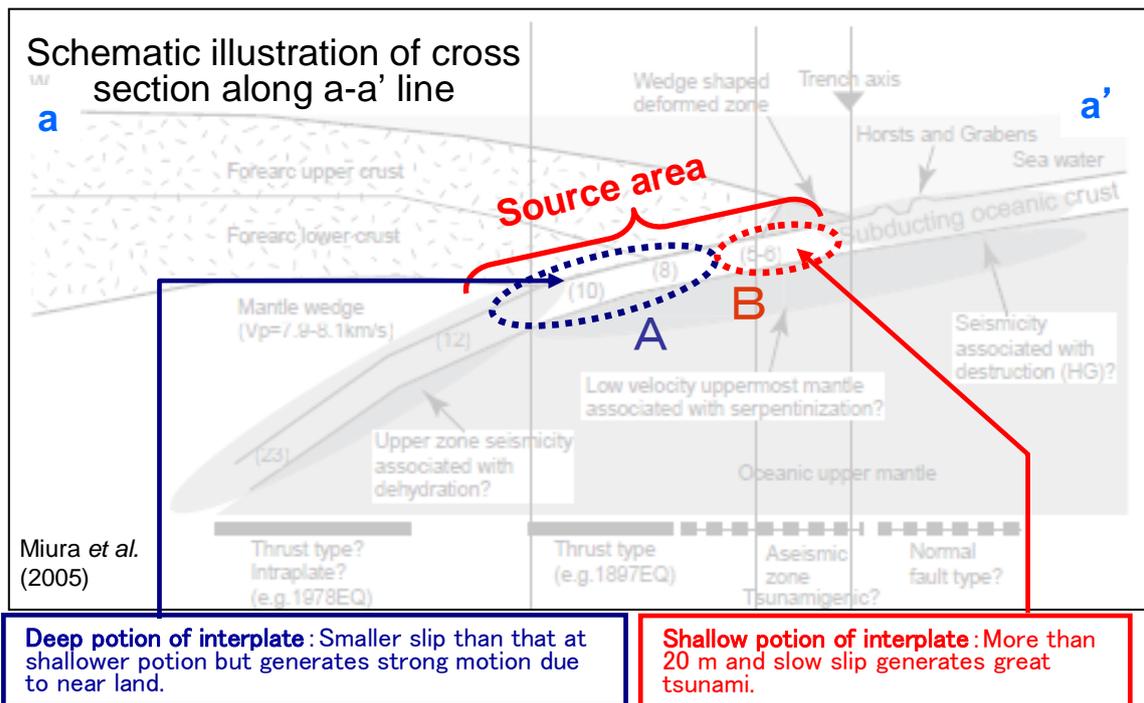
Fig. II-1-1 The source area of the Tohoku District-Off the Pacific Ocean Earthquake consisting of multiple seismic source areas.

- Magnitude: The recent Tohoku earthquake occurred along the Japan Trench as shown in Figure II-1-1 at 14:46 on March 11, 2011. It was estimated that the hypocenter of the earthquake occurred this time was in the area off the coast of Miyagi Prefecture as shown in Figure II-1-1, with a depth of 24 km, a moment magnitude of Mw9.0, and a source area of more than 400 km long and approximately 200 km wide.

- Consecutive rupturing: It was estimated that a plate rupture started at the hypocenter in the area off the coast of Miyagi Prefecture and then propagated consecutively to multiple seismic source areas off Iwate Prefecture in the north and off Fukushima and Ibaraki Prefectures in the south (Figure II-1-1).

- Slip: It was estimated that the area near the southern trench off the Sanriku coast and a part of the near-trench offshore areas from North Sanriku to Boso had large slip, with a maximum slip of more than 20 m (Figure II-1-1).

- Interplate coupling in source areas: Thus far, it had been assumed that the shallow plate boundary along the Japan Trench in the offshore area of Miyagi Prefecture was unlikely to store a large amount of strain energy since the area was believed to be creeping. In fact, however, there had been a strong interplate coupling in this area, with the strain energy having been stored for a long time, which resulted in a rupture off the coast of Miyagi Prefecture triggering the extensive Tohoku earthquake (Figure II-1-1).

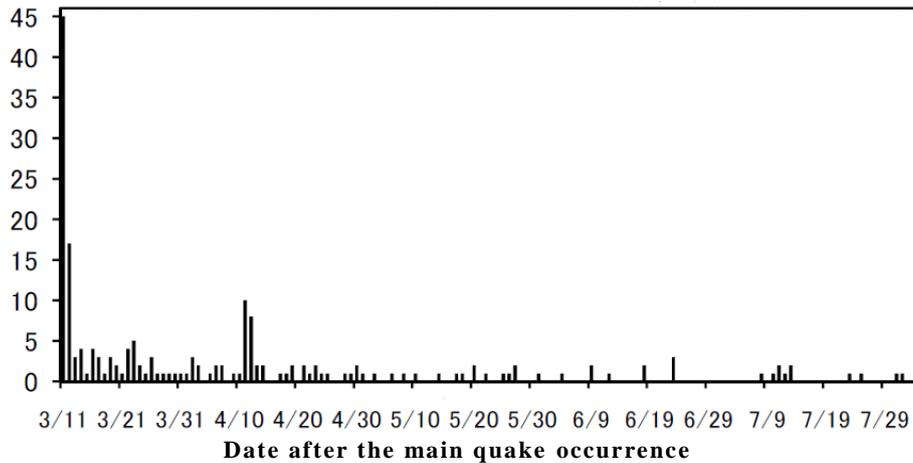
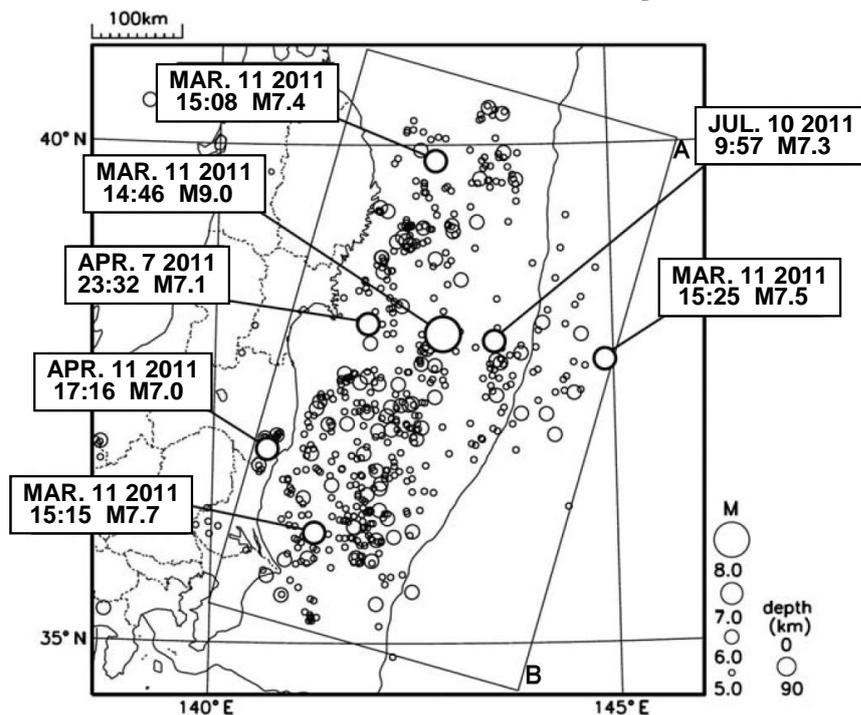
The number of aftershocks has been gradually decreasing, and the interval of occurrences of earthquakes having a seismic intensity of 4 or greater has become longer compared to June and before, as shown in Figure II-1-2. The only earthquake of M7 or greater that occurred after June was one of M7.3 off the coast of Sanriku on July 10, as shown in Figure II-1-2 (having a maximum intensity of 4). This earthquake caused tsunamis, and the observed highest height of tsunami was 12 cm at Sendai port. Figure II-1-2 also shows the main quake on March 11 and the distribution of subsequent major aftershocks. Among these, in land areas of Fukushima Prefecture, where an M7.0 earthquake occurred on April 11, to Ibaraki Prefecture, shallow earthquakes of M3 to M4 have frequently occurred (with intensity of 3 to 4).

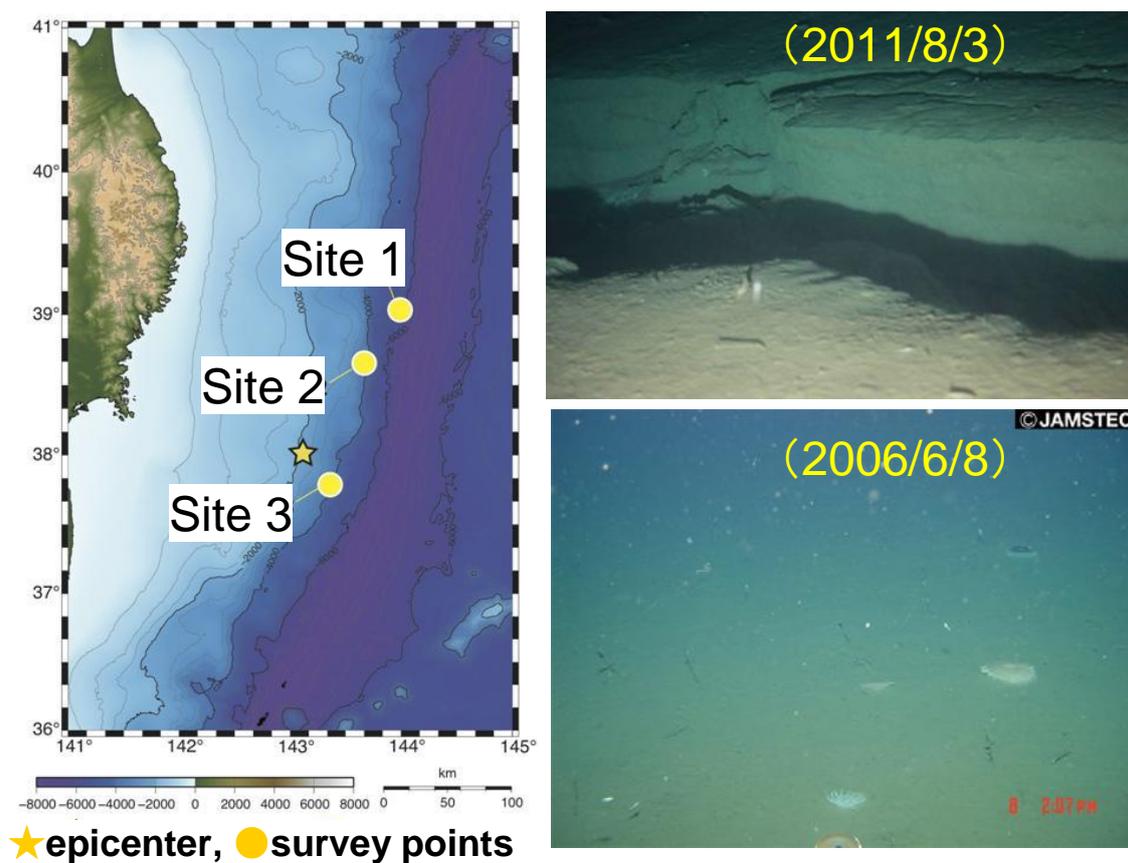
a location where previous surveys had found no cracks (Figure II-1-4, Site 1). JAMSTEC indicated that the crack was likely to be caused by a sequence of seismic activities including the Tohoku earthquake.

Right bottom figure: surface without crack at site 1 before the main quake (June 8, 2006, No 957 submerging).

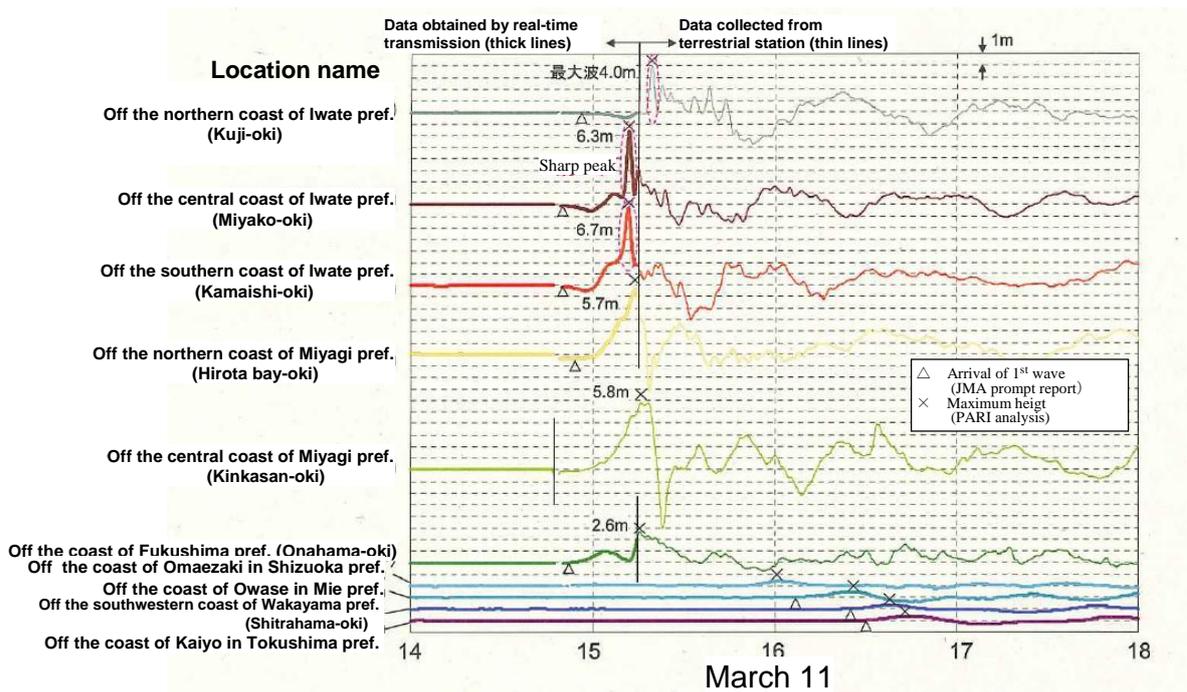
Fig. II-1-5 Observed tsunami height by GPS buoy system.

The Port and Airport Research Institute (PARI), an independent administrative agency, published additional observation records, as well as recovering recording instruments and analyzing data obtained, of the observed tsunami waveforms by GPS buoys, which had been unavailable due to the disruption of communications when the tsunamis occurred (Figure II-1-5).

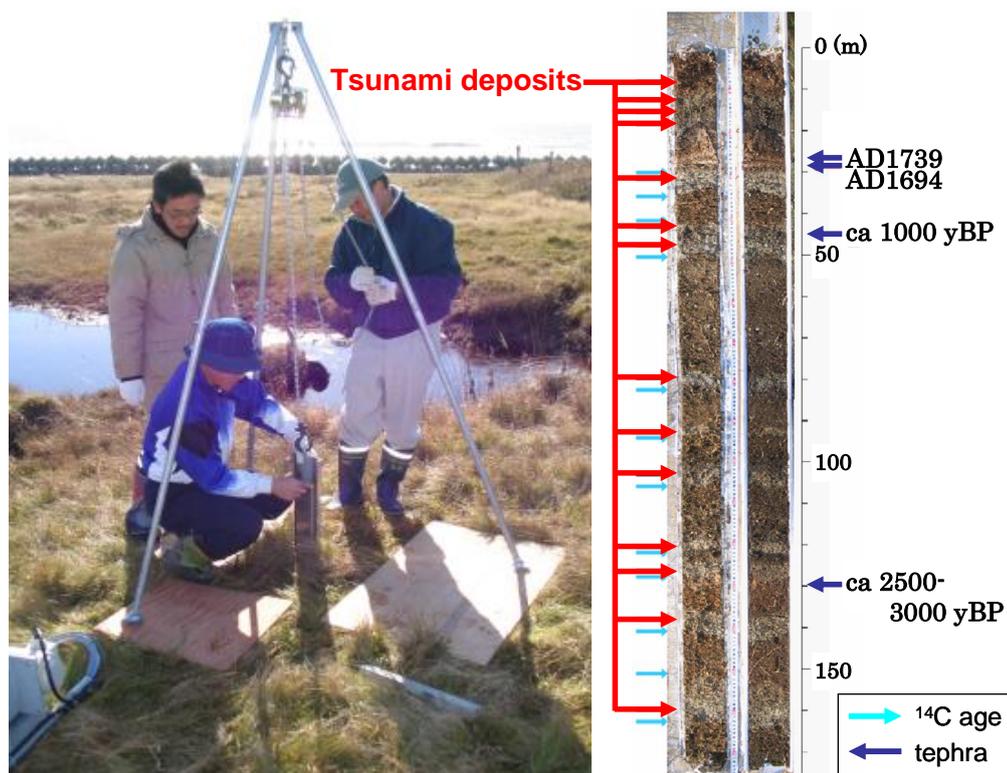
Fig. II-1-6 Landscape of tsunami deposit survey.

Exploration of tsunami sediment is actively proceeding as shown in Figure II-1-6. At a coast of Kesenuma City, Miyagi Prefecture, Hirakawa (2011) found the tsunami traces, which indicate that 10 m class giant tsunamis had arrived six times in the past 6,000 years. This is showing the possibility of repeated occurrence of M9-class giant earthquakes like the Tohoku

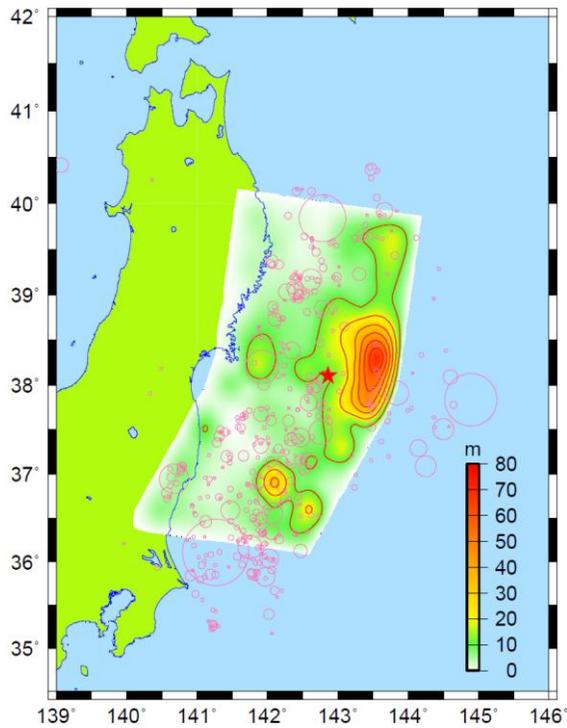
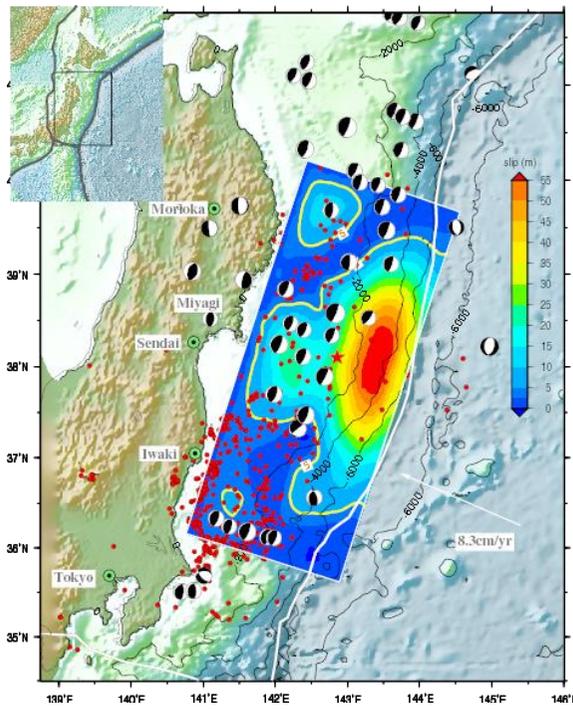
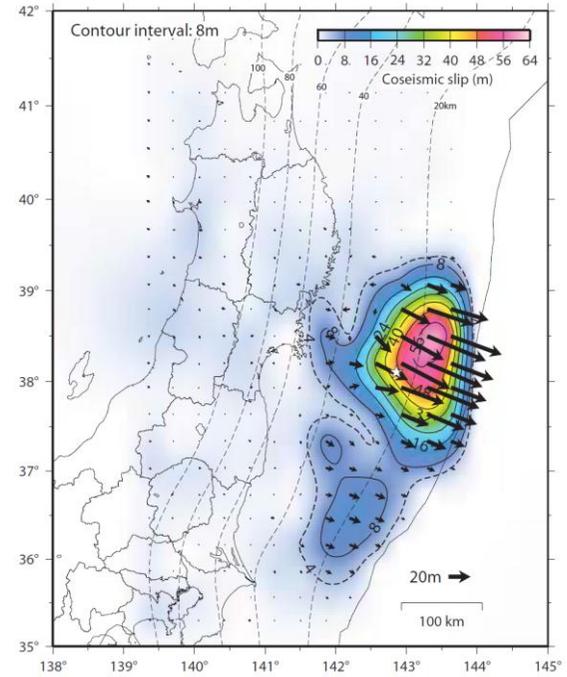
Fig. II-1-8 Slip distribution associating with main quake and aftershock distribution.

Shao et al. (2011), by using teleseismic waveforms, conducted an inversion analysis of the source rupture process of the Tohoku earthquake, and proposed the seismic source model with an estimation of a large slip of about 55 m occurring on the west side of the trench (Figure II-1-8, middle).

All of the above three seismic source models based on long-period ground motions estimated slips in the range of 55 m to just less than 70 m, which are consistent with models based on GPS observation and seafloor crustal movement observation. These studies found that slips caused by the recent earthquake, depending on areas, may have been between 55 m and not quite 70 m. Further refinement in investigation and analysis is expected.

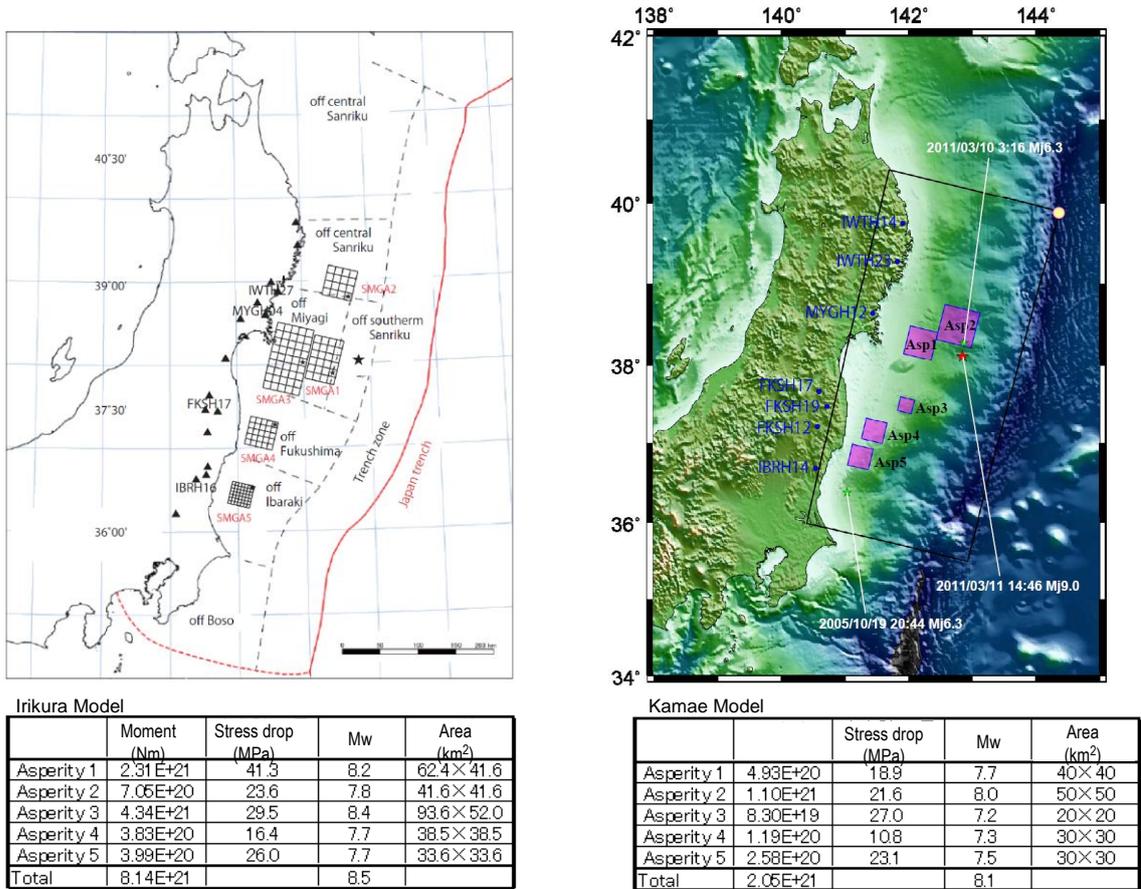
Fig. II-1-9 Source models illuminating strong ground motion.
 Left figure: model proposed by Irikura and Kurahashi.
 Right figure: model by proposed by Kawabe and Kamae.

Irikura and Kurahashi (2011), on the assumption of a configuration of asperities, proposed a seismic source model to simulate strong ground motions based on the empirical Green's function method (Figure II-1-9, to the left). Meanwhile, Kawabe and Kamae (2011) are also proposing their own model (Figure II-1-9, right side). These models enabled characteristic seismic waveforms observed at observation stations in the coastal areas from Iwate Prefecture to Ibaraki Prefecture to be simulated for the most part. The areas generating short-period strong motions as shown in Figure II-1-9 are not the same asperities estimated from long-period ground motions, in which there

occurred a large slip along the Trench, but are mostly found in the deep areas on the west side of the hypocenter (rupture starting point), which is one of the major characteristics common to the models proposed by Irikura/Kurahashi (2011) and Kawabe/Kame (2011). It is considered that such a concentration of asperities in the plate subducting direction from the point of view of the hypocenter is causing a directivity effect, the dependence of the shape and the strength of the short-period waves on the rupture propagation direction. The fault model method allows for the directivity effect. Another major characteristic is that all of the seismic moments released in the areas established as asperities generating short-period strong motions were estimated as having moment magnitudes of Mw8.4 or lower.

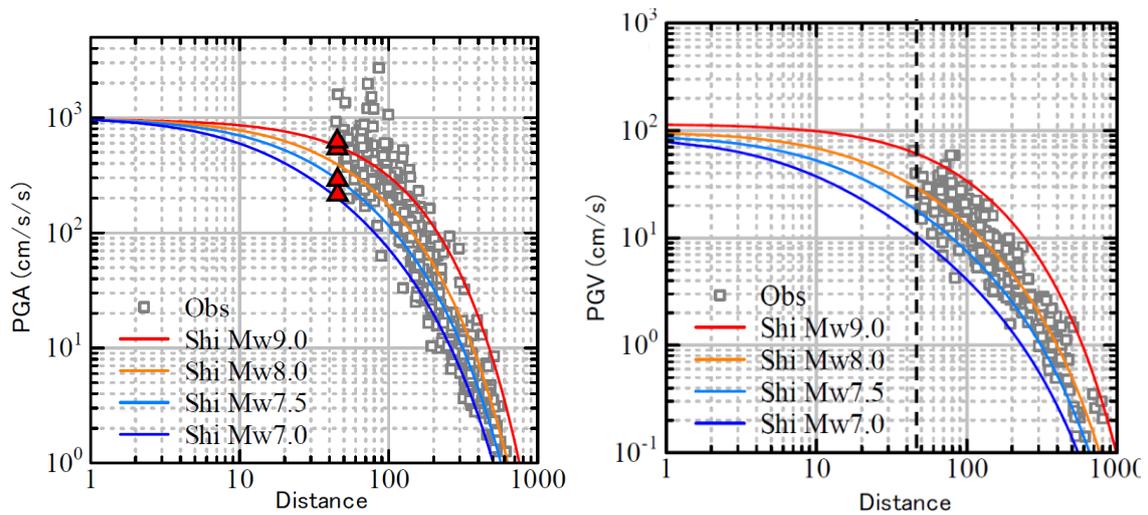
Meanwhile, Irikura and Kurahashi (2011) compared the values of peak ground acceleration and maximum velocity observed in the Tohoku earthquake with the findings using an attenuation relationship (strong motion prediction equation) (Figure II-1-10). Based on the comparison results, they note that peak ground acceleration (PGA, Figure II-1-10, right side) was virtually equivalent to an earthquake of Mw8 in terms of strong ground motions. In addition, peak ground acceleration (PGA, Figure II-1-10, left side) was virtually equivalent to an earthquake of Mw8 in the distance of over 100 km. However, confined to the vicinity of the fault, there is a tendency to exceed Mw8.0 earthquake level. The one of the reasons is that, by the attenuation relationship, the directivity effect important for short-period waves is not expressed.

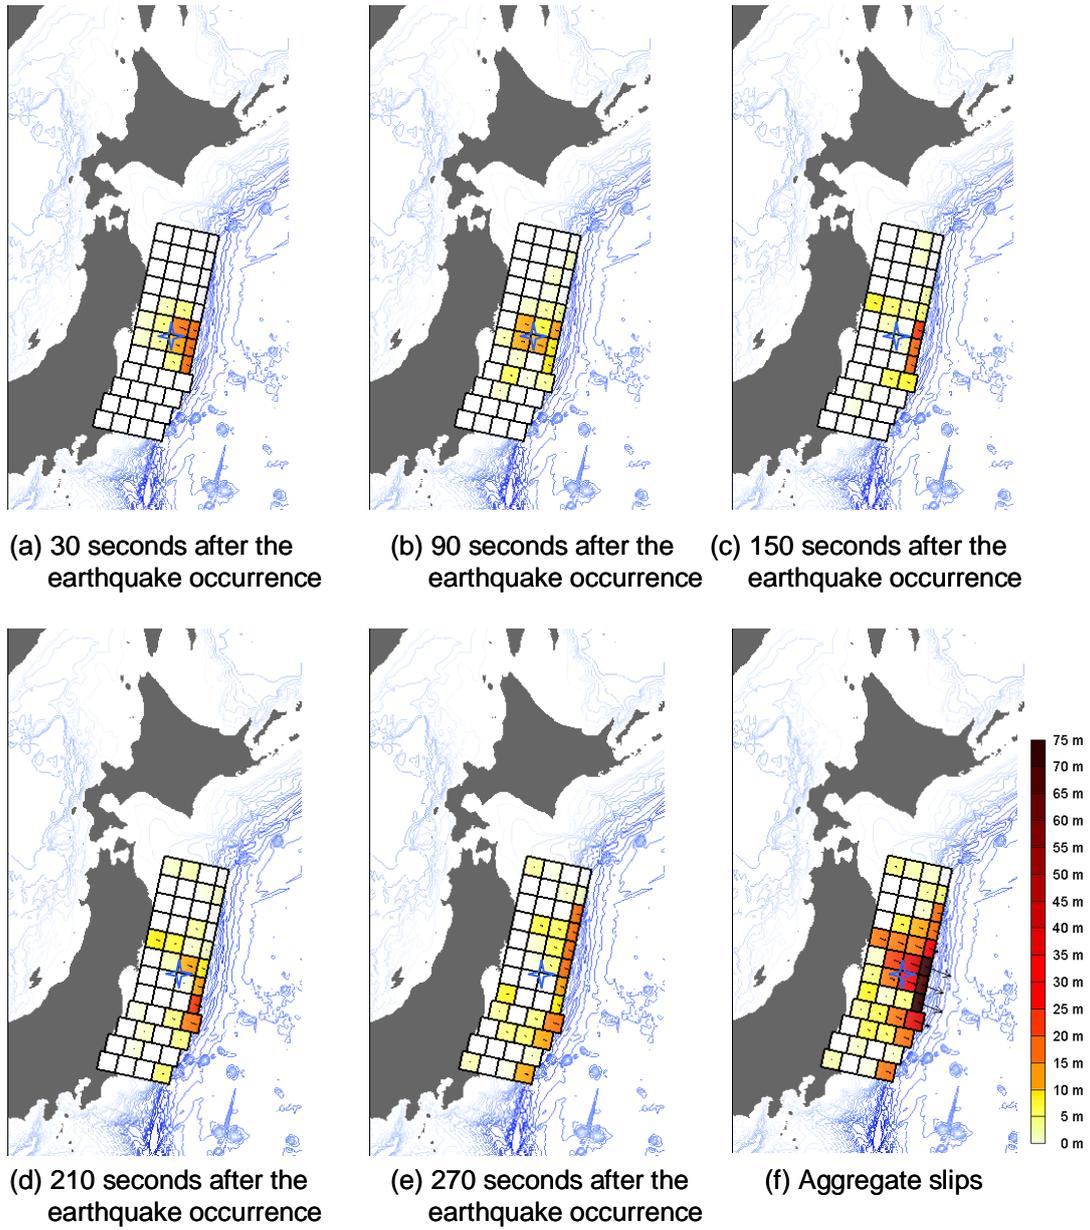
Fig. II-1-20 Analysis results using tsunami source model of JNES: trends in distribution of slips (shown by (a) to (e)) and the aggregate slips (shown by (f)).

The estimated tsunami source rupture process (tsunami source model) by the joint inversion analysis is as shown in Figure II-1-20(a) to (e) showing trends in distribution of slips, by every minute, after the earthquake occurred. Indicated in Figure II-1-20(f) is the distribution of aggregate slips of these slips by sub faults. The figures above found that, in the first place, plate slips had propagated near the rupture start point. Then supposedly, they propagated into slightly deeper areas on the west side of the rupture start point, after which they shifted to the shallow areas mostly along the trench and continued to propagate. A concentration of asperities of large slips was located in the shallow areas along the trench, resulting in a maximum slip of above 70 m. These findings above are virtually consistent with the estimation results of the seismic source rupture process models, and of the tsunami source rupture process, in universities and research institutes at home and abroad.
