(2) Conditions of the Fukushima Dai-ichi NPS

This part overviews the current conditions of the Fukushima Dai-ichi NPS. Specifically, it introduces the current conditions of cooling the reactor and the SFP, the status of discharge of radioactive materials, contamination over on-site of the NPS, and the seismic safety in each Unit of the Fukushima Dai-ichi NPS.

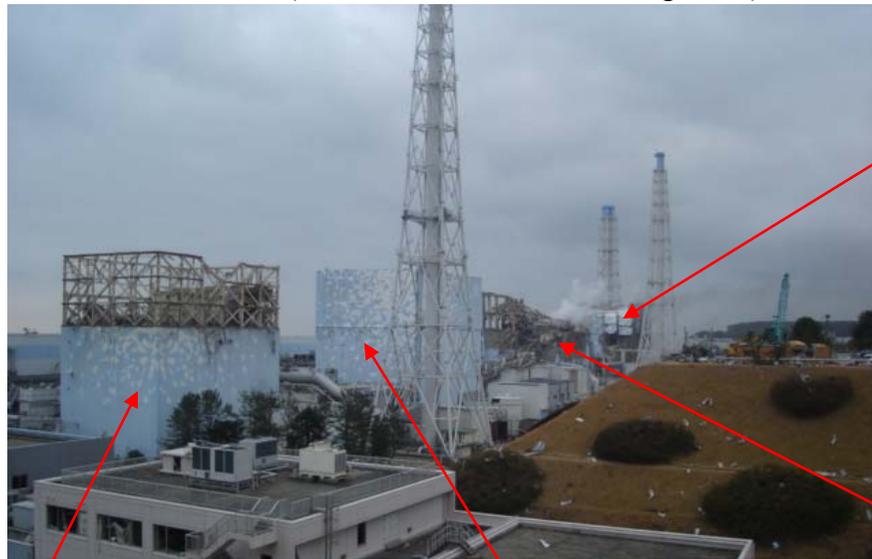
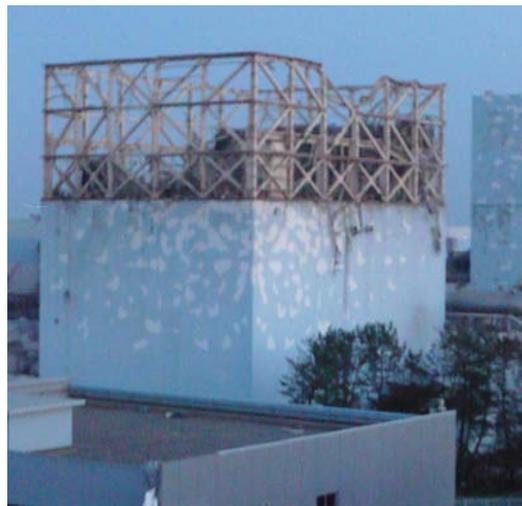
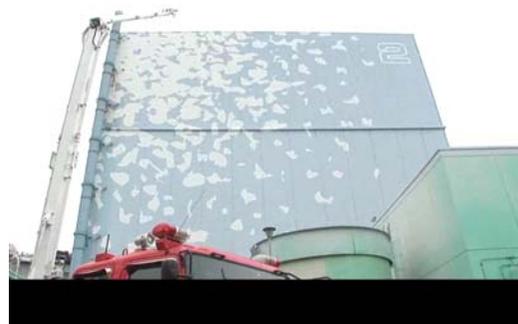
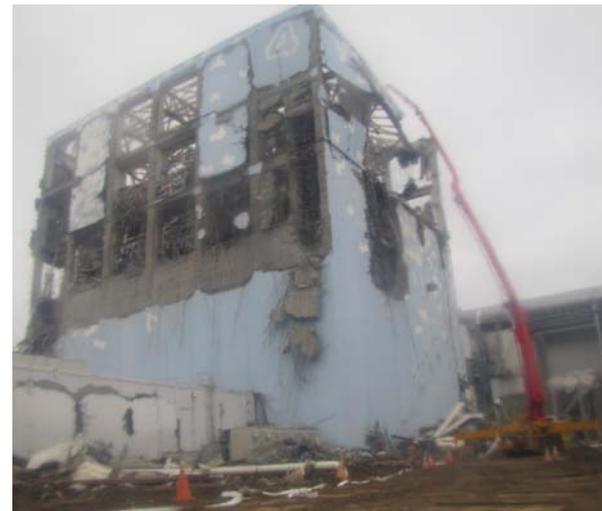
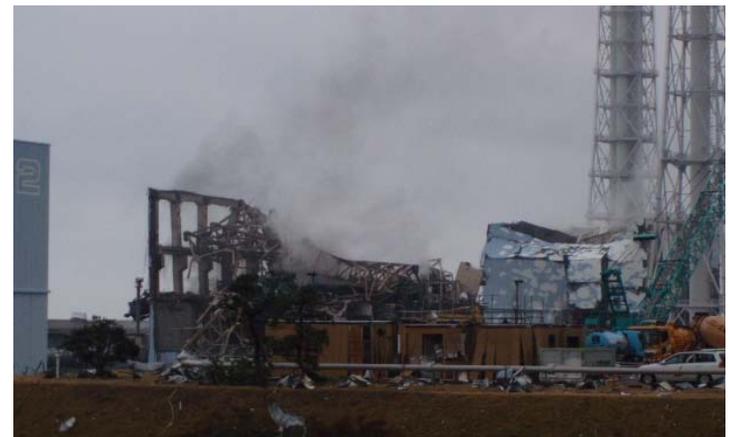
Figure II-2-26 Condition of Reactor Buildings, Units 1 to 4, Fukushima Dai-ichi NPS

The conditions of reactor buildings at Units 1 to 4 are shown in Figure II-2-26.

A large sound was confirmed and damage to the reactor building of Unit 4 was ascertained around 6:00 on March 15 (Figure II-2-26). Regarding the cause of this, in the June Report, the possibility was indicated that due to PCV venting in Unit 3, the current of air in the PCV venting including hydrogen gas flowed through the ventilation stack (Figure II-2-35 and Figure II-2-36).

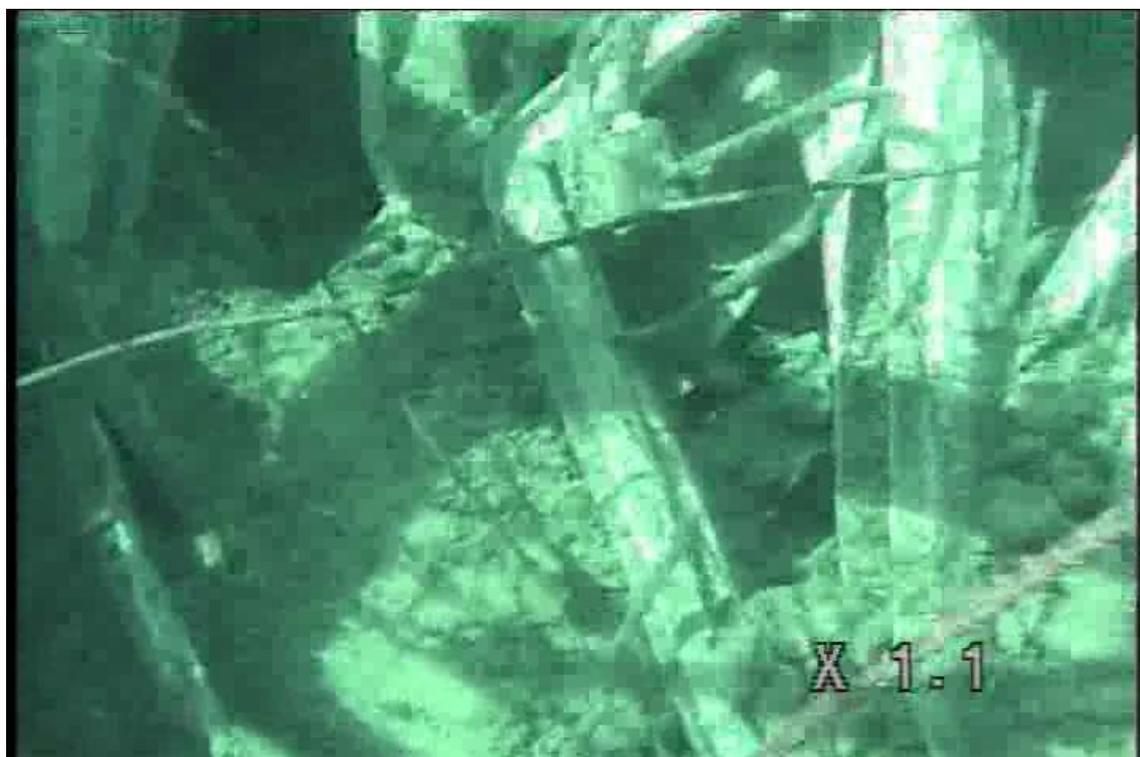
Figure II-2-41 Unit 3 Spent Fuel Pool Viewed from Underwater

When pool water sampling was conducted on May 8, filming by video camera was done at the same time. Picture is shown in Figure II-2-41. Because a large amount of rubbles fell inside of pool water, conditions of fuel etc. stored in pool couldn't be confirmed.

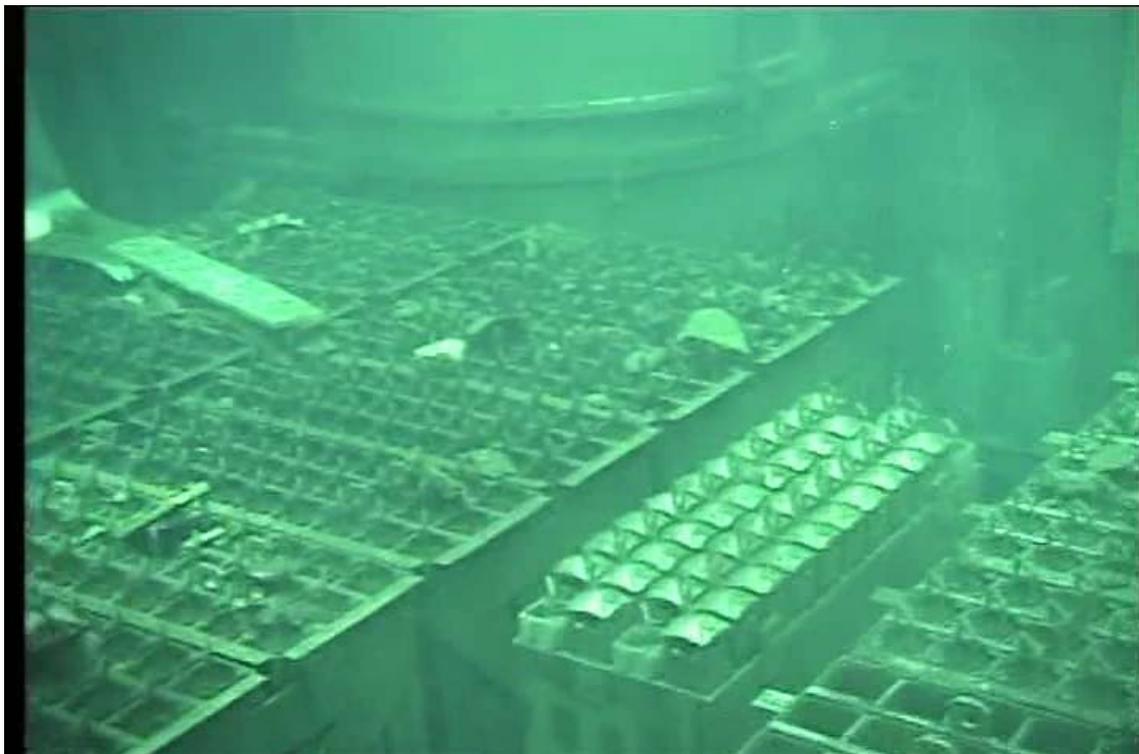
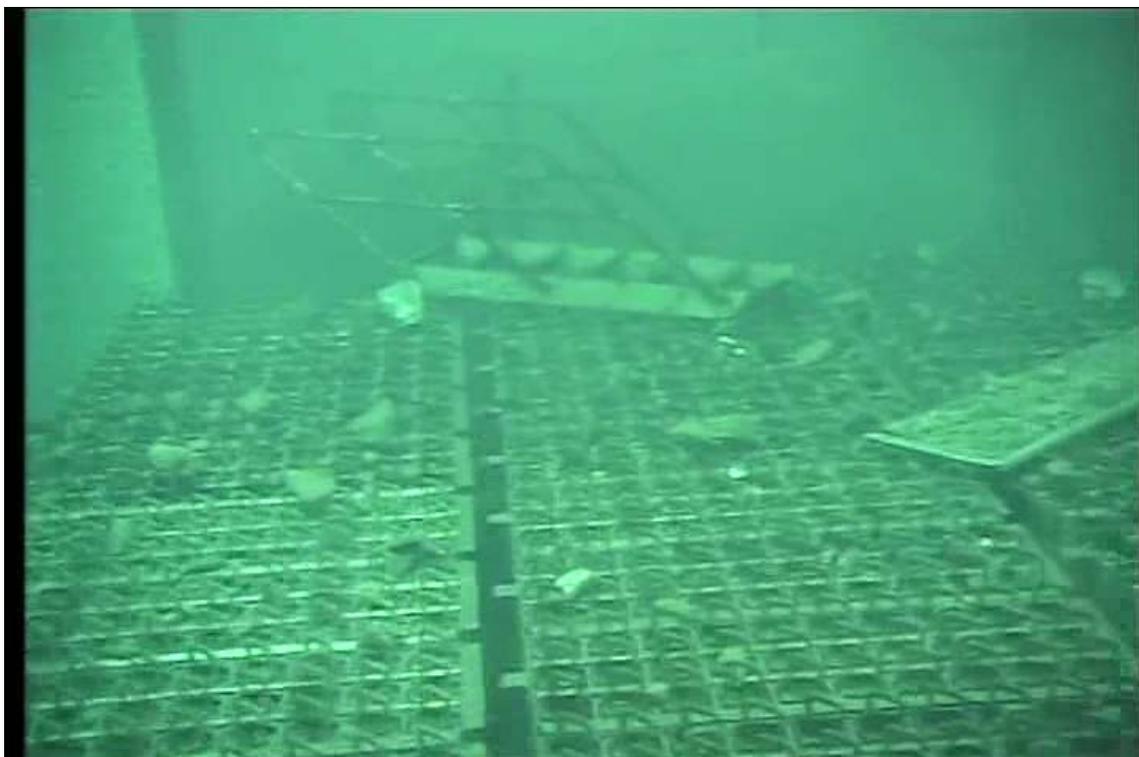
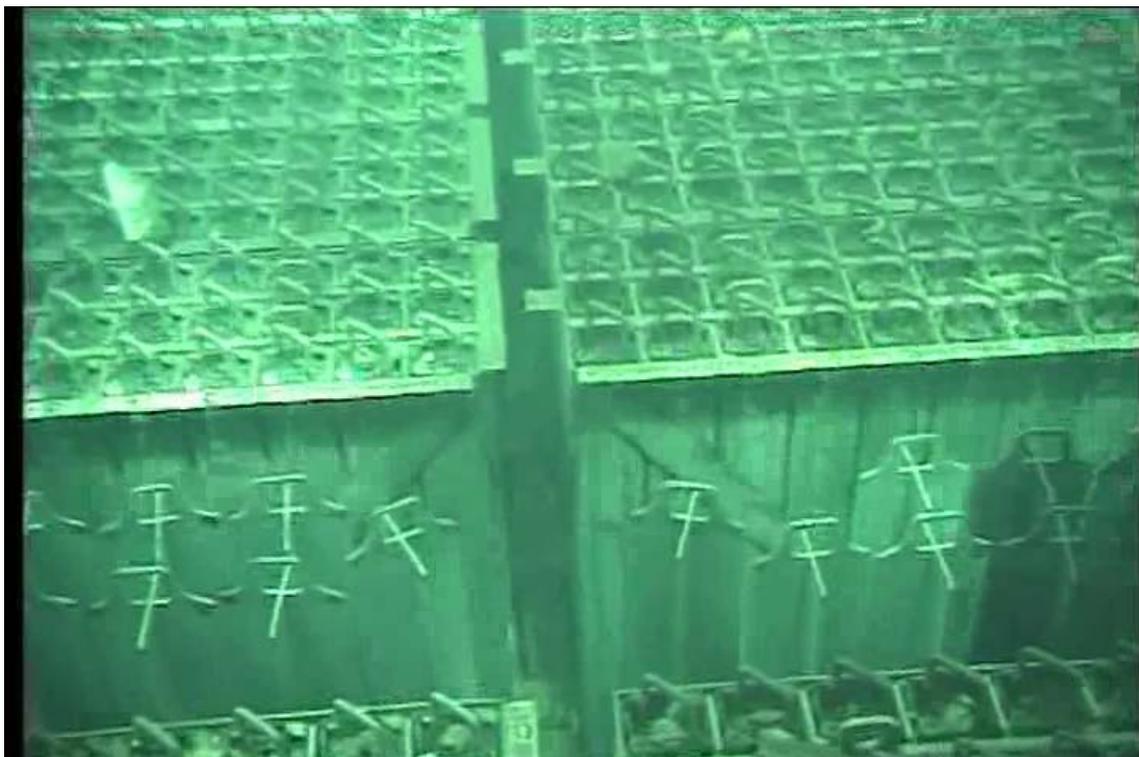
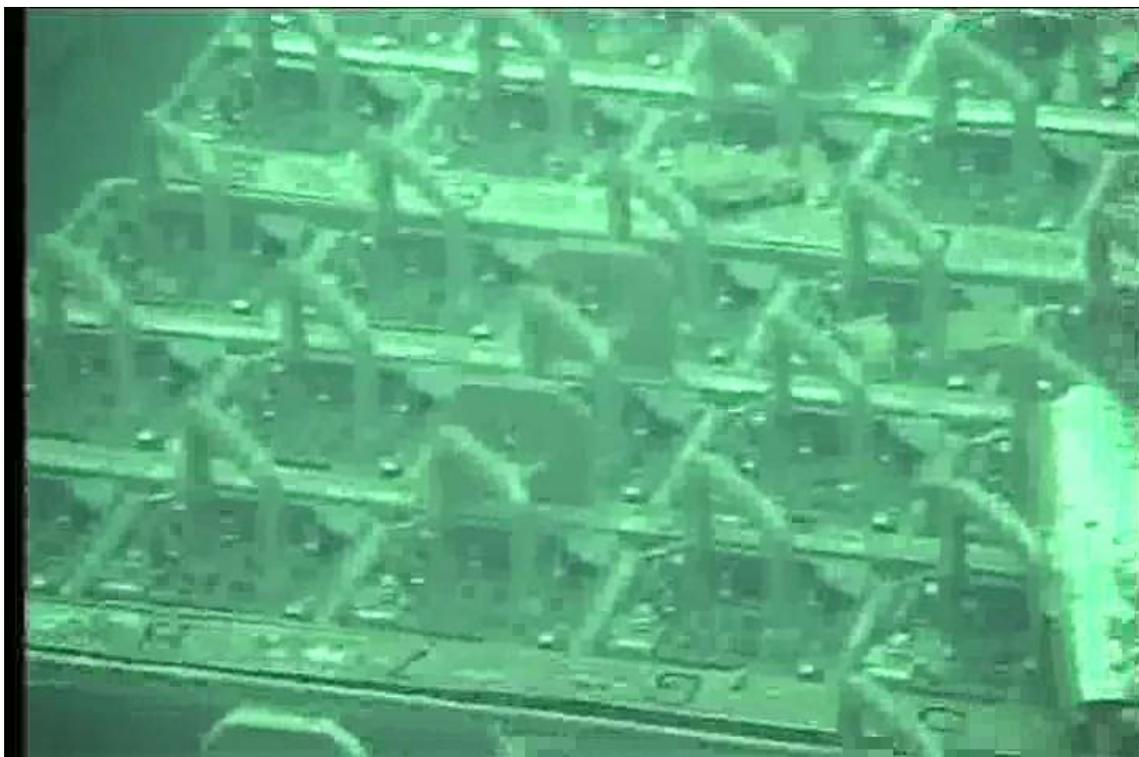
When pool water sampling was conducted on May 7, filming by video camera was done at the same time. Pictures are shown in Figure II-2-46 to Figure II-2-49. Even though small and large rubbles fell down into pool water, it was observed that fuel stored in SFP had kept a condition of being stored in rack.

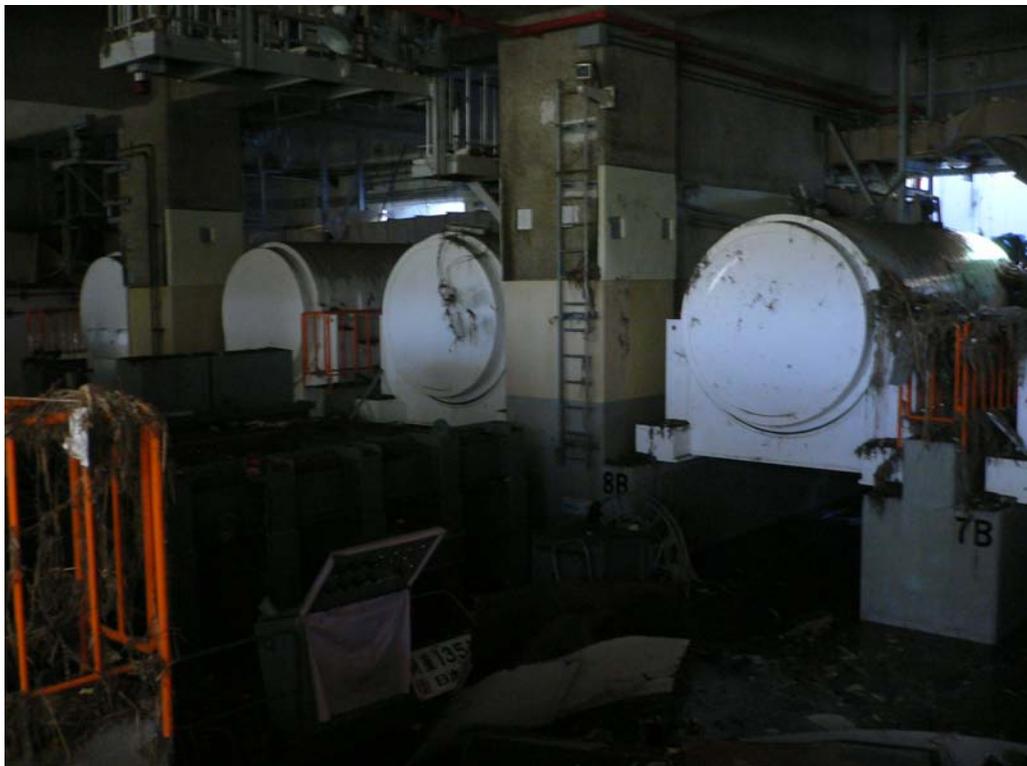
Figure II-2-56 Situation in Dry Storage Cask Facility

Except that they are covered with the rubbles that was washed into the building by the tsunami, the casks remained bolted in their original positions, and so far, no issues on their integrity have been identified from appearance. The dose level within the cask building (up to few tens of $\mu\text{Sv/h}$) is not abnormally high compared to background radiation. Dry storage casks have high seal performance ensured by a double sealing structure through primary and secondary covers, but at the moment, the integrity of their sealing performance has not yet been verified directly through leakage tests. Figure II-2-56 is a photo showing the conditions inside the cask building.

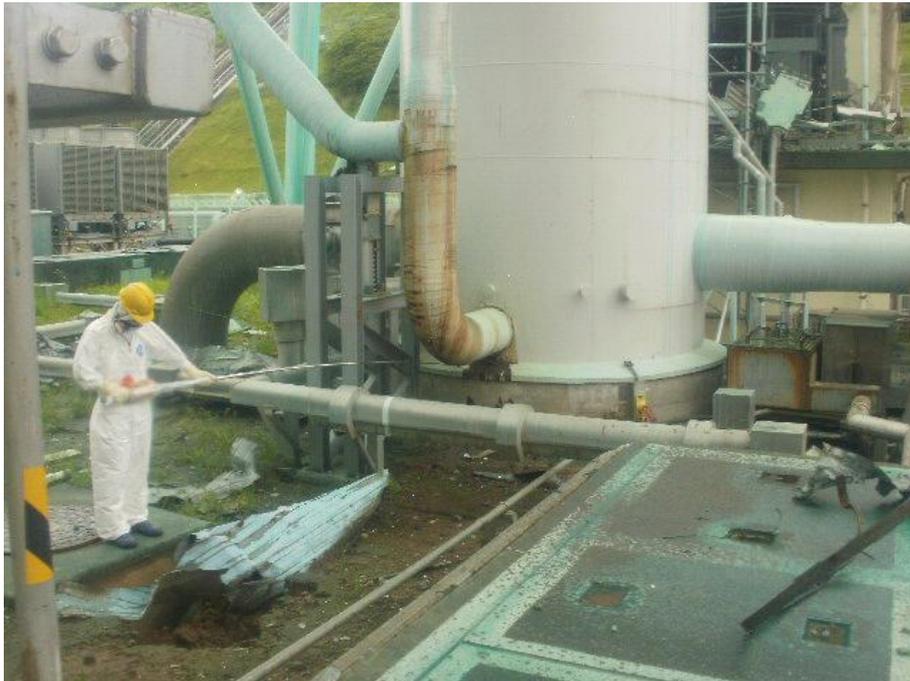
Location: Near the standby gas treatment system pipe joint at the bottom of the main exhaust stack of Units 1 and 2
Time: August 1, 2011, around 14:30
Photographed by: TEPCO

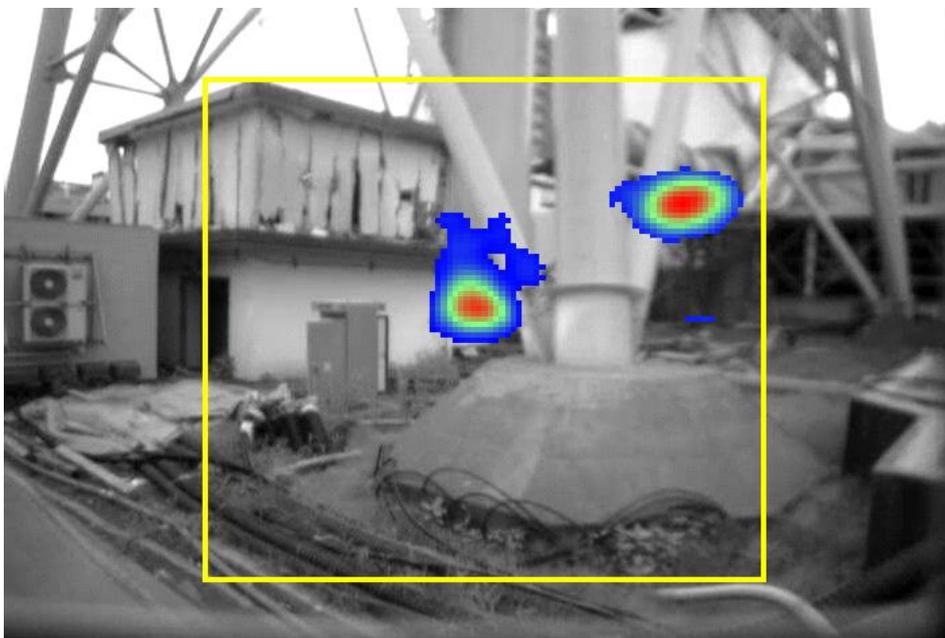
Location: Near the main exhaust stack of Units 1 and 2
Time: July 31, 2011, around 16:00
Photographed by: TEPCO

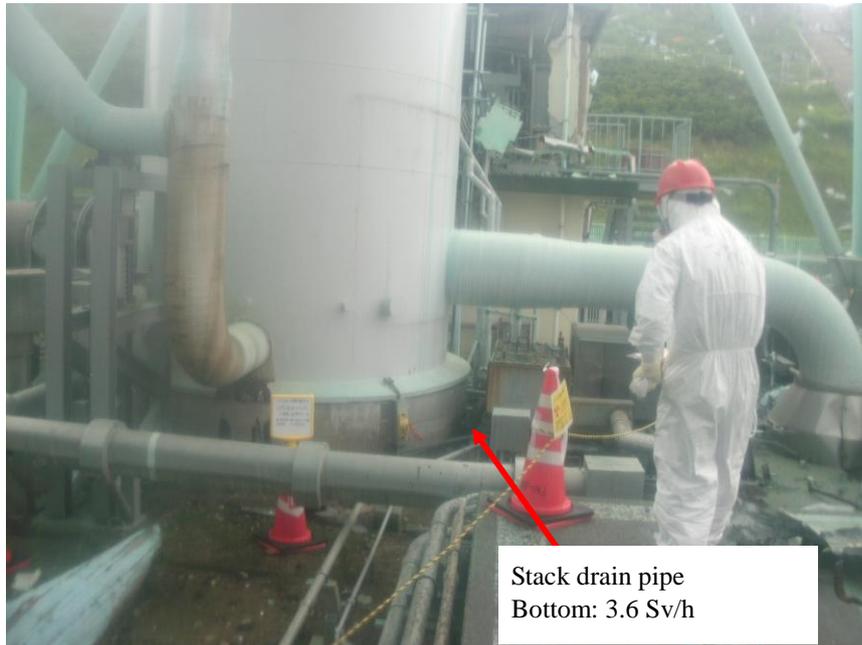
Location: Stack drain pipe at the main exhaust stack of Units 1 and 2 (view from the east side)

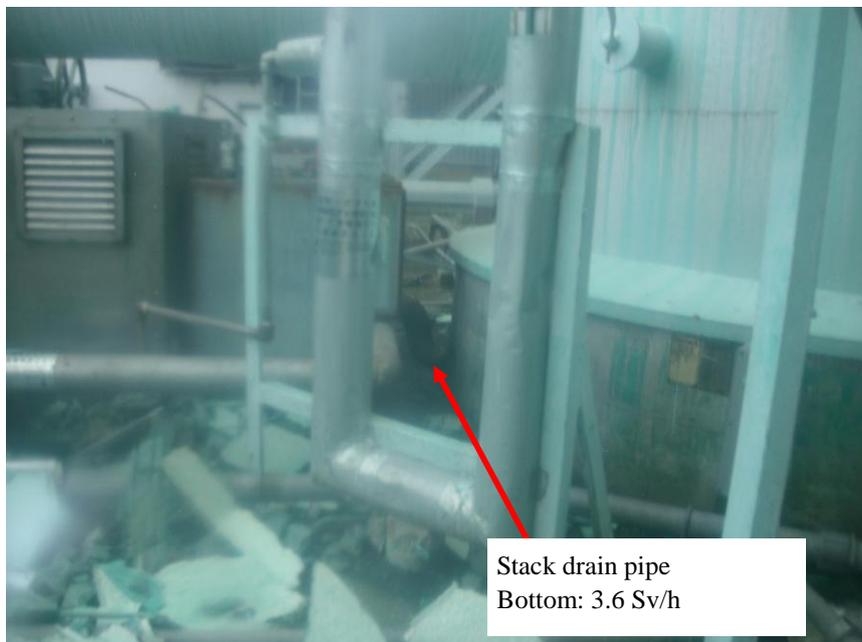
Location: Stack drain pipe at the main exhaust stack of Units 1 and 2 (view from the west side)
