2. Damage caused by the earthquake and tsunami hitting Fukushima NPSs

(1) Seismic ground motion and tsunami height observed at Fukushima Dai-ichi NPS

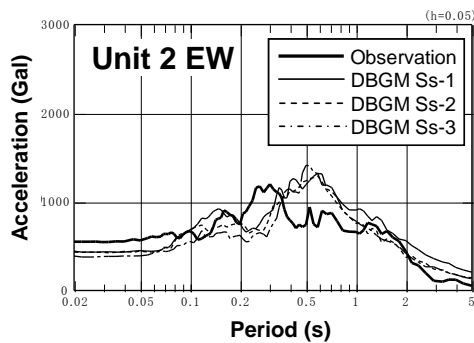
Fig. III-2-2(a) Acceleration seismogram on the base mat at R/B in Unit-2 at Fukushima Dai-ichi NPS.

motion Ss at the site where seismometers were installed at the base mat level on the first basement level of the reactor buildings. The table shows that observed maximum acceleration is mostly smaller than maximum response acceleration to the standard seismic ground motion Ss. However, maximum acceleration observed in east-west direction at Units 2, 3 and 5 is larger than maximum response acceleration to Ss. Figure III-2-2(a) shows acceleration time history of east-west component in Unit 2.

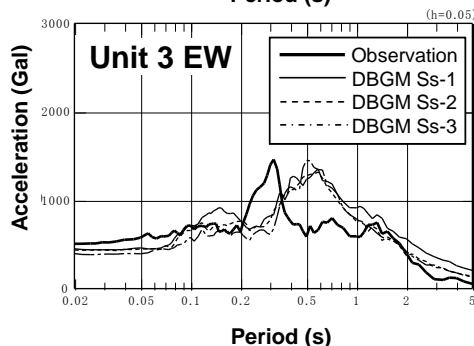
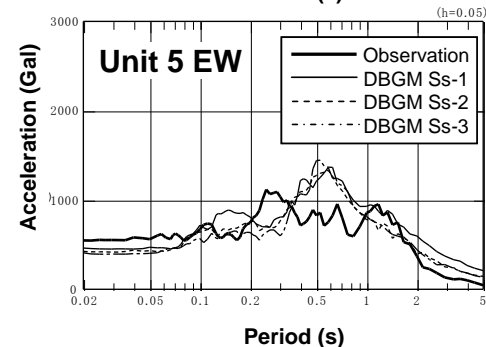
Fig. III-2-2(b) Response spectra on the base mats at R/Bs at Fukushima Dai-ichi NPS.

Figure III-2-2(b) shows the comparison chart between the response spectra of observed seismic ground motion at the base mat level of the reactor building of Units 2, 3 and 5 and the response spectra at the base mat level of the building, inputting the standard seismic ground motion Ss into the base mat. The Figure shows that the response spectra of observation records of Units 2, 3 and 5 exceeds the response to Ss with a period of 0.2 to 0.3 second.

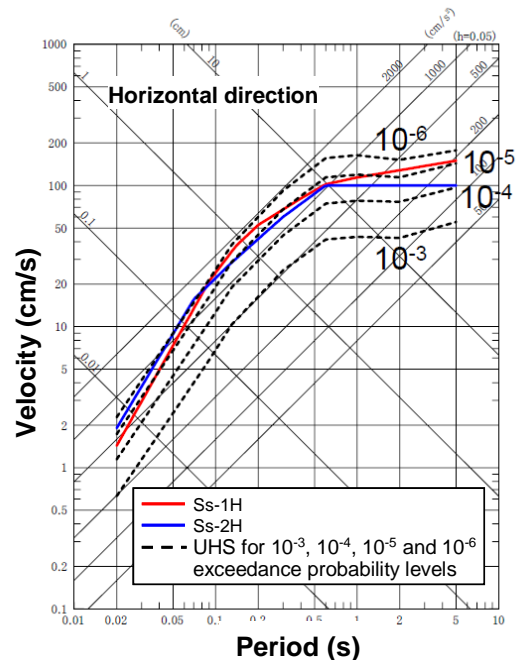
Fig. III-2-3 DBGM Ss and Uniform Hazard Spectra (UHS) for Fukushima Dai-ichi NPS.

Figure III-2-3 shows the uniform hazard spectra of Fukushima Dai-ichi NPS. In the Figure, Ss-1H and Ss-2H response spectra are also shown. The figure shows exceedance probability of the standard seismic ground motion Ss is within the range of 10^{-4} to 10^{-6} per year.

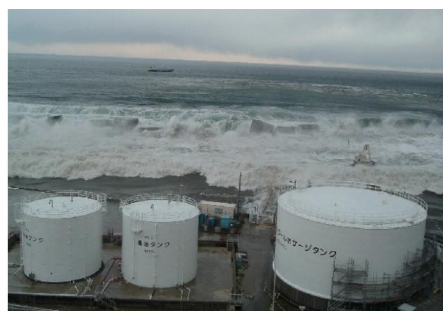
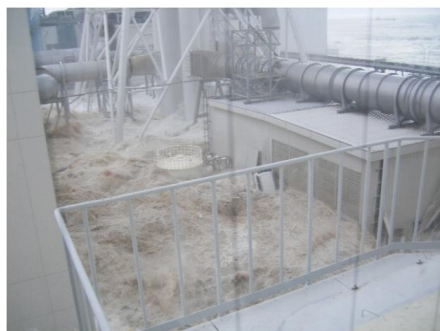
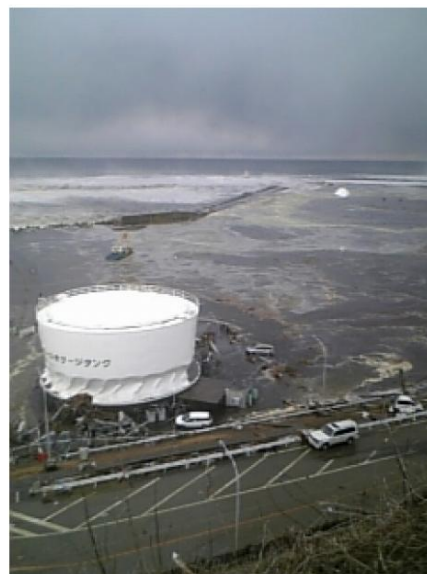
Fig. III-2-4(b) Photos showing plant damages at the Fukushima Dai-ichi NPS.

【福島第1原発 津波来襲状況 2011年3月11日 固体廃棄物貯蔵庫東側のり面(6号機の近傍(南側)から東側を撮影)＝東京電力提供】

【福島第1原発への津波来襲状況 2011年3月11日 廃棄物処理建屋4階から北側を撮影】午後3時43分ごろ(2)＝東京電力提供】

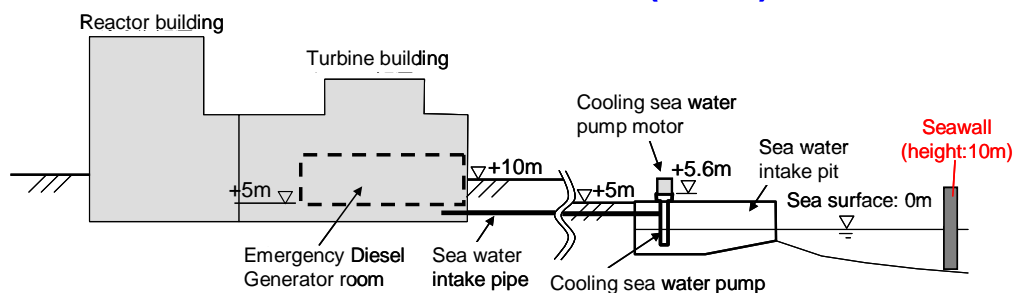
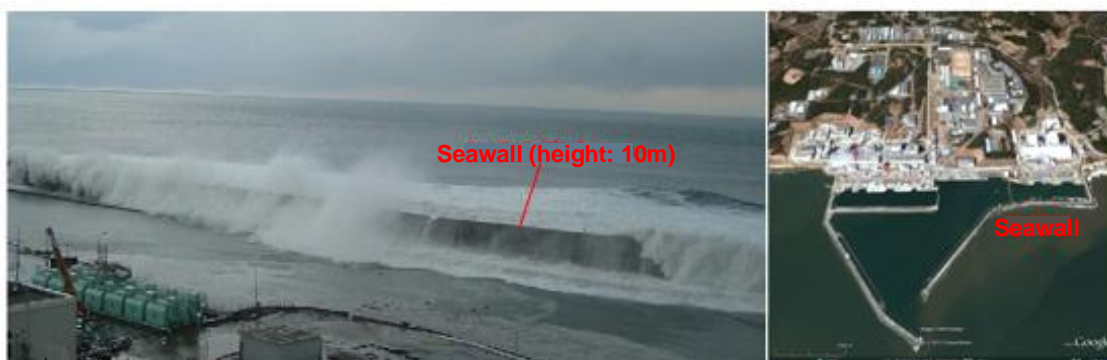
Fig. III-2-5 Tsunami getting over seawall at the Fukushima Dai-ichi NPS.

Cross section of Fukushima Dai-ichi (Unit-1)

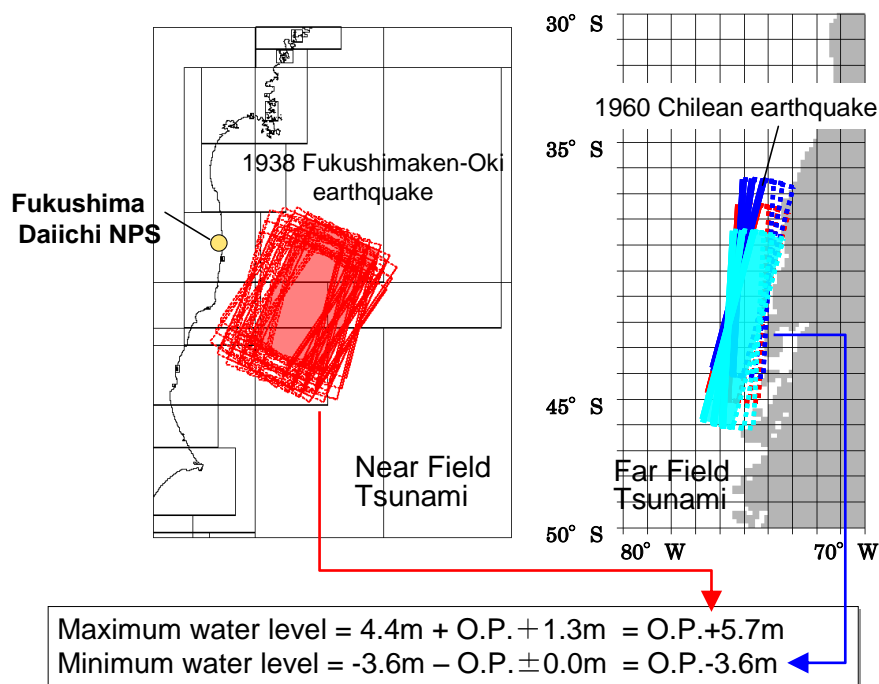
Fig. III-2-6 Design tsunami level evaluated by TEPCO for the Fukushima Dai-ichi NPS.

As shown in Figure III-2-6, in the application document for establishment permit, subject tsunami source is Chile Earthquake (M9.5 in 1960) and the design basis tsunami water level is 3.1 m. In 2002, TEPCO evaluated the design tsunami height based on the “Tsunami Assessment Method for Nuclear Power Plants in Japan (2002)” of the Tsunami Evaluation Subcommittee, the Nuclear Civil Engineering Committee, Japan Society of Civil Engineers (hereafter referred to as Tsunami Assessment Method of JSCE), assessing off the coast of Fukushima Prefecture Earthquake (M7.9 in 1938) shown in Figure III-2-6 as M8.0 voluntary, and the highest water level of each Unit was set as 5.4 to 5.7 m. According to the evaluation, elevation of Unit 6 sea water pump motor of

emergency diesel generator was raised up 20 cm and also that of sea water pump motor for High Pressure Core Spray was raised up 22 cm.

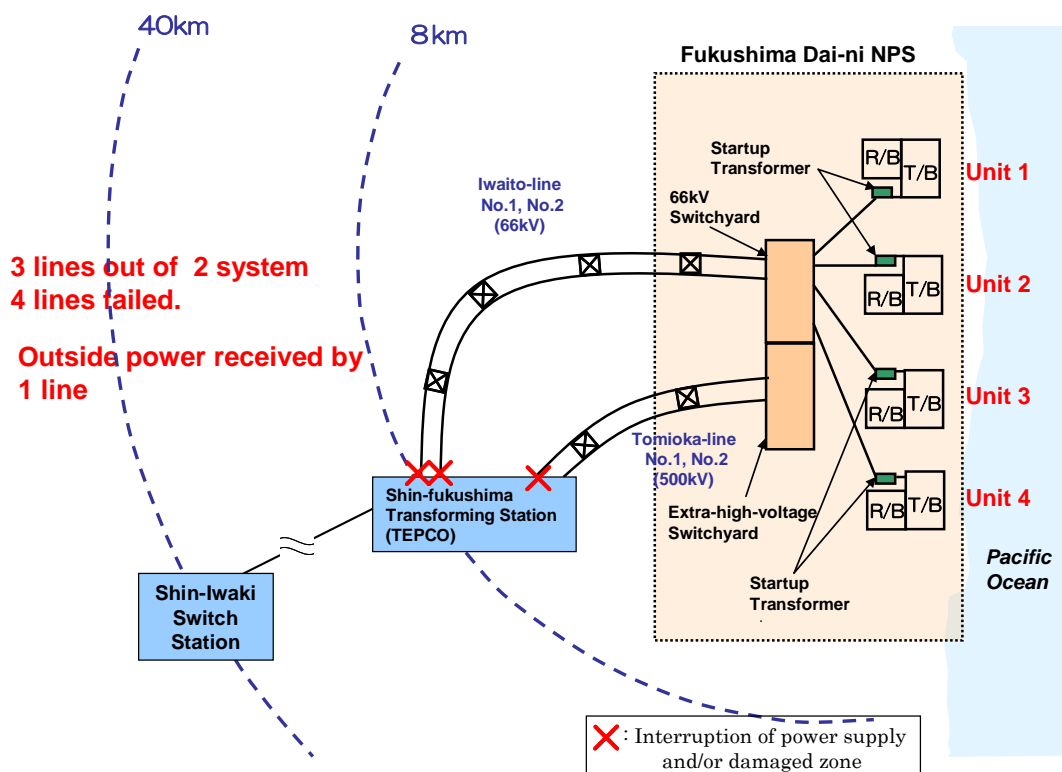
Fig. III-2-8(a) Damage of external power supply systems for the Fukushima Dai-ichi and Dai-ni NPSs (1).

Figures III-2-8(a) and III-2-8(b) show the transmission network of external power supply of Fukushima Dai-ichi NPS and the damage situation. As shown in the Figures, the Okuma Nos. 1 and 2 power transmission lines (275 kV) from Shin Fukushima Power Substation connected to the normal high voltage switchboards of Units 1 and 2 via the switchyards for Units 1 and 2, and in addition, TEPCO nuclear line (66 kV) from Tohoku Electric Power Co., Inc. connected to the normal high voltage switchboard of Unit 1 via the switchyards for Units 1 and 2. As to Units 3 and 4, the Okuma Nos. 3 and 4

The earthquake caused damage to the breakers of the switchyards of Units 1 and 2. As to TEPCO nuclear line from Tohoku Electric Power, although it is not possible to estimate the cause, cables were damaged. Concerning Units 3 and 4, in addition to the Okuma No. 3 transmission line under construction, the breakers of Nos. 3 and 4 transmission lines on the side of Shin Fukushima Power Substation failed. In addition, for Units 5 and 6, one transmission line tower (tower No. 27) connecting to the switchyards of Units 5 and 6 was collapsed. As a result, all external power supplies of Units 1 to 6 were lost.

The seismic intensity in the area around Shin Fukushima Power Substation is estimated to be 6 upper. The Tomioka No. 2 transmission line (500 kV) and the Iwaido No. 2 transmission line (66 kV) to Units 1 to 4 of Fukushima Dai-ni NPS stopped transmission due to failure of devices on the side of the switchboard, caused by strong ground motion in this earthquake. However, the power supply to Units 1 to 4 was continued since the Tomioka No. 1 transmission line could supply electric power (refer to Fig.III-2-8(a)).

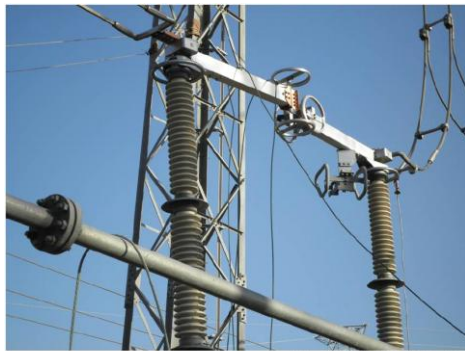
**Okuma line 3L, Ground wire
(disconnected)**

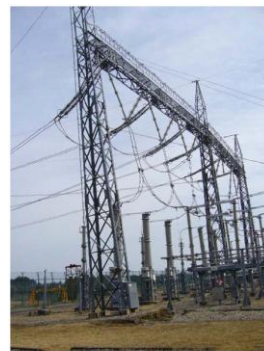
**Okuma line 3L & 4L, Steel
structure for lead-in (tilted)**

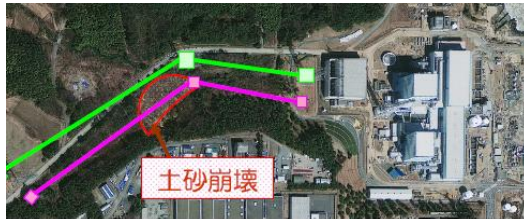
Landslide of slope

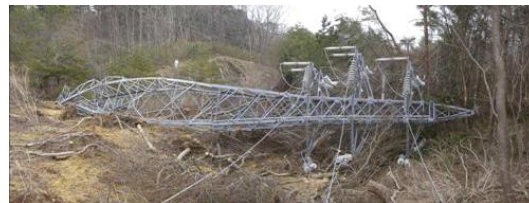
Collapsed tower

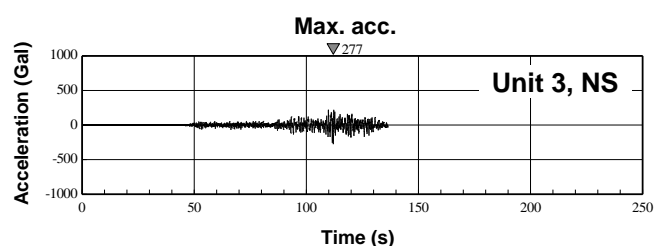
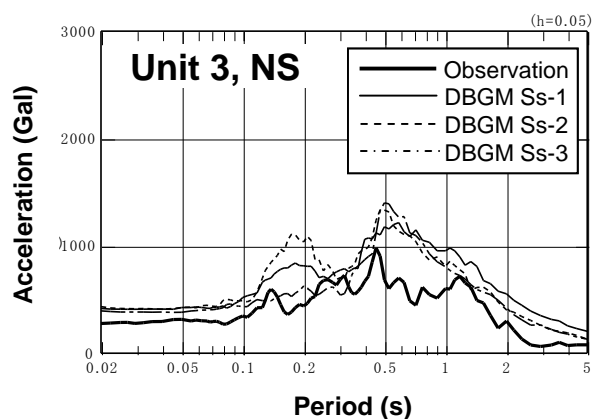
Fig. III-2-9 Acceleration seismogram and response spectra on the base mat at R/B in Unit-3 at the Fukushima Dai-ni NPS.

Figure III-2-9 shows the acceleration time history and the response spectra of observed seismic ground motion at the base mat level of the reactor building of Unit 3 whose acceleration in horizontal direction was highest. The figure also shows the response spectra on the base mat level inputting the standard seismic ground motion Ss into the base mat. The figure implies that the response spectra obtained from observation records

fall below the response spectra inputting the standard seismic ground motion Ss

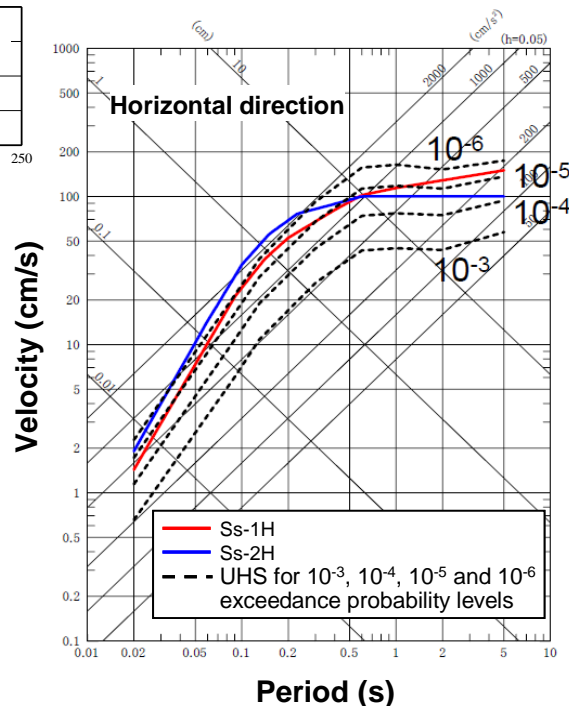
Fig. III-2-10 DBGM Ss and Uniform Hazard Spectra (UHS) for the Fukushima Dai-ni NPS.

Figure III-2-10 shows the uniform hazard spectra of Fukushima Dai-ni NPS. The response spectra of Ss-1H and Ss-2H are also shown. The Figure shows that the exceedance probability of the standard seismic ground motion Ss is within the range of 10^{-4} to 10^{-6} per year.

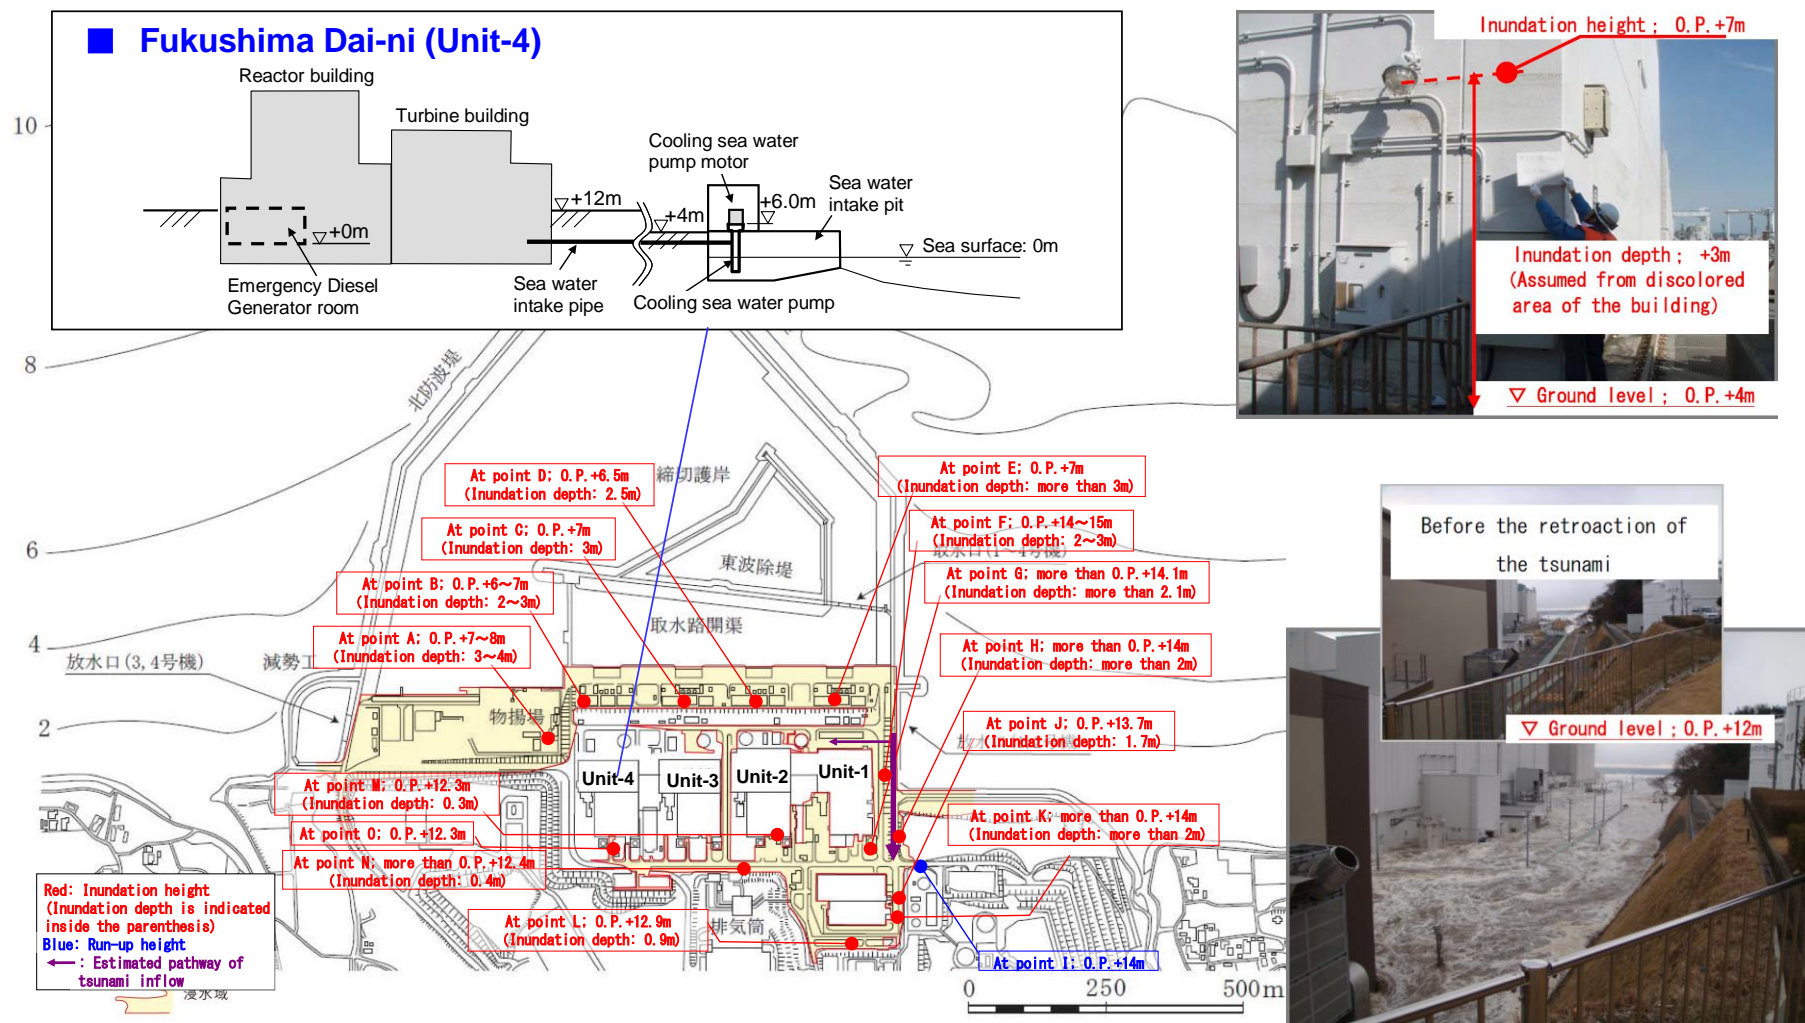
Fig. III-2-11(a) Damage of Fukushima Dai-ni NPS due to the tsunami.

TEPCO reported about the inundation height based on the results of trace investigation at flooding as well as Fukushima Dai-ichi NPS previously described in section 2.(1). Figure III-2-11(a) shows the report results. Fukushima Dai-ni NPS consists of the ocean-side area where seawater pumps, etc. are installed and the raised mountain-side area where reactor buildings, turbine buildings, etc. are installed. Tsunami at first flooded from the ocean-side area in front of the site. Afterward, as shown in the Figure, tsunami flooded from the narrow space between the south side of Unit 1 and the slope in the mountain-side area, and reached the back of the mountain-side area. There was no flooding except from the narrow place. The inundation height in the ocean-side area was O.P. approximately +6.5 to 7 m, and O.P. approximately +14 to 15 m in the mountain-side area (O.P. means base level of Onahama Port construction).

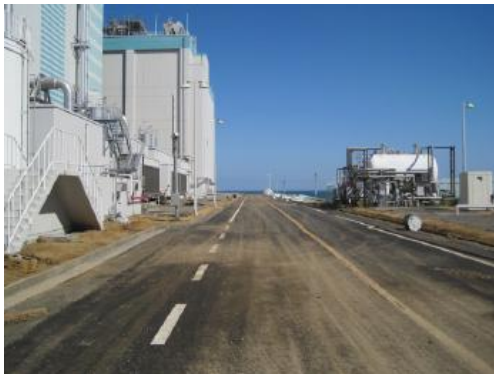
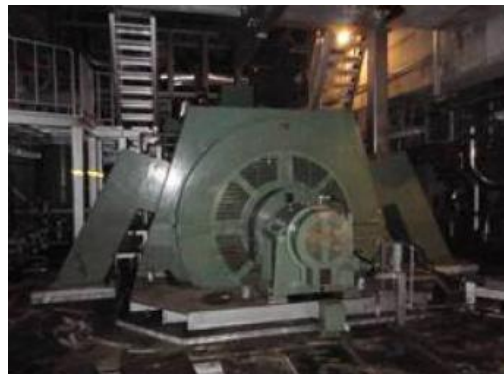
The Emergency Diesel Generators installed in the basement of the reactor buildings (height: 0 m) kept their functions for Unit 3 and 4, however, those for other Units lost

their functions by completely flooding (Fig. III-2-11(b)).

Damages of reactor building and emergency diesel generator (Unit 1)
