Discovery of a crack in a connection valve between tanks for concentrated water* treated by Reverse Osmosis at Fukushima Daiichi NPS

On 17 September 2014, the Nuclear Regulation Authority (NRA) of Japan received a report from TEPCO regarding a recent incident at Fukushima Daiichi NPS, pursuant to the Act on Regulation of Nuclear Source Material, Nuclear Fuel Material and Nuclear Reactors. The report delineates as follows:

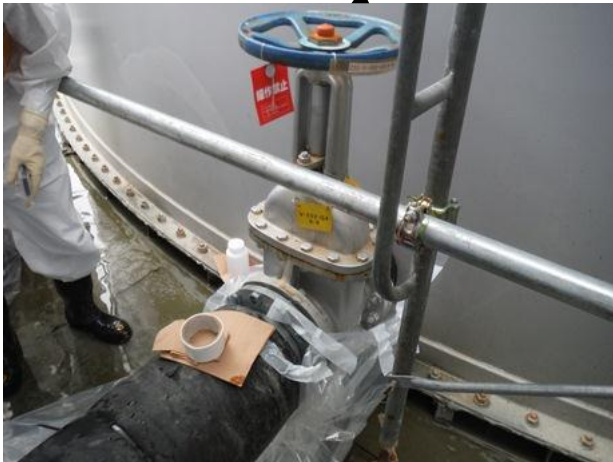
- TEPCO found on 4 September that the concentrated water treated by Reverse Osmosis (RO) was leaking from a connection valve between A5 tank and A6 tank in the G4 South Tank Area. The leaked water was remaining within the dike surrounding the area.
- As a result of inspection by TEPCO, it was found on 17 September that the connection valve had a crack which penetrated the valve.
- Therefore, this crack constitutes a lack of functionality in ensuring safety in the nuclear reactor facility under TEPCO's Implementation Plan.

the valve where the leakage was found

- To swiftly inspect similar valves connecting storage tanks which are not surrounded by dikes, to ensure there are no cracks.
- To take prevention measures including review of inspections of equipment (i.e. tanks, valves and connection pipes) in light of the result of cause-finding measure.

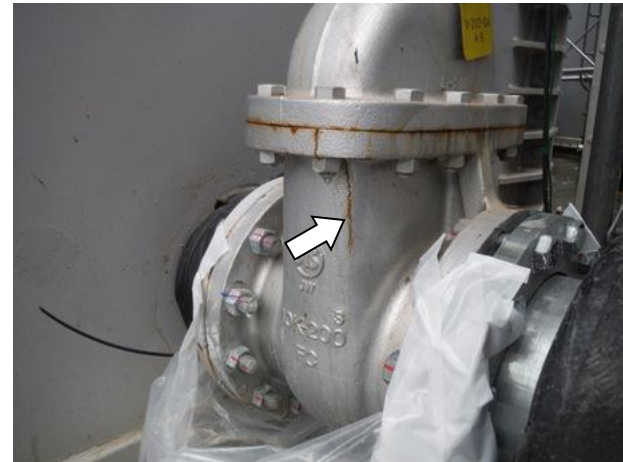
location of the crack
