# Press Release

Nuclear Regulation Authority, Japan

On 2 October, the Nuclear Regulation Authority (NRA) received a report from TEPCO pursuant to the Act on Regulation of Nuclear Source Material, Nuclear Fuel Material and Nuclear Reactors. The report delineates it was found by TEPCO that the water was leaking from the top plate of storage tank (B-A5) in B Tank South Area into/outside of the dike surrounding the tank.

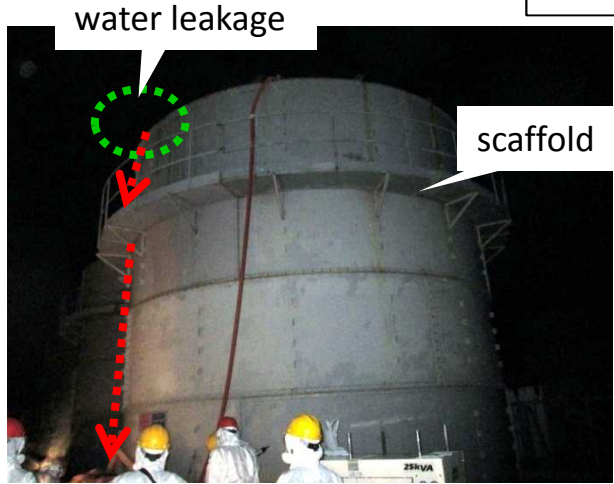
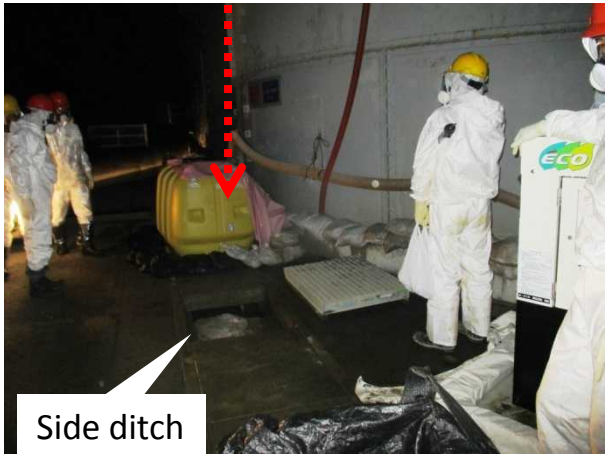
The water was leaking from the top plate of storage tank(B-A5) in B Tank South Area into/outside of the dike surrounding the tank.

- To screen contaminated area;
- To recover promptly the water and soil in B Tank South Area;
- To analyze promptly sampling-water obtained in the side ditch near B Tank South Area and the drainage channel toward its outlet; and
- To take countermeasures for contaminated water not to flow to the sea.
