INTERNATIONAL ATOMIC ENERGY AGENCY

ENGINEERING SAFETY REVIEW SERVICES SEISMIC SAFETY EXPERT MISSION

"PRELIMINARY FINDINGS AND LESSONS LEARNED FROM THE 16 JULY 2007 EARTHQUAKE AT KASHIWAZAKI-KARIWA NPP"

Kashiwazaki-Kariwa NPP and Tokyo, Japan 6 – 10 August 2007

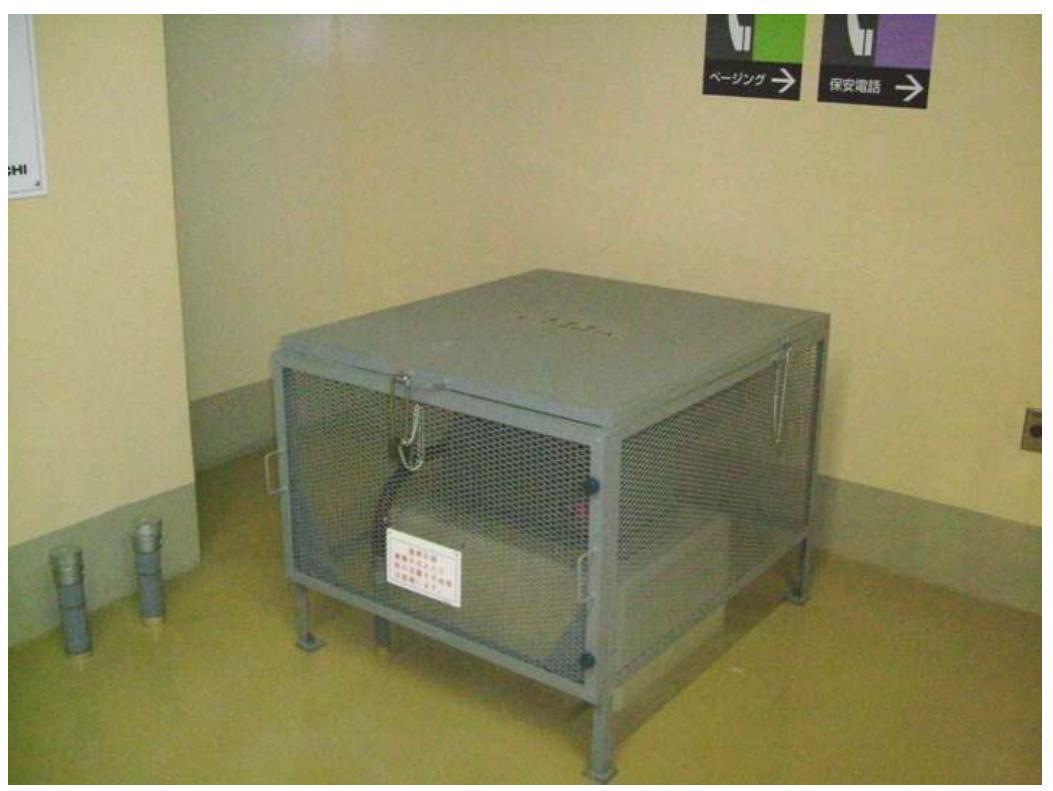
Photo 1:Seismic instrumentation to record in-structure response(A.1-1)

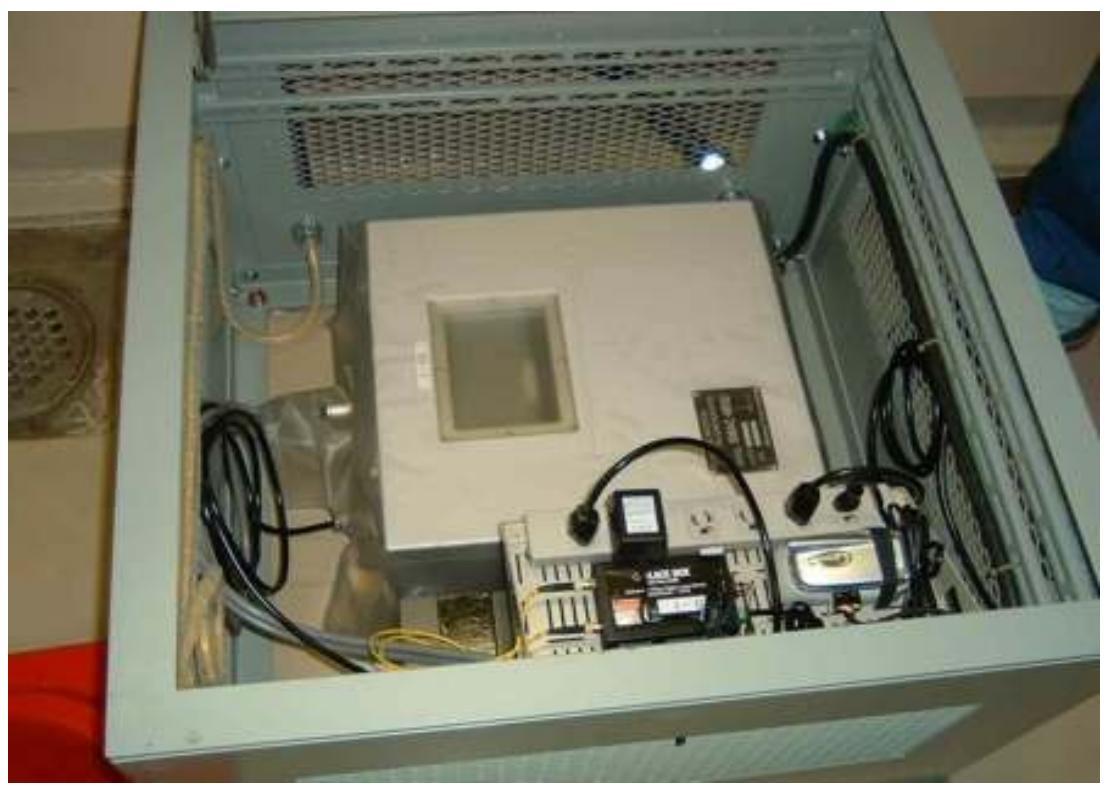
Photo 3: Seismic instrumentation Unit 1 at foundation mat level (A.1-1)

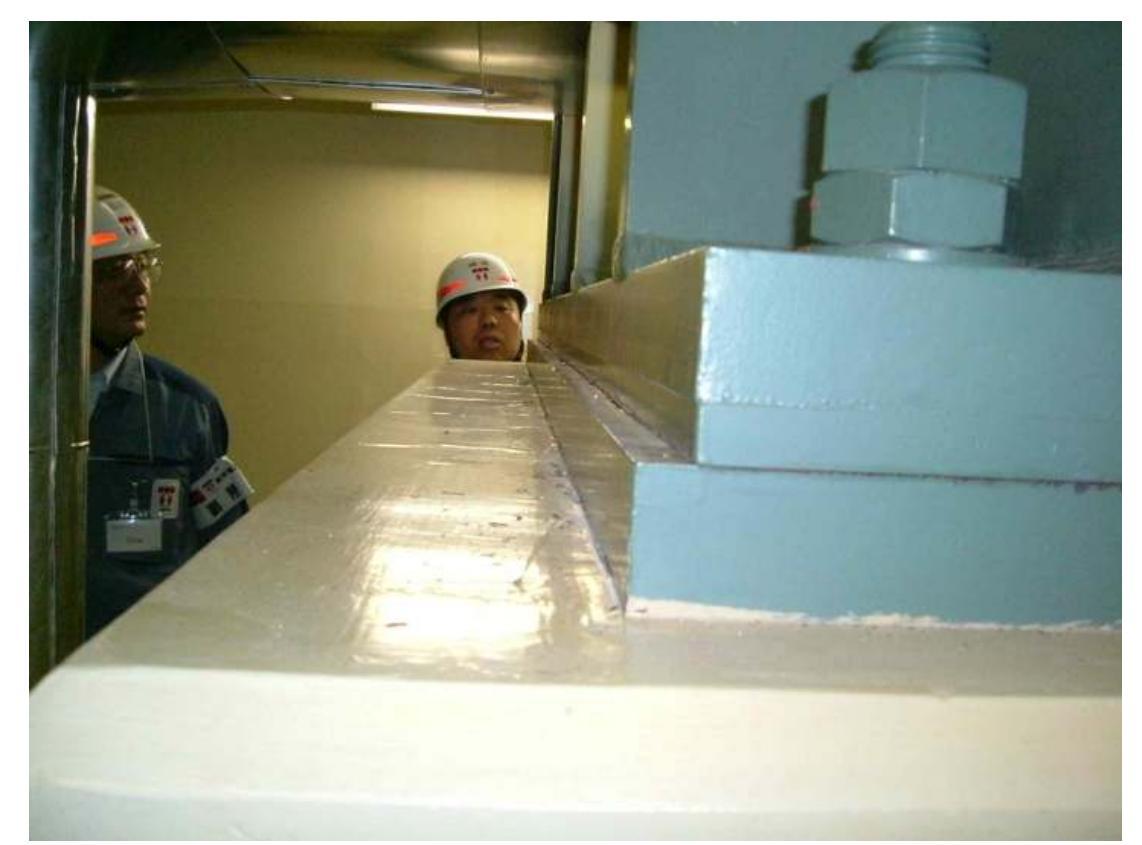
Photo 4: Unit 4-TB-Level: -16.300 – Sliding of the foundation plates of Heat Exchanger (A.2)

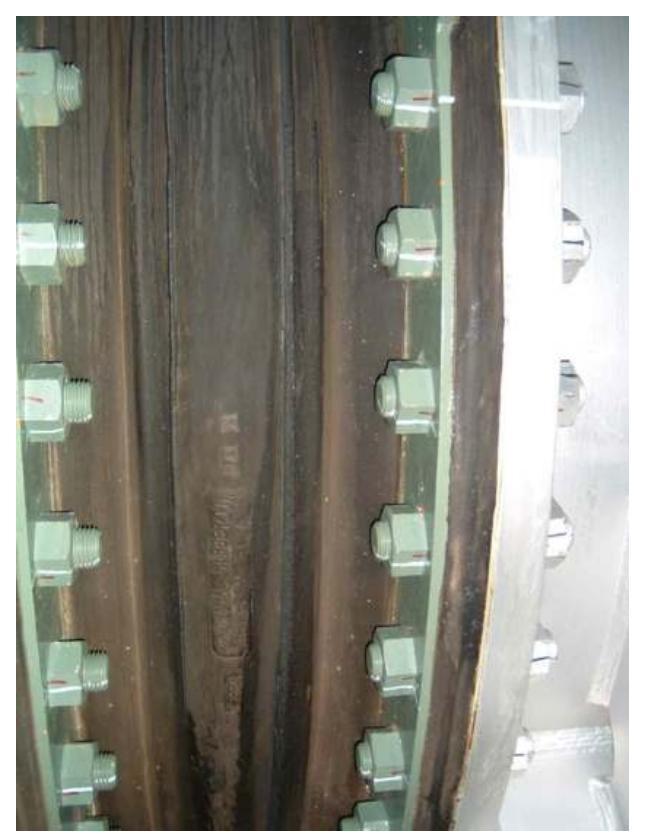
Photo 5: Unit 4-TB: Failure of the rubber flexible joint between condenser B seawater box and connecting valve, causing seawater leakage. (A.2)

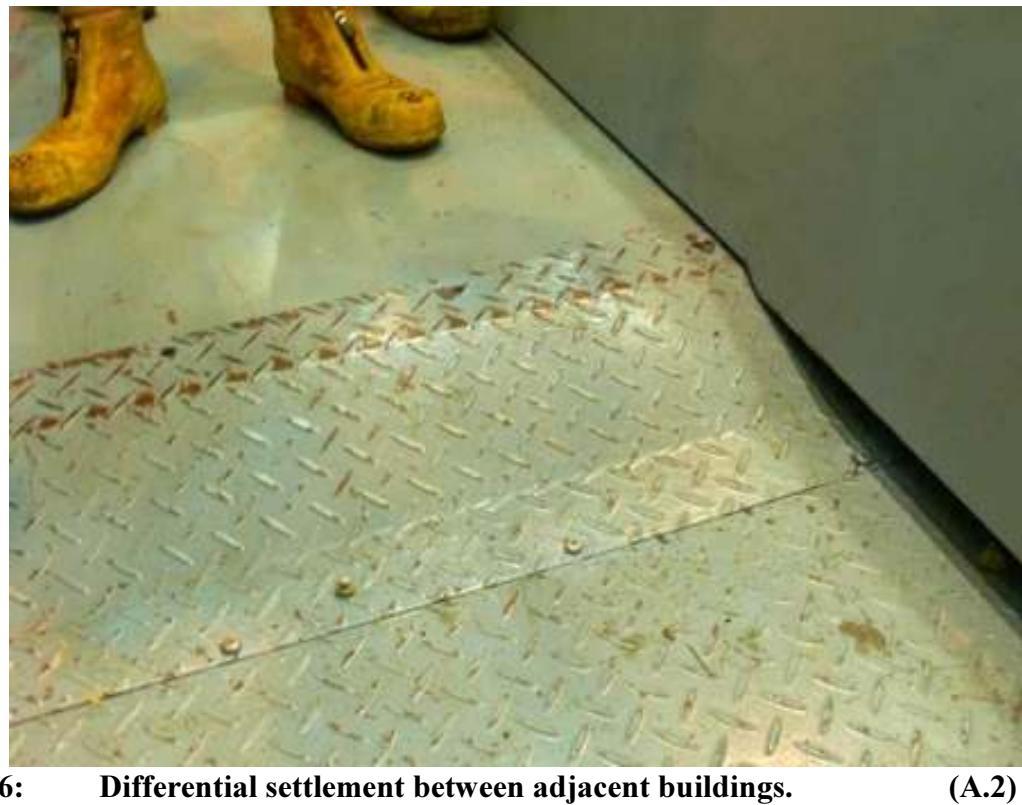
Photo 6: Differential settlement between adjacent buildings.

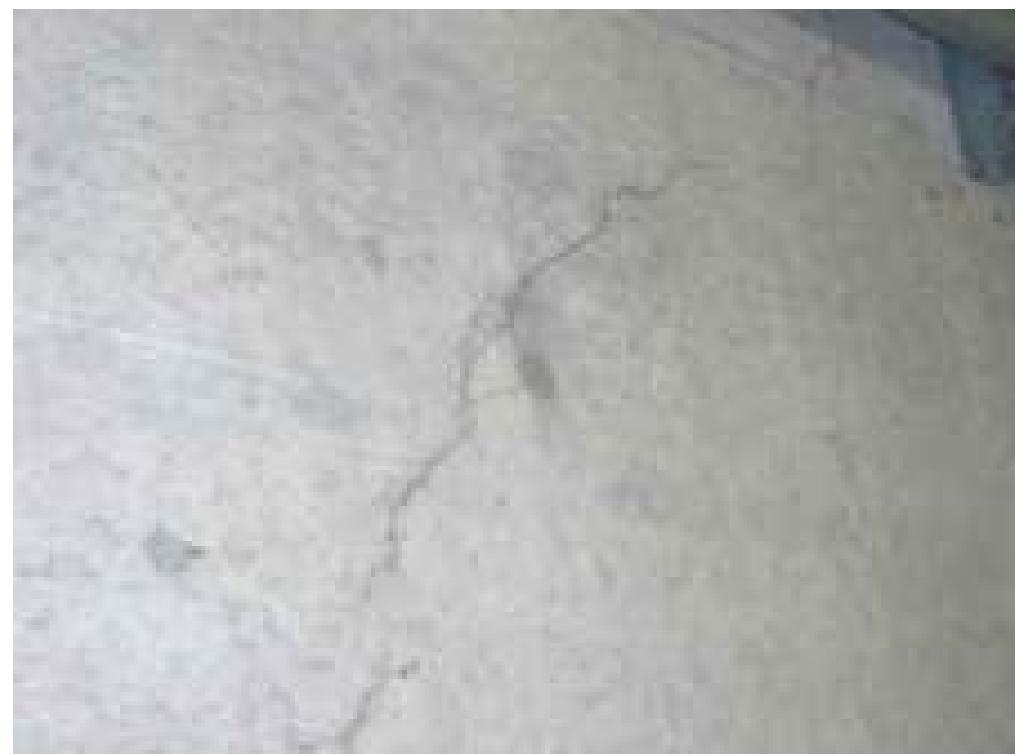
Photo 7: Minor cracking in shear walls was observed in a few cases (A.2)

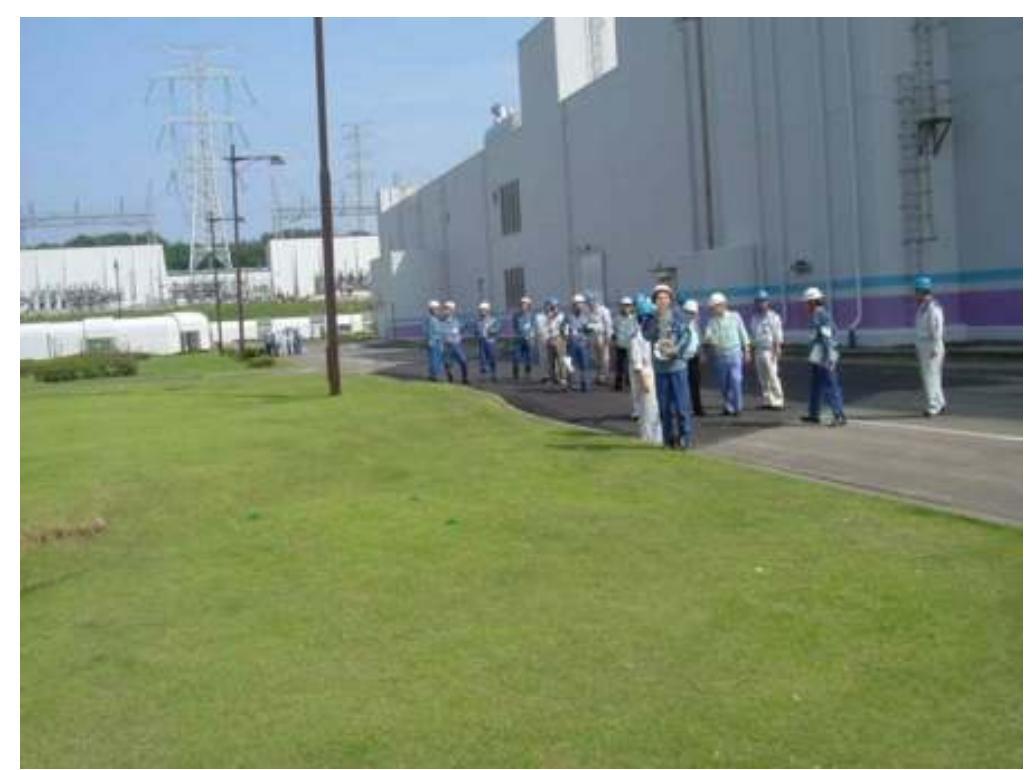
Photo 8:First day group touring outside the structures. Note soil displacements. Also
note in the background the undamaged switchyard connecting to the grid.
Off-site power was not lost during the seismic event.(A.2-1, A.2-4)

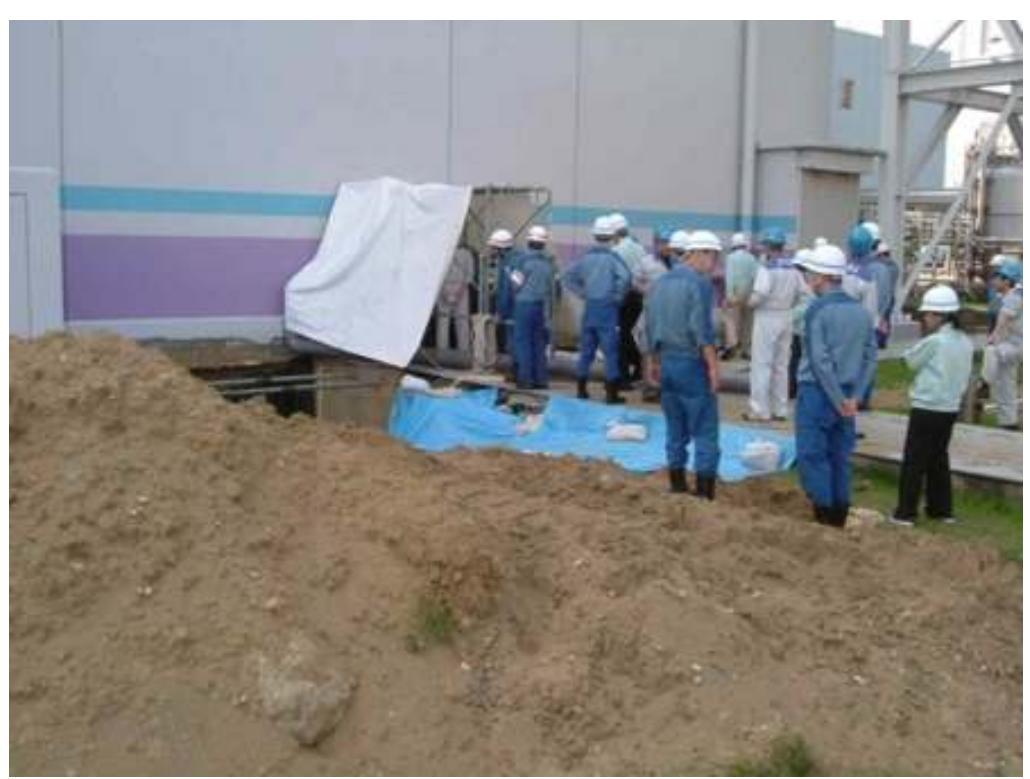
Photo 10: Unit 1: A buried fire fighting pipe failure caused mud to penetrate into the reactor building through cable tray penetrations. Maximum amount of water leakage ~2000m3; depth of water/mud in floors ~0.48m (A.2-2)

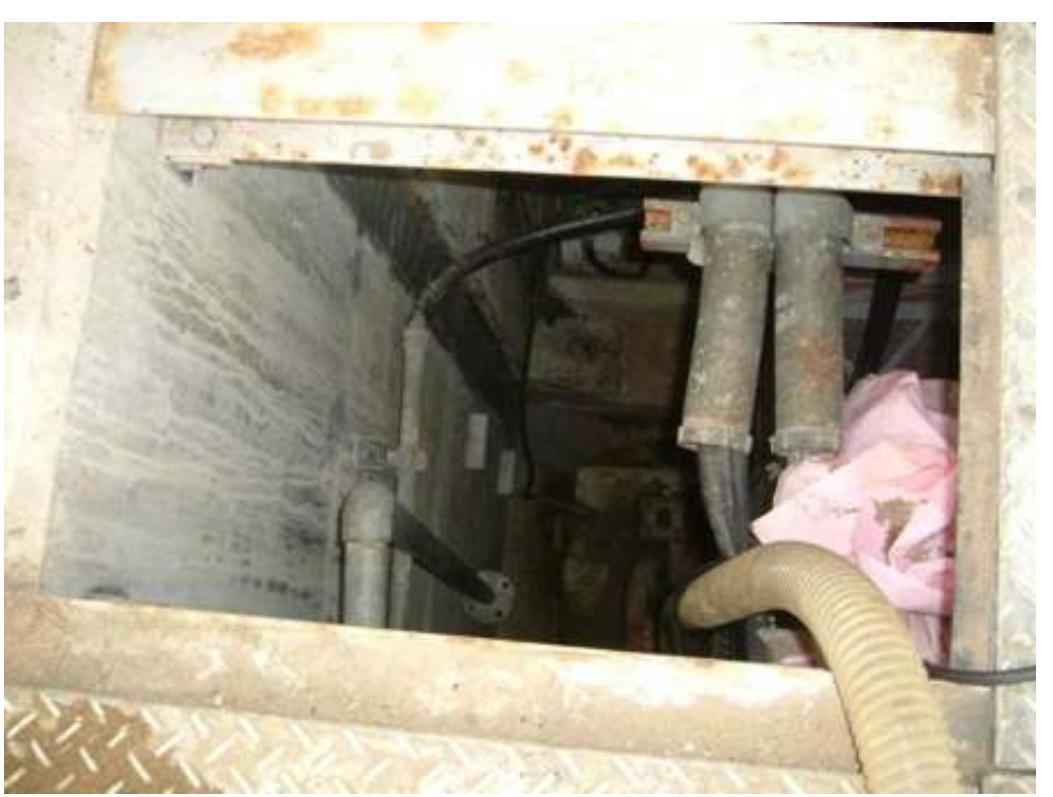
Photo 11:Unit 1 - The route of the mud that went all the way down to the lowest
levels of the R/B.(A.2-2)

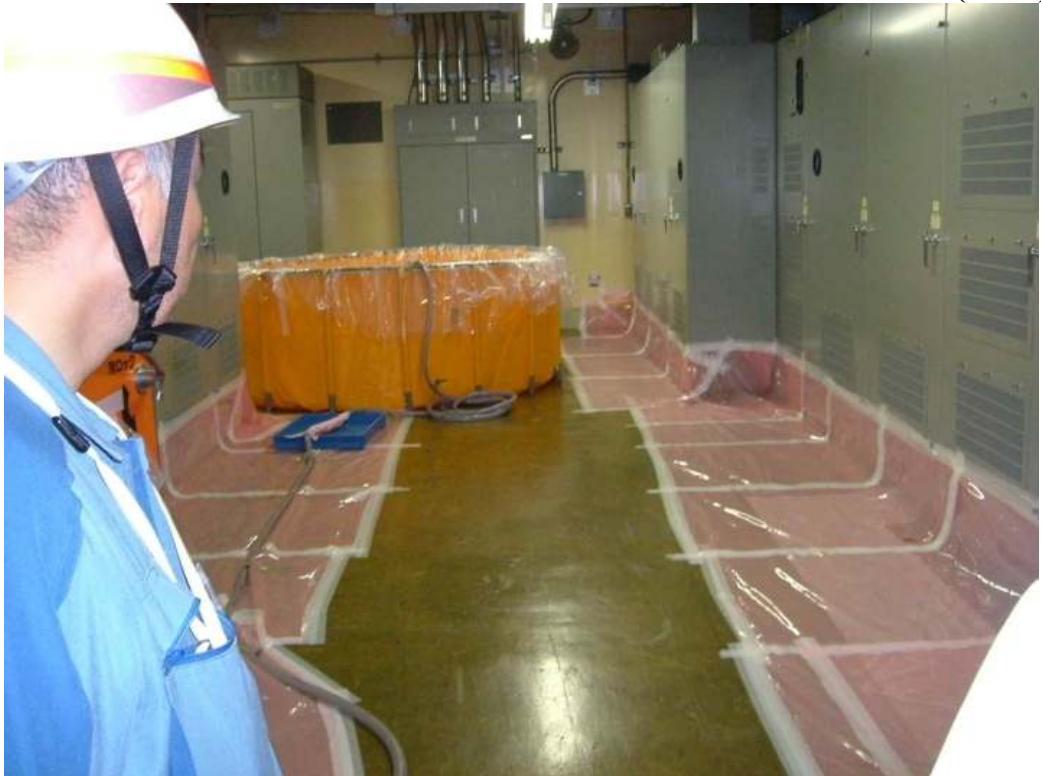
Photo 12: Unit 1 – Cleaning operation of leakage mud/water in lowest levels of R/B. (A.2-2)

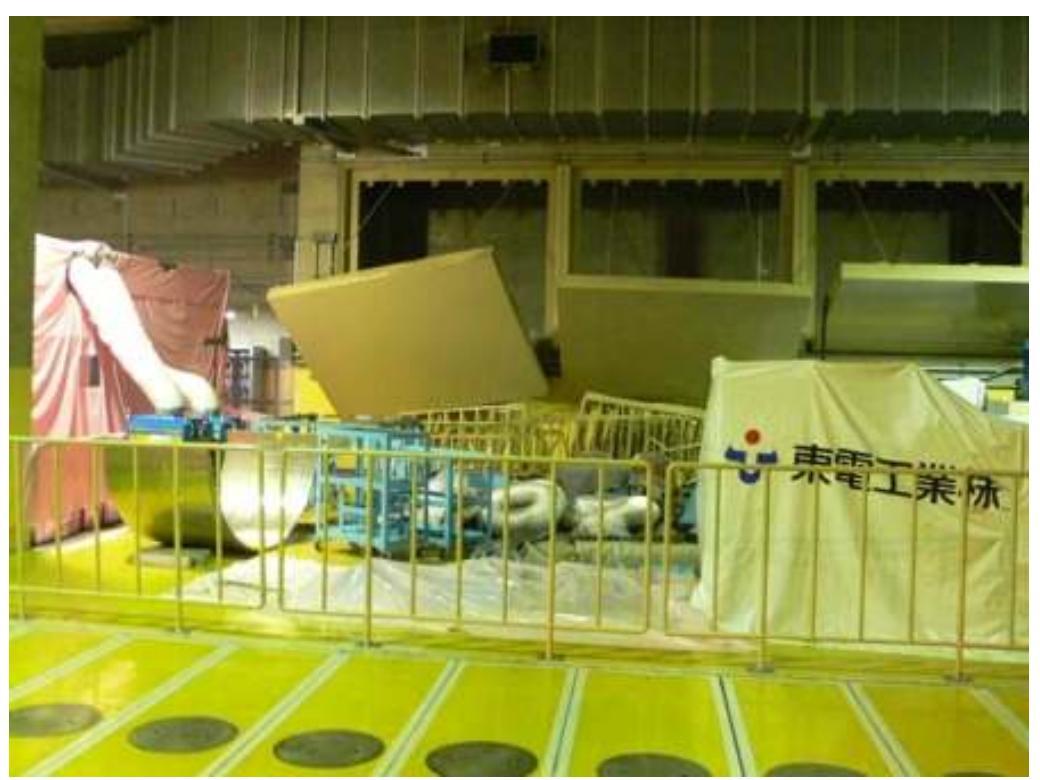
Photo 13: Blow-out panels

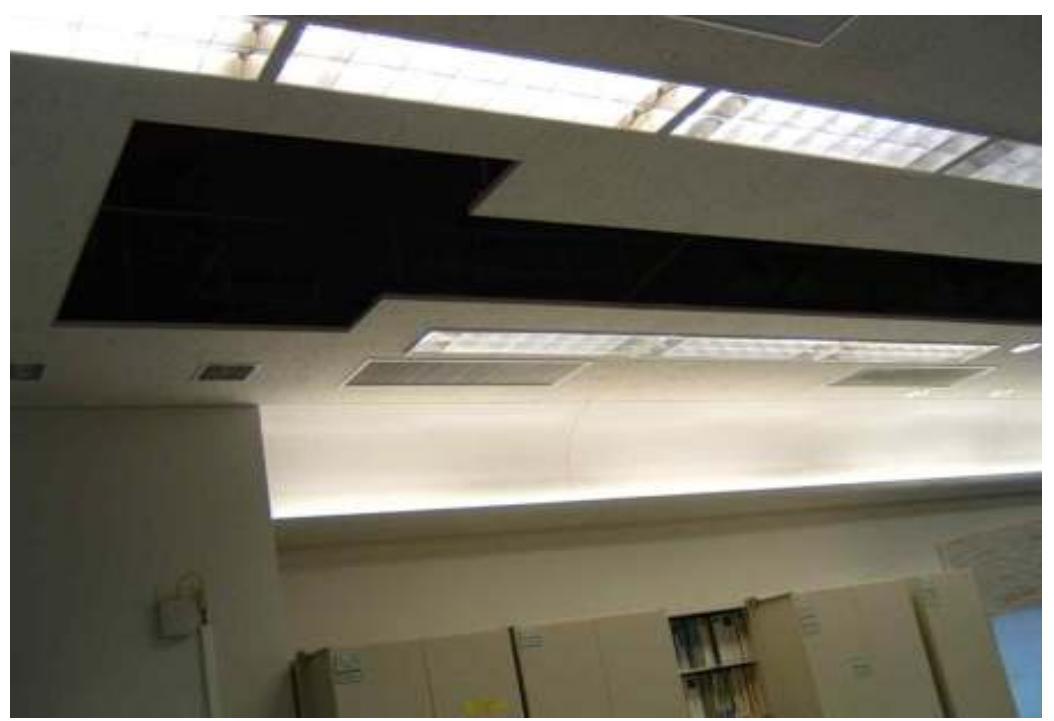
Photo 15: Failure of portions of ceiling panels with potential for interaction effects (A.2-2)

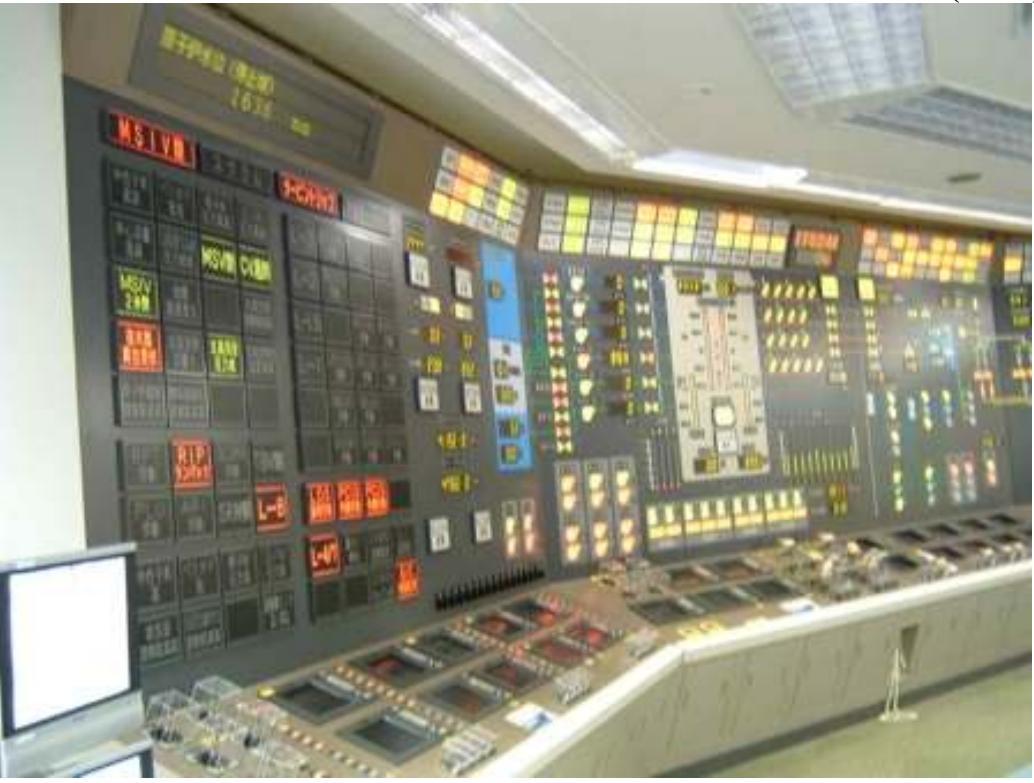
Photo 16: Control room panels behaved well. No interactions were reported. (A.2-2)

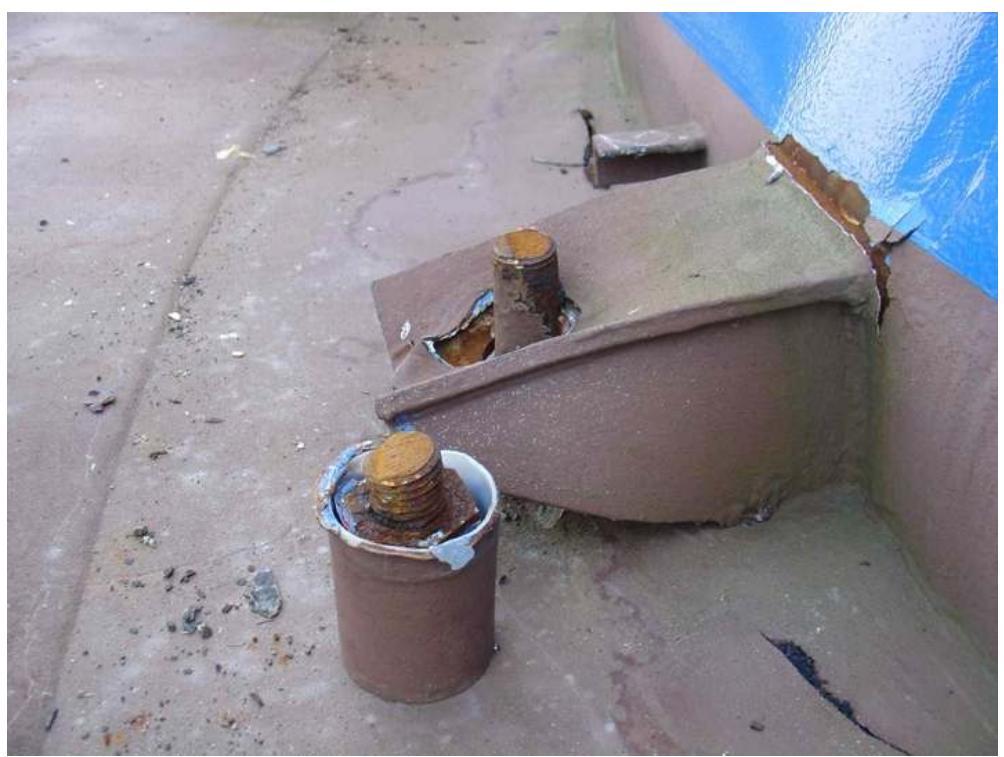
Photo 20: Bolt failure surface shows variation in colouring and corrosion, indicating possible previous damage. The bolt was anchoring the service water tank (non safety related) for the fire extinguishing system which were not functional after the earthquake (A.2-3, A.2-5)

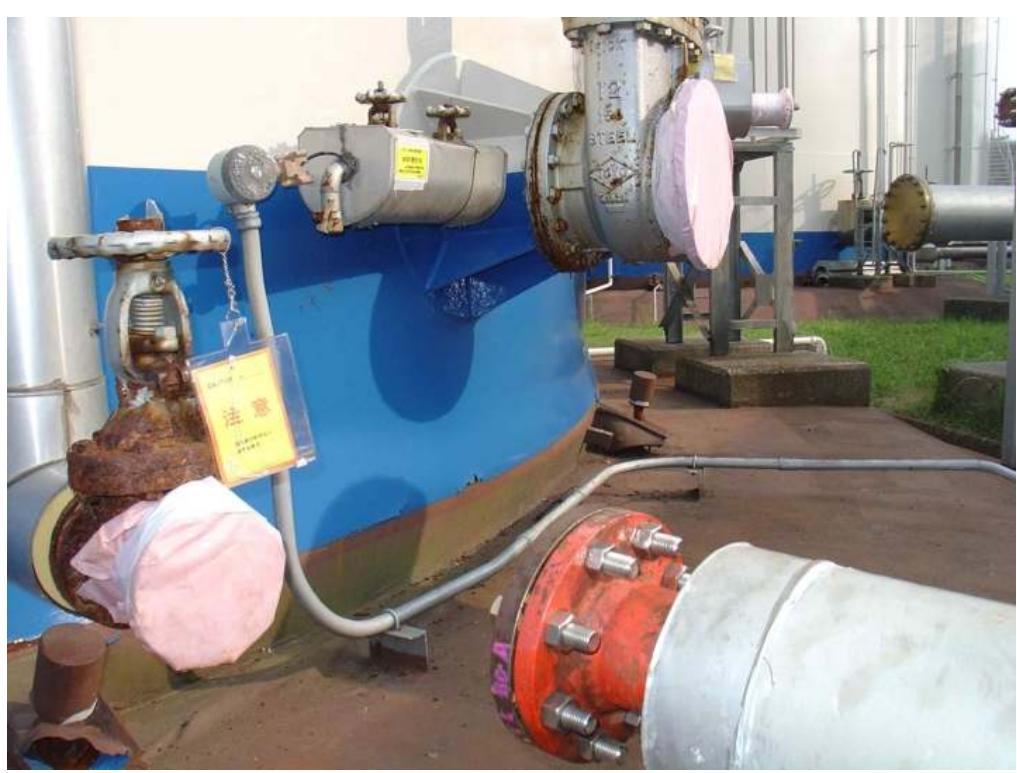
Photo 21: The fire fighting system was not operational after the earthquake (A.2-2)

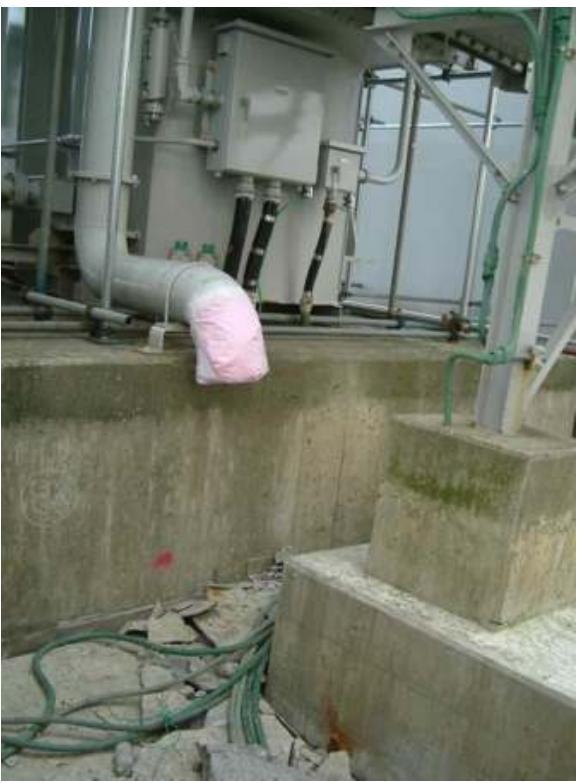
Photo 22:The failure of house transformers was also due to the foundation
settlement of connecting structures.(A.2-3, A.2-4)

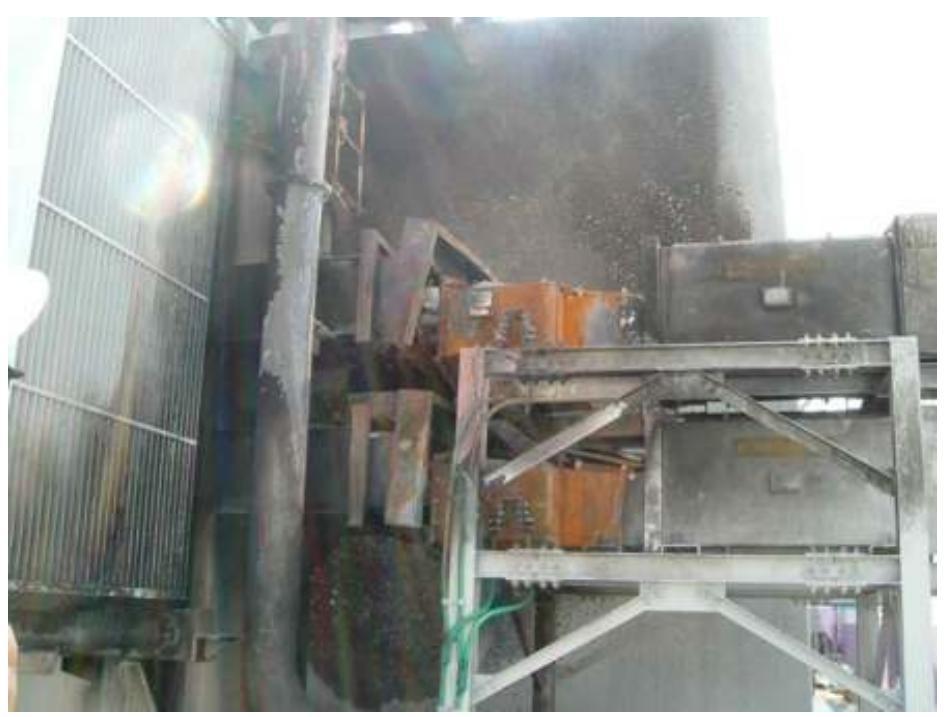
Photo 23: The fire at the in-house transformer was caused by the ignition of the transformer insulation oil that leaked from the broken porcelain, ignited by the sparks from a short circuit at the bus duct all due to the different displacement between the connecting structure (on shallow foundation) that settled and the transformer built on piles. (A.2-3, A.2-4)

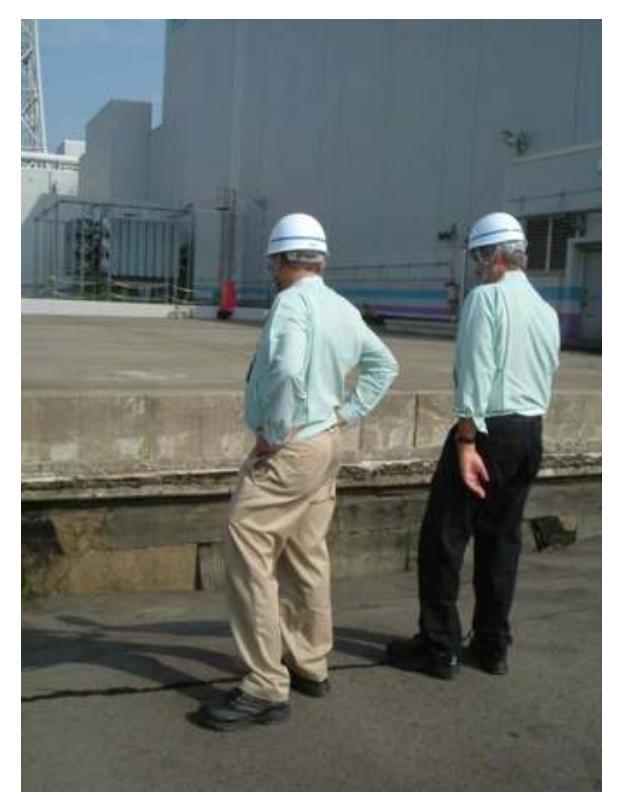
Photo 24: Soil surrounding structures on deep foundation showed significant settlement (A.2-4)

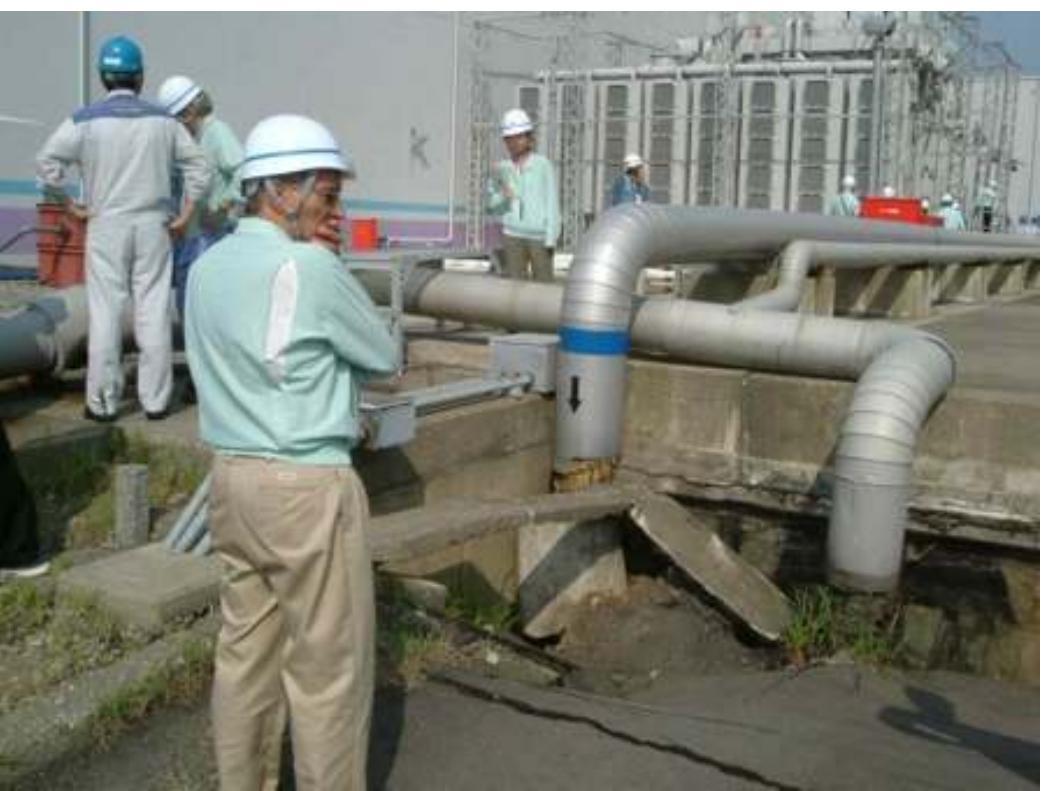
Photo 25: A good indication of the order of magnitude of soil settlement which caused damage to non-safety SSCs on shallow foundation. (A.2-4)

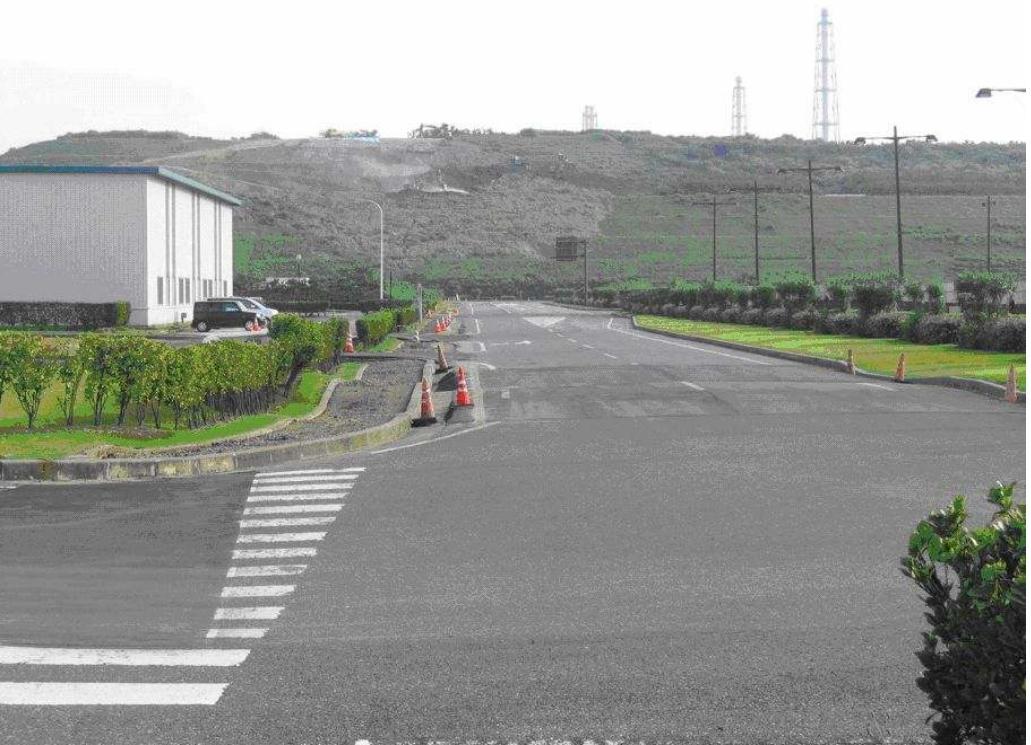
Photo 26: Landslide on a man-made hill at the site

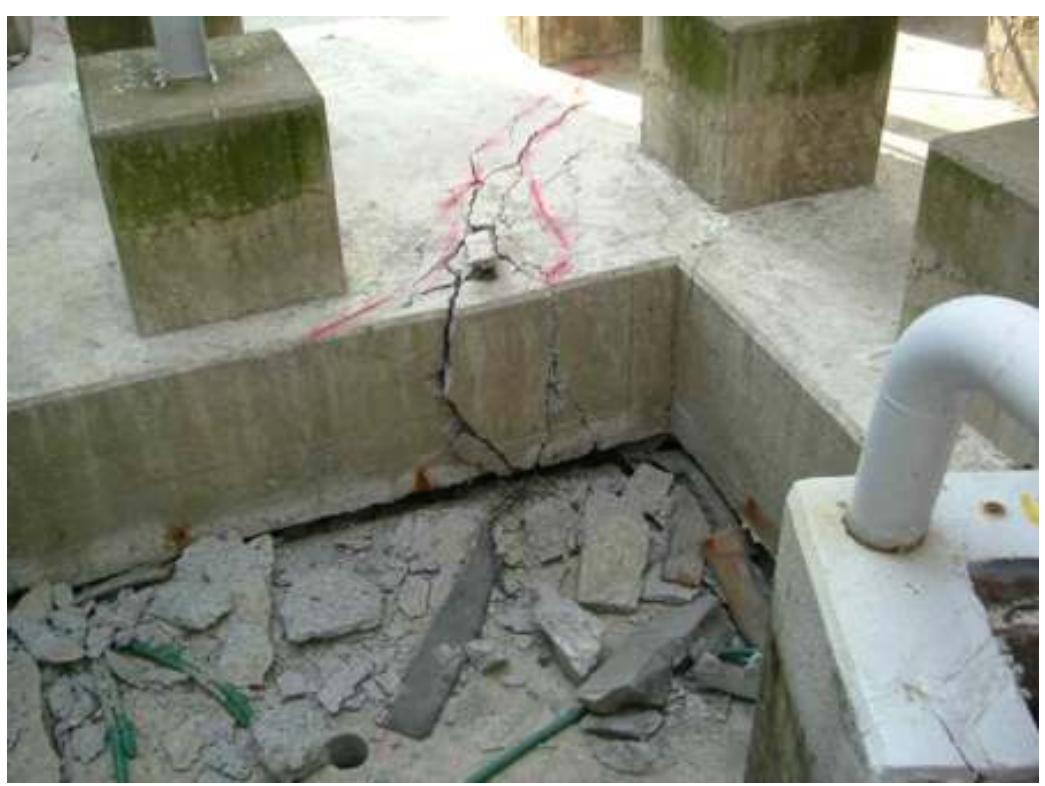
Photo 27:Damage to the foundation plate of the house transformer caused by the
settlement of the connecting structure.(A.2-4)

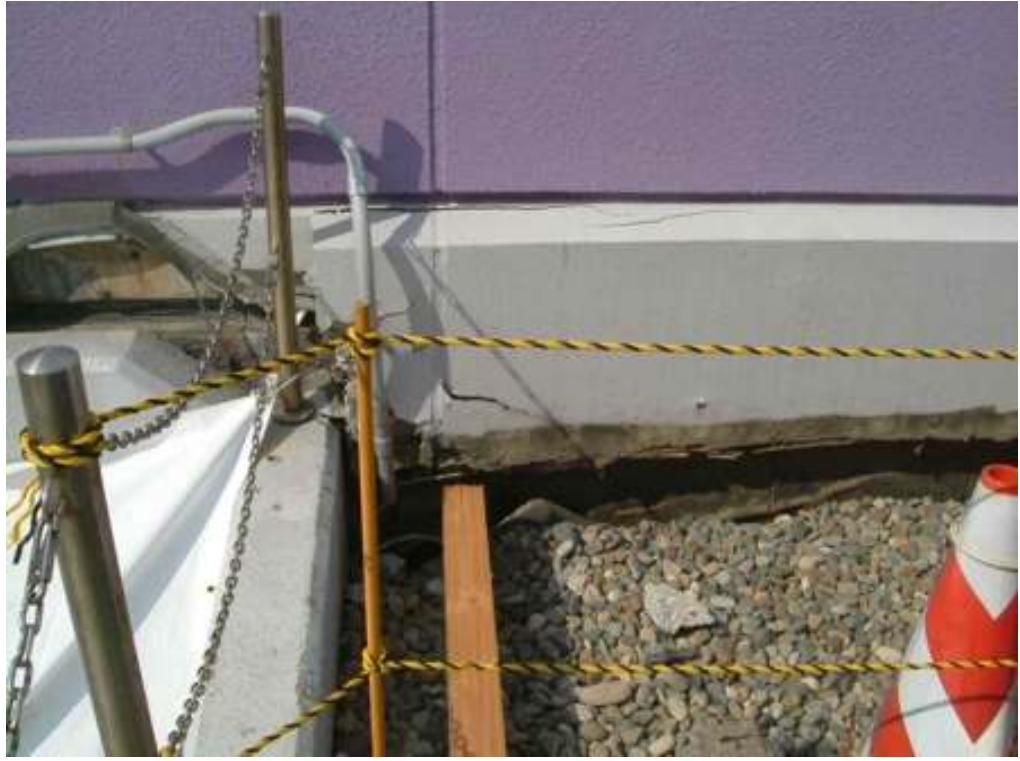
Photo 28: A detail of the damage at the connection of the foundation slab of the transformer and the connecting structure. (A.2-4)

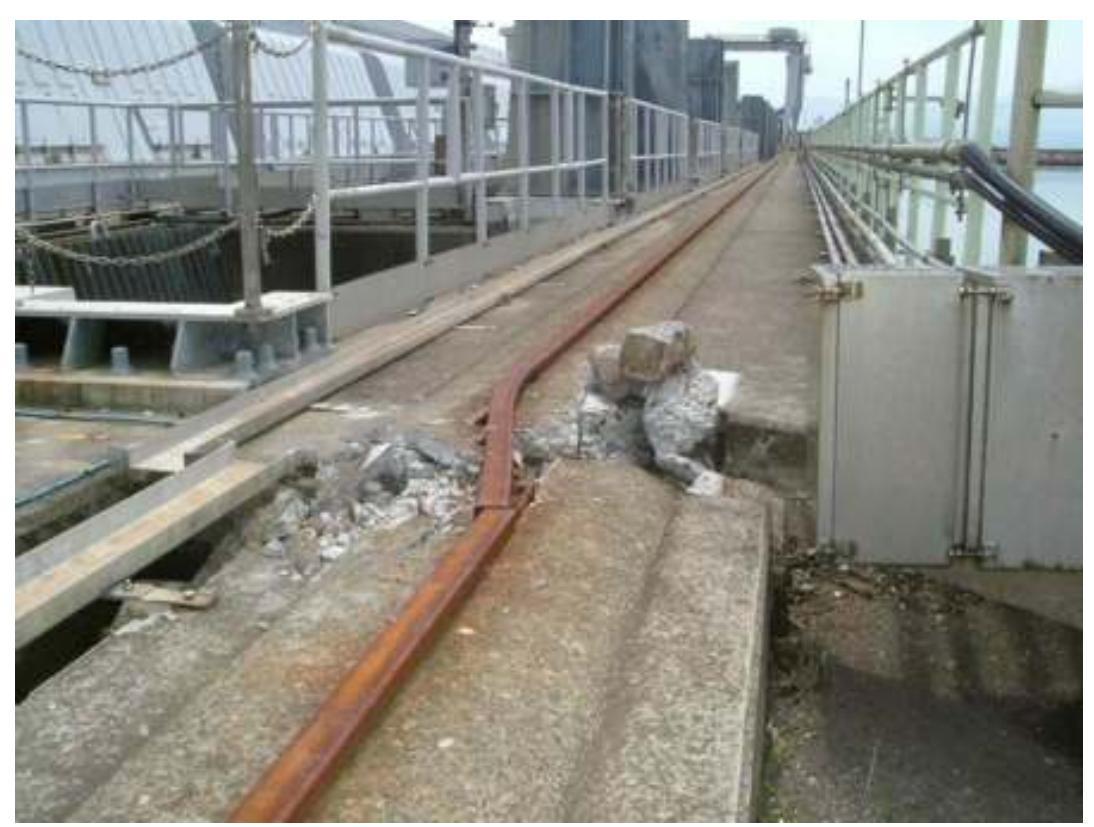
Photo 29: Failure of part of the water intake structure near the pump house (A.2-4)

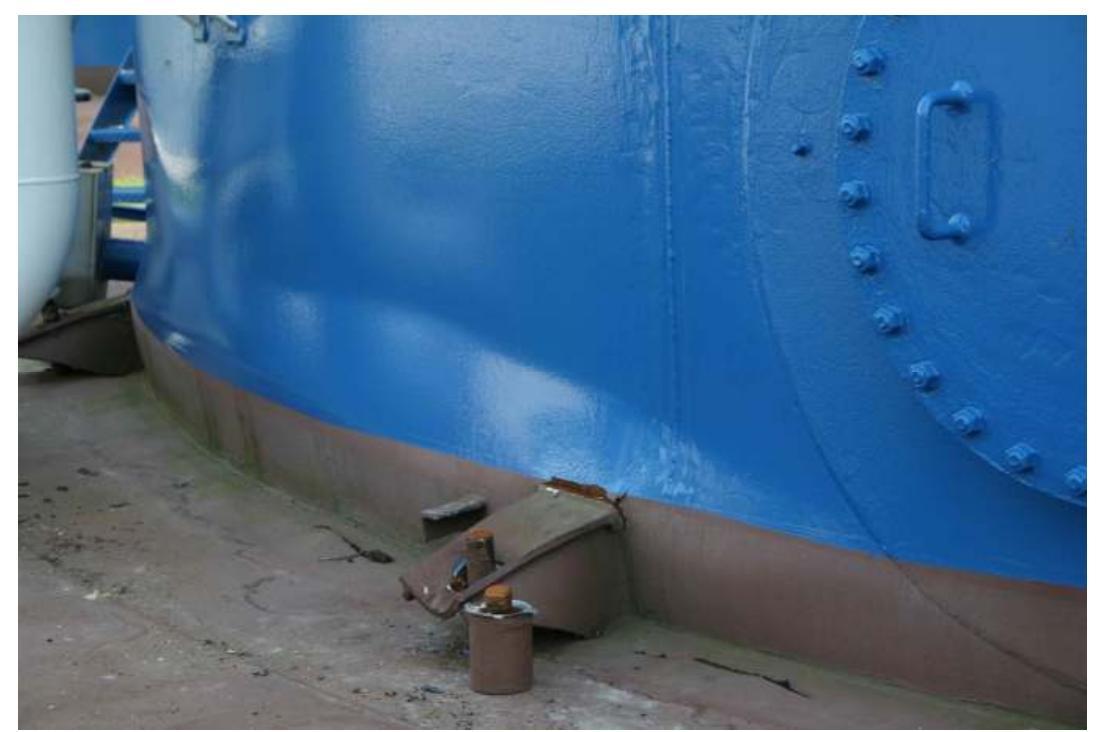
Photo 30: Failure of the anchorage for the water tank for the fire extinguishing system – note also the elephant foot buckling of the tank itself (A.2-5)

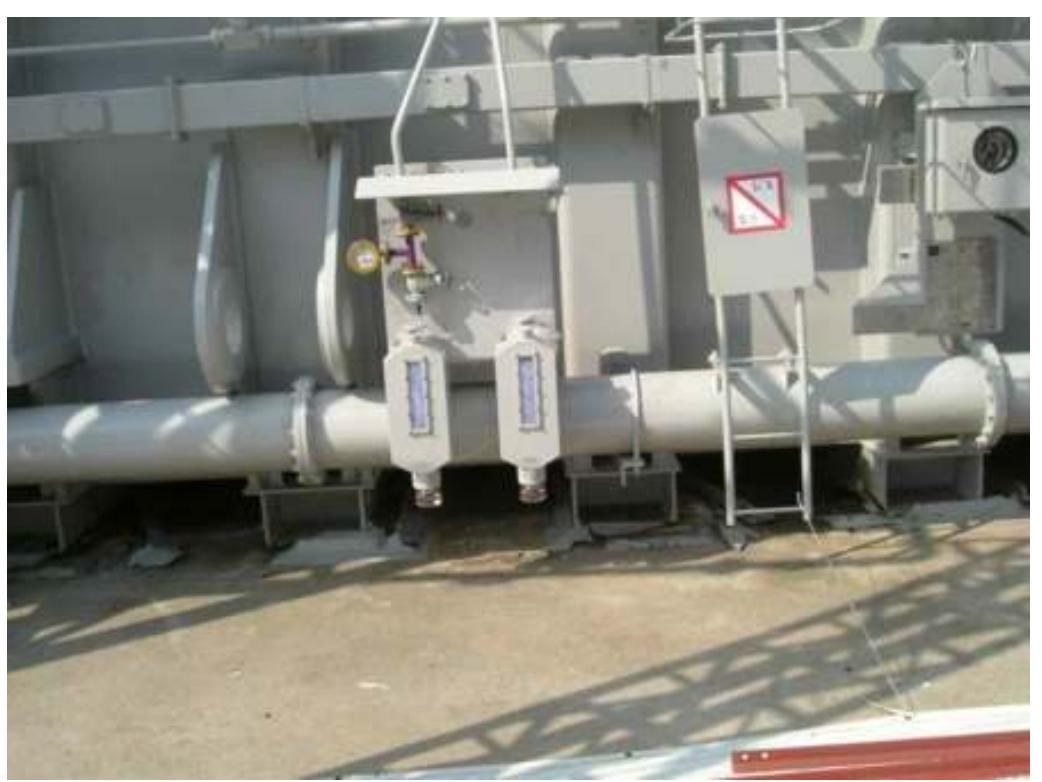
Photo 31:Lateral displacement of the foundation beams that failed the anchor bolts
– transformer building(A.2-5)

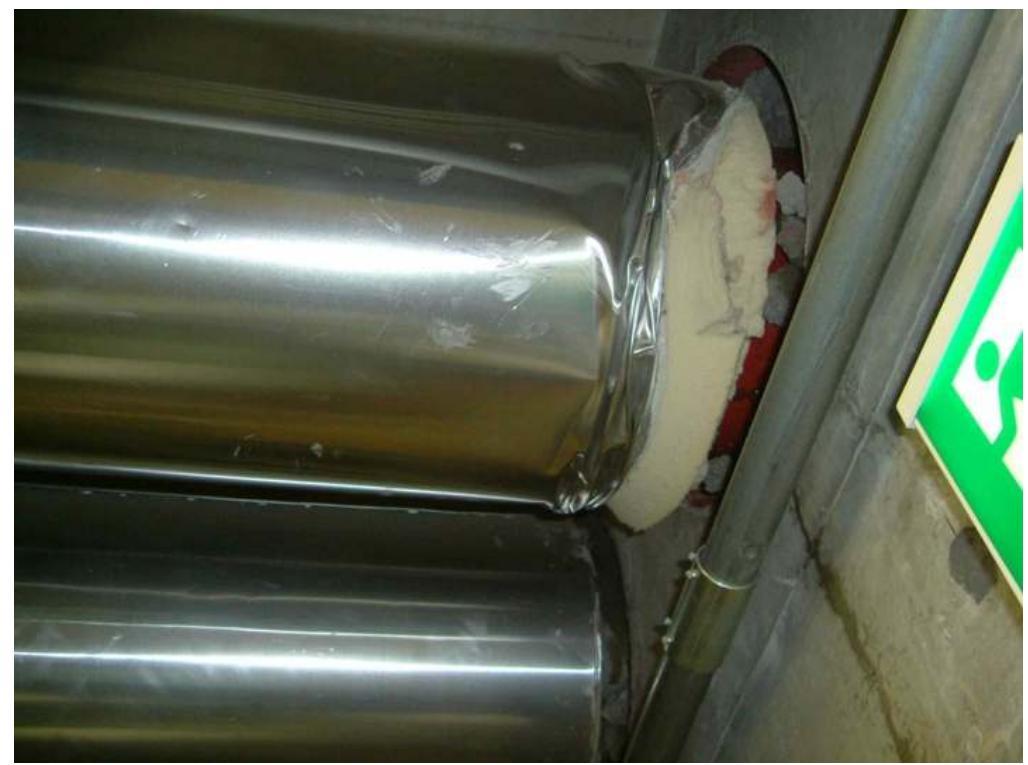
Photo 32: Local buckling of piping insulation cover at penetration point (A.2-5)

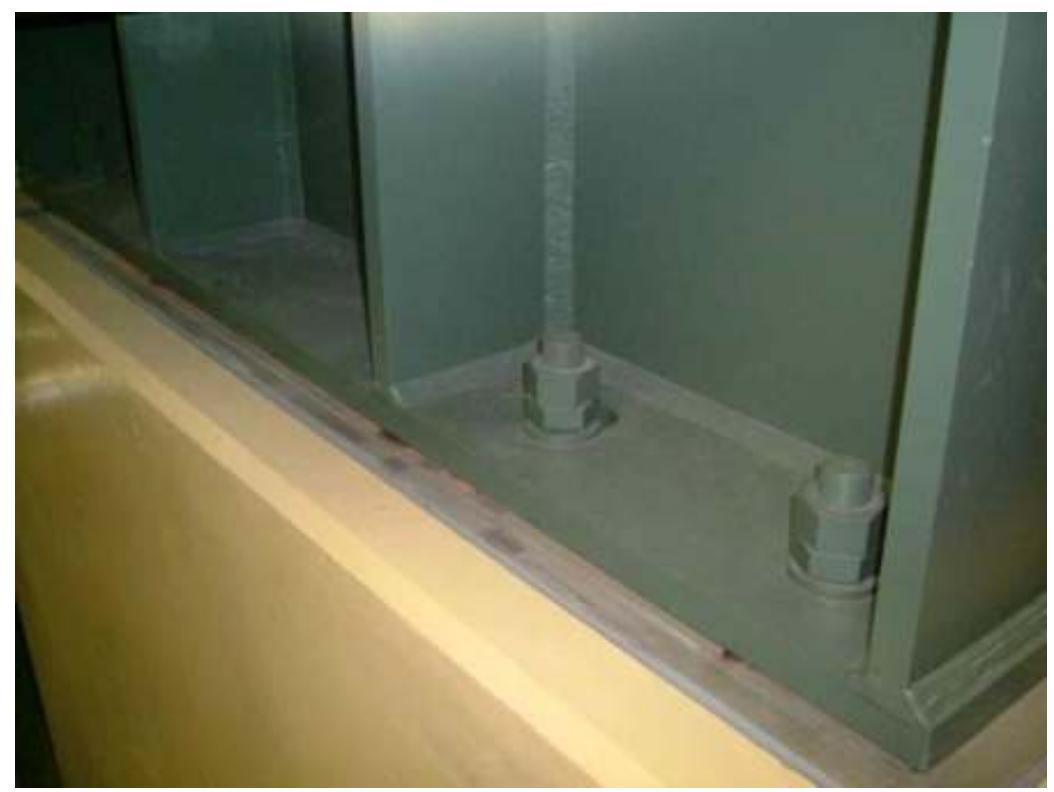
Photo 34: Relative sliding between concrete foundation pad and component leg support. (A.2-5)

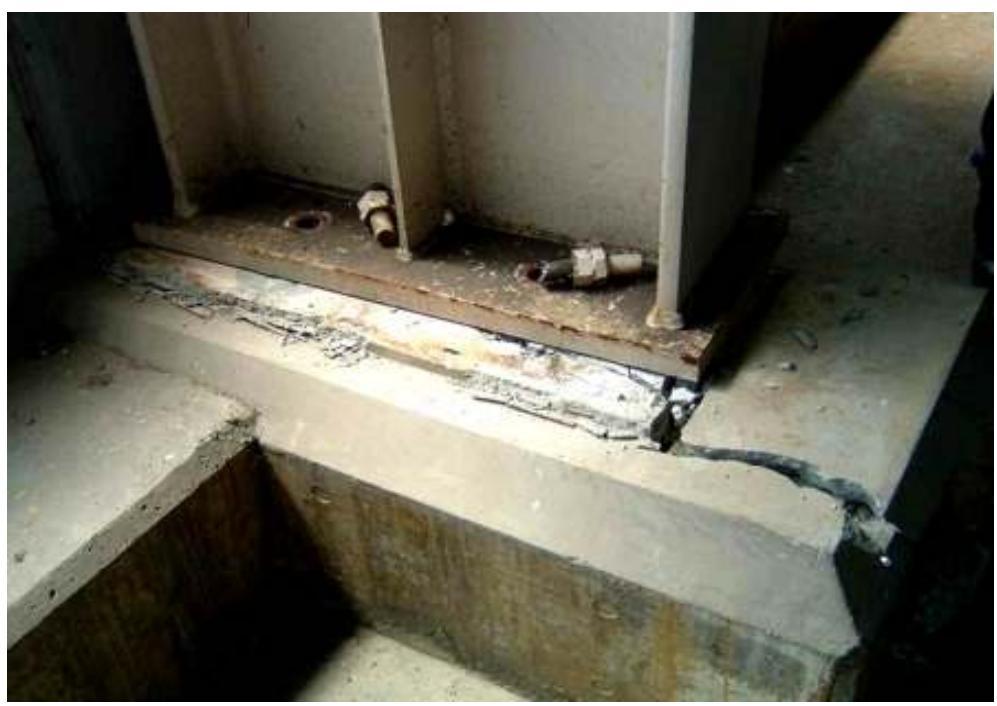
Photo 35: Unit 2-Failure of steel structure connection of the concrete base – water intake building structure. This structure was seriously damaged. (A.2-5)
