INTERNATIONAL ATOMIC ENERGY AGENCY

ENGINEERING SAFETY REVIEW SERVICES SEISMIC SAFETY EXPERT MISSION

"PRELIMINARY FINDINGS AND LESSONS LEARNED FROM THE 16 JULY 2007 EARTHQUAKE AT KASHIWAZAKI-KARIWA NPP"

Kashiwazaki-Kariwa NPP and Tokyo, Japan 6 – 10 August 2007

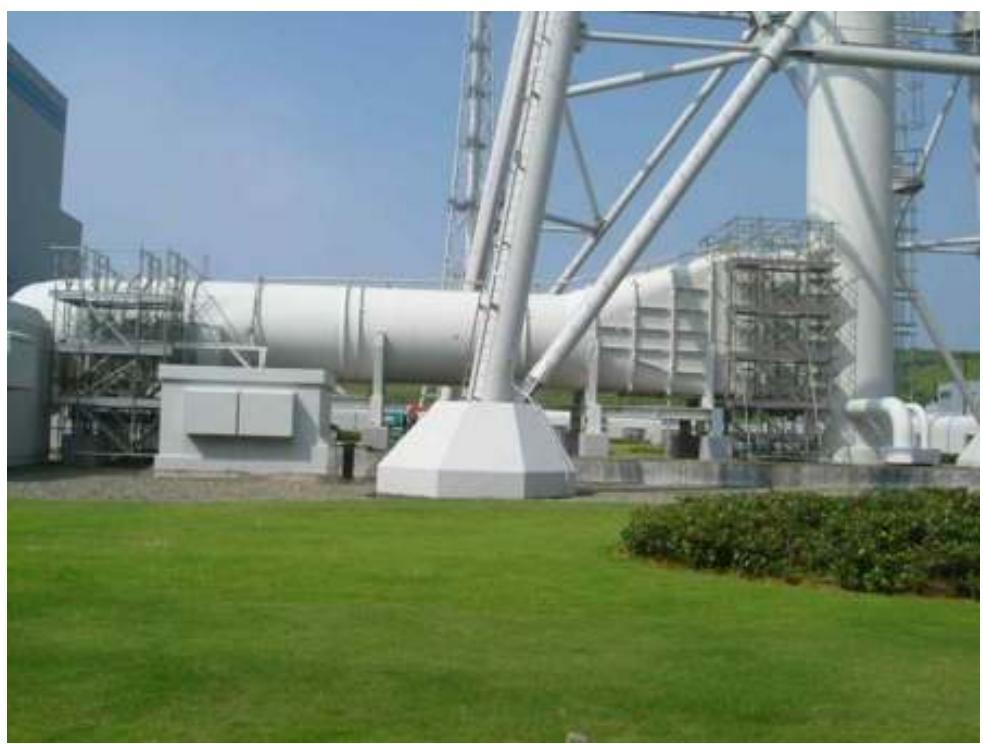
Photo 36: Typical damage of the duct (shallow foundation) connecting to the exhaust stack which is on piles. Soil settlement caused differential displacements to these structures. This is the pathway for the releases to the atmosphere (A.3-2, A.2-4)

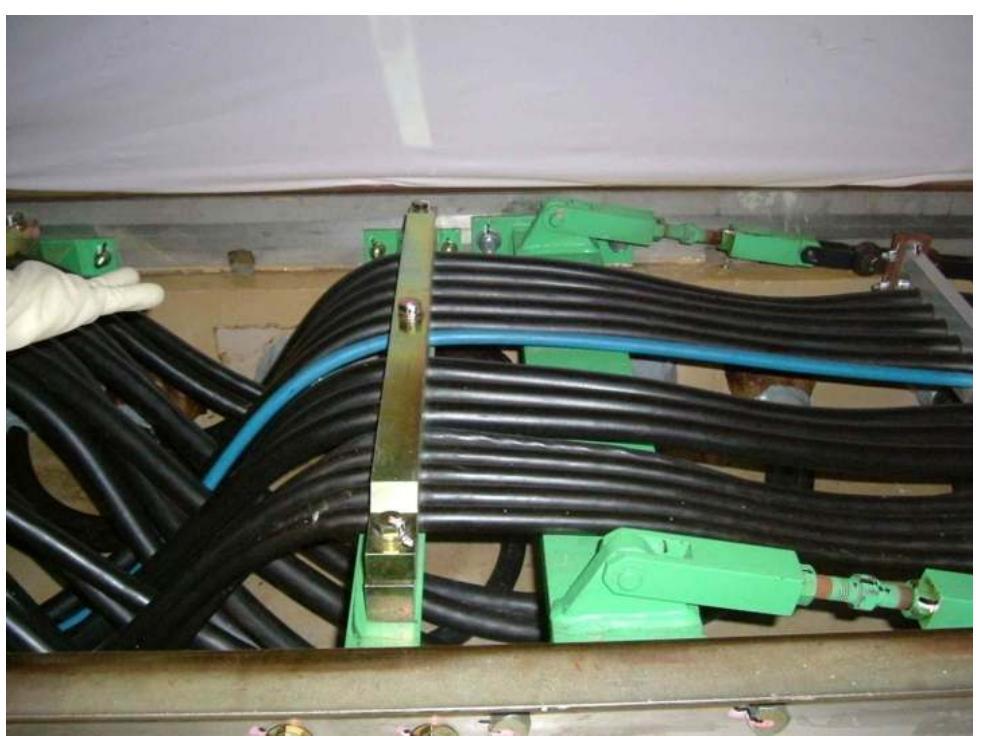
Photo 37: Cable penetrations on the floor, through which the water overflowed from the sloshing in the spent fuel pool flowed to the lower floors. This is on the pathway for the radioactive release to the sea. (A.3-2, A.2-2)

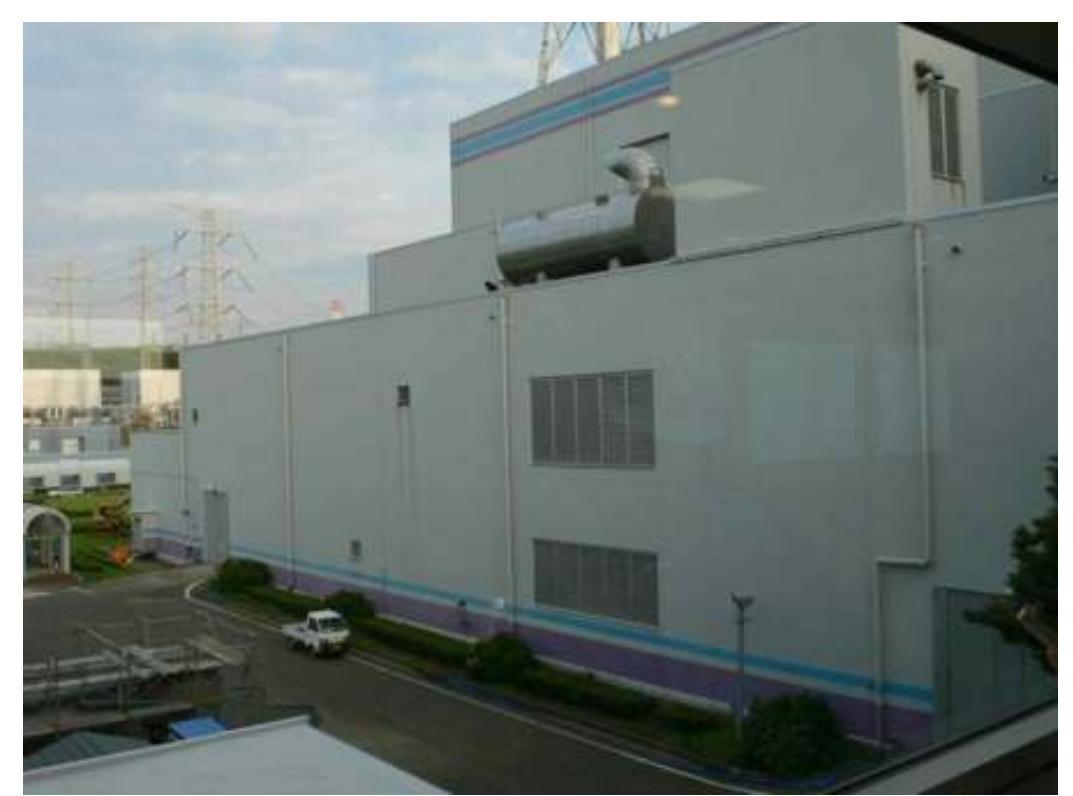
Photo 46: A great majority of safety related structures showed no visual evidence of damage due to the earthquake

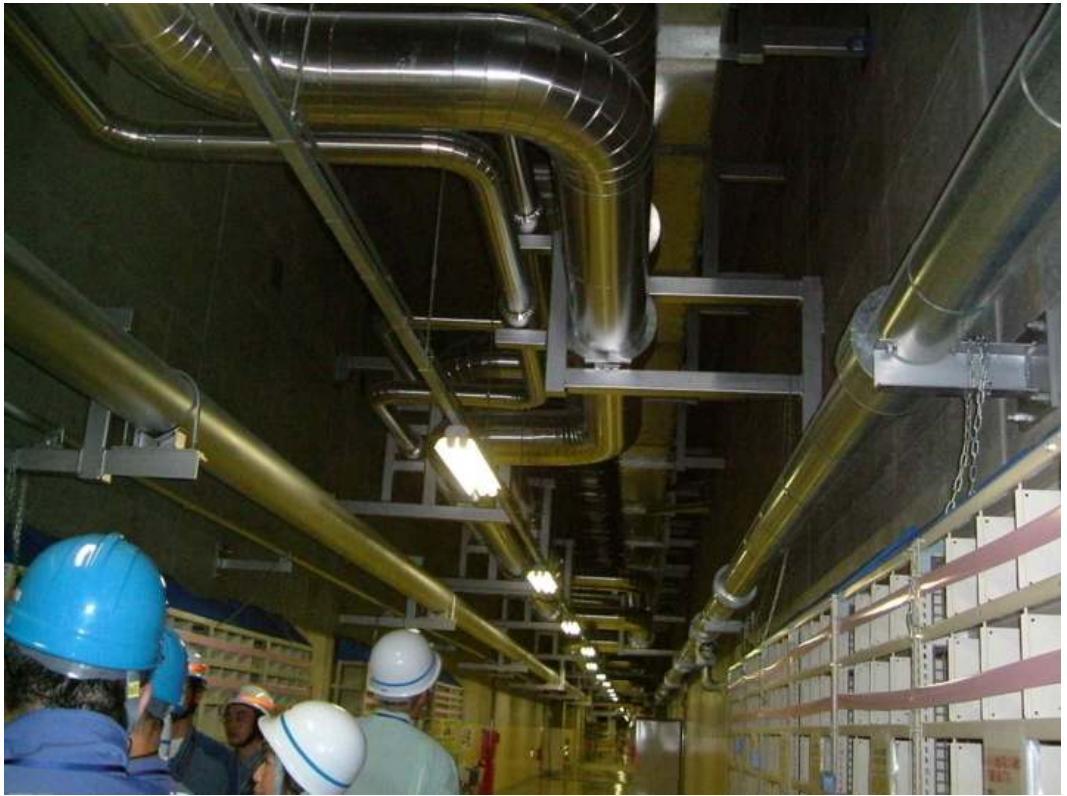
Photo 47: A variety of pipe supports and spans-all behaved very well. See anchors. No interactions
