Regulatory Perspective on CANDU Feeder Pipe Degradation due to FAC and IGSCC

John C. Jin, Specialist
Raoul Awad ,
Director,
Canadian Nuclear Safety Commission
Commission canadienne de surete nucleaire

IAEA Workshop
April 21-23, 2009, Moscow

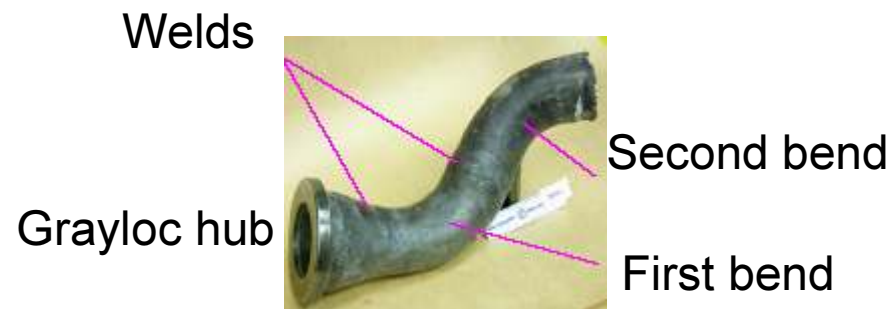
- Extent -All outlet feeder pipes at all CANDU plants are experiencing pipe wall thinning due to the FAC at a rate much higher than design allowance.
 - General and local thinning at bends
 - Local and blunt flaw near weld
 - thinning rate: 0.05 ~ 0.2 mm/yr (linear)
- Failure History
 - Several feeders have been replaced, but no pipe failures occurred during operation

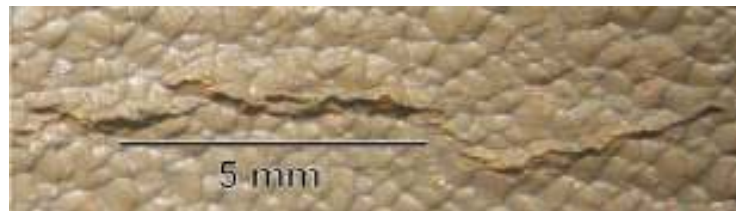
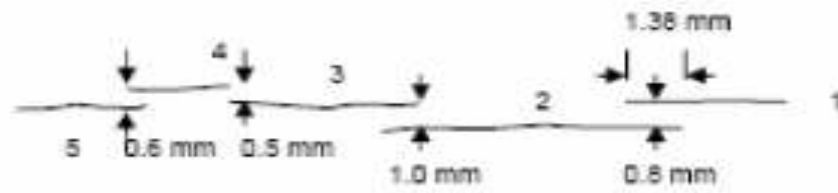
Magnetic Rubber Replicas

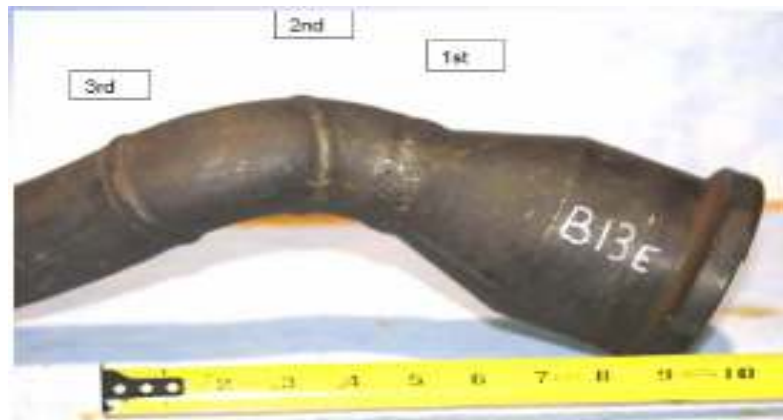
Wall Thickness Measurements

- P1 B13E removed in 2005 and tested in 2006
- 90°C
- 50 cycles under 10.7 MPa internal pressure and 0-4 kN·m bending moment
- Failure pressure 65 MPa, and Bending moment 0.9 kN·m

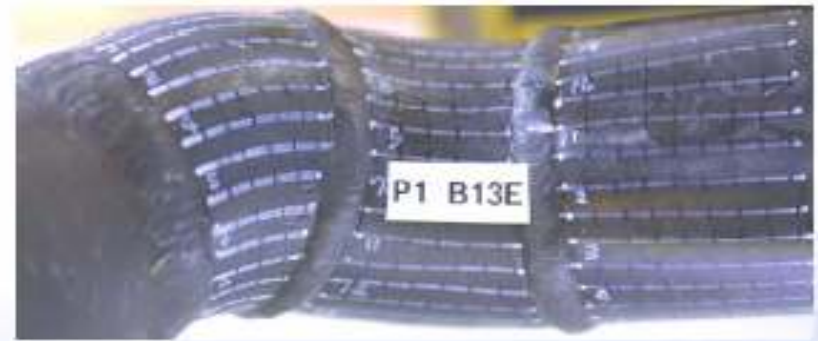
Distribution of wall thickness

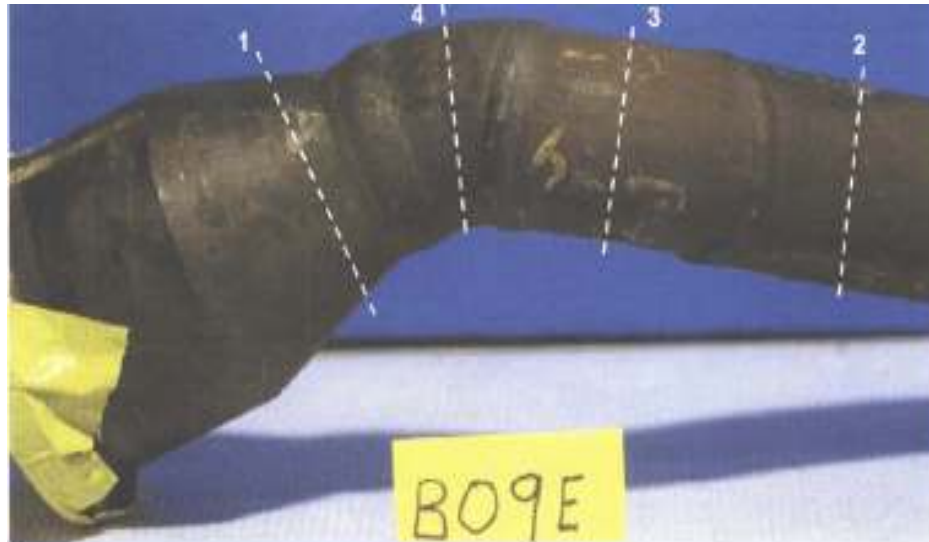
More Wall Thickness Measurements

Another evidence of
local wall thinning at
the intrados.

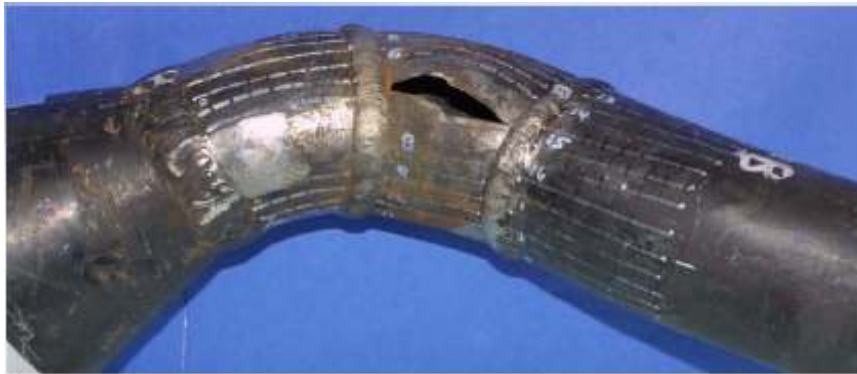
Post-test Met Examination

- Internal Pressure
 - Measured failure pressure of 64.1 MPa
 - Predicted failure pressure of 51.4 MPa
 - Design Pressure ~ 10.7 MPa
 - Level C Pressure ~ 12.4 MPa

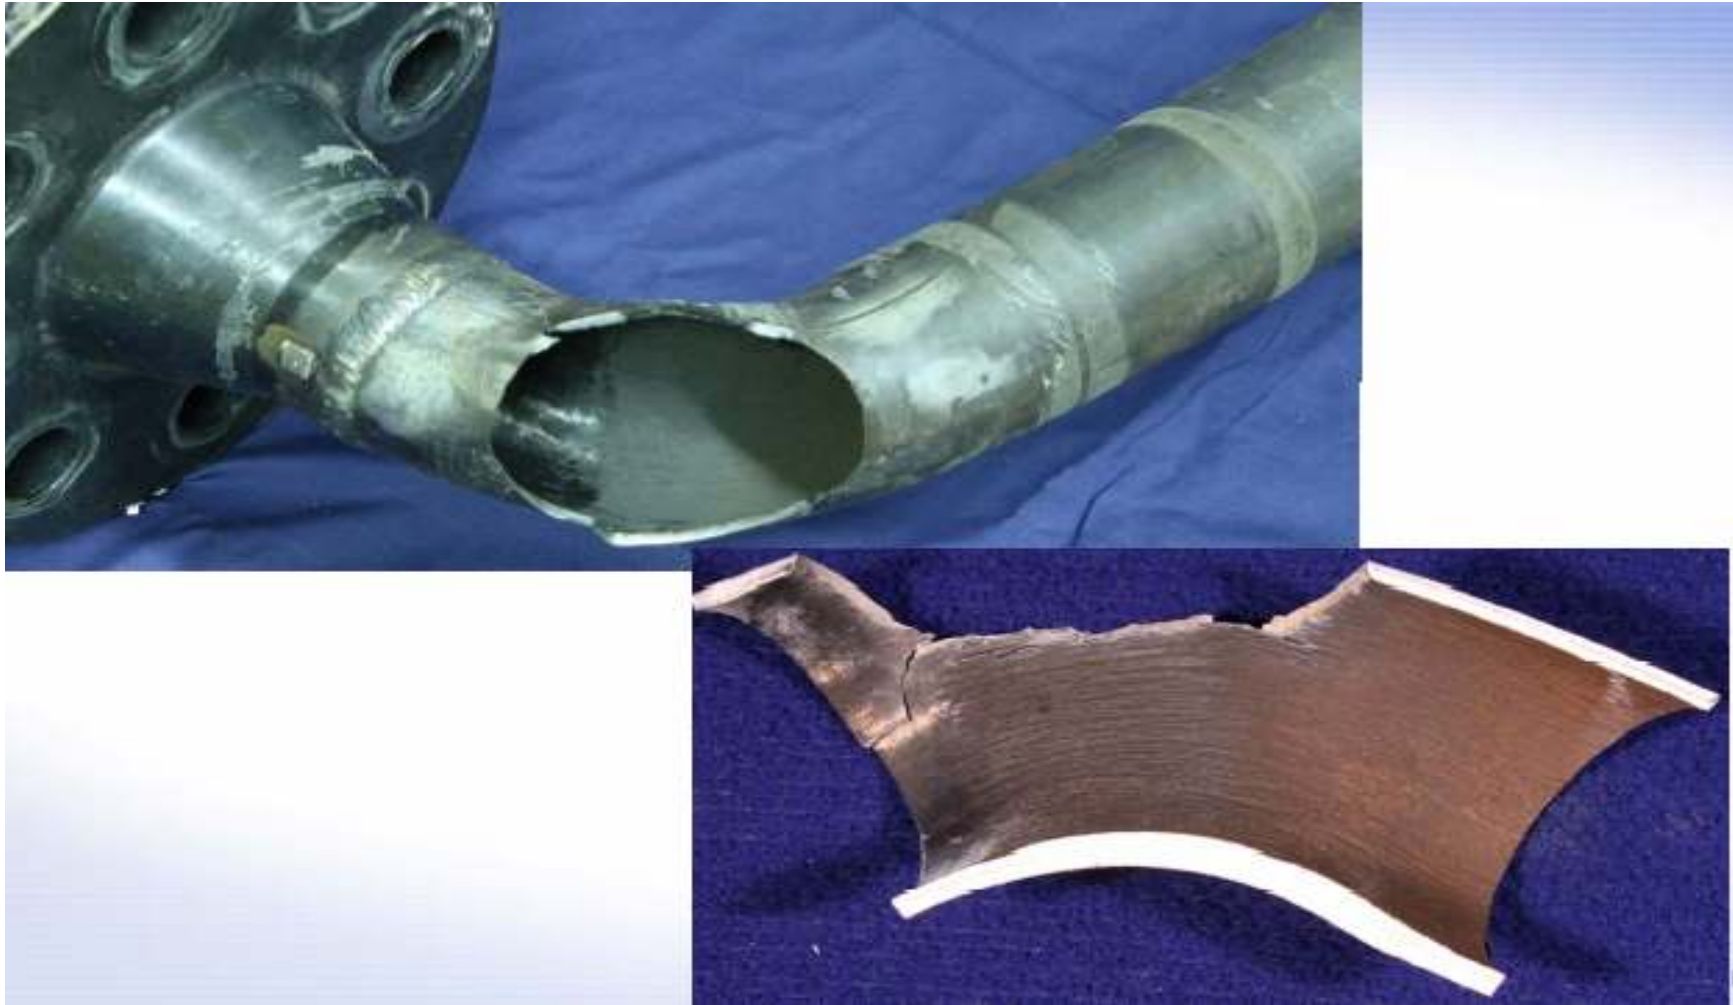
AECL's Feeder bend testing – Phase III for FAC

- NPS2½ or NPS2 Schedule 80 SA-106 Gr.B
- 300°C (265°C in Phase 1&2)
- General thinning: 40% t_{nom}
- Internal pressure 10.3 MPa
- Large bending moment (cyclic & monotonic)
- Local thinning flaw
 - 70% t_{min} wall thickness (2.3mm for NPS2½)
 - 45° or 90° circumferential extent
 - 12 mm axial length
