## Swedish experiences on remediation projects in the Baltic region

*Bo Nirvin, Project Manager, SKB International Consultants AB, Sweden*

### **PALDISKI - FORMER SOVIET TRAINING BASE FOR NUCLEAR SUBMARINE CREWS**

RETRIEVAL, CONDITIONING, DEMOLITION AND ENVIRONMENTAL RESTORATION

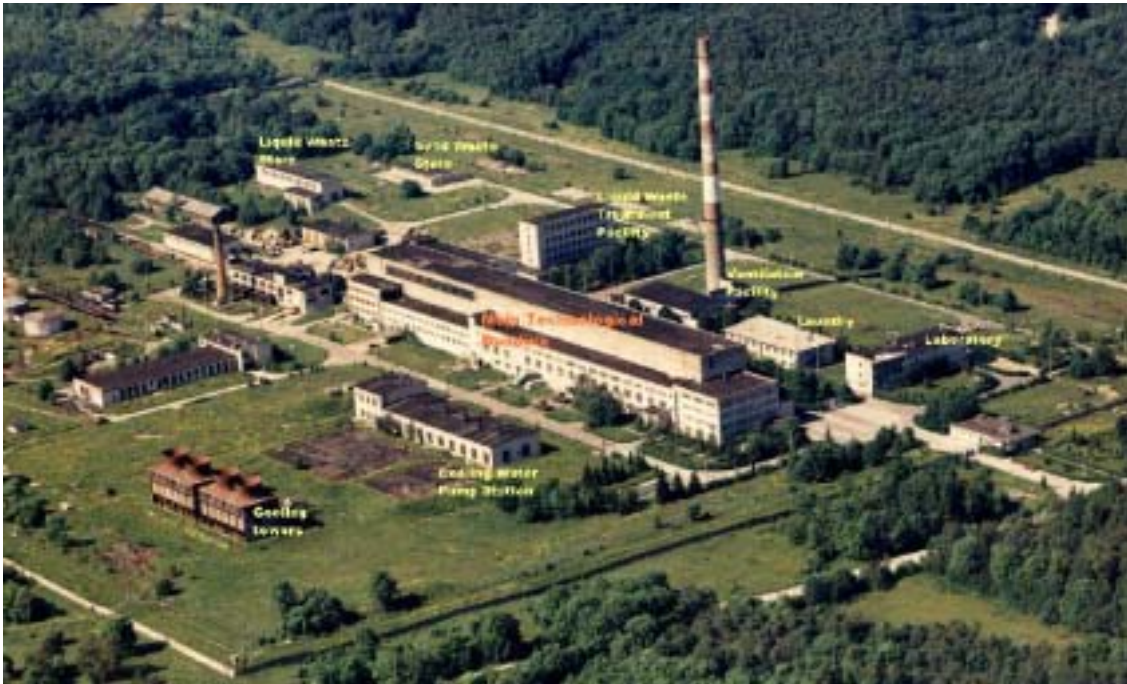
**Fig.2. Aerial view of the Paldiski site in year 1995**

In the centre is the Main Technological Building with parts of the two submarines. Up in the centre of the picture is the Solid Waste Storage.

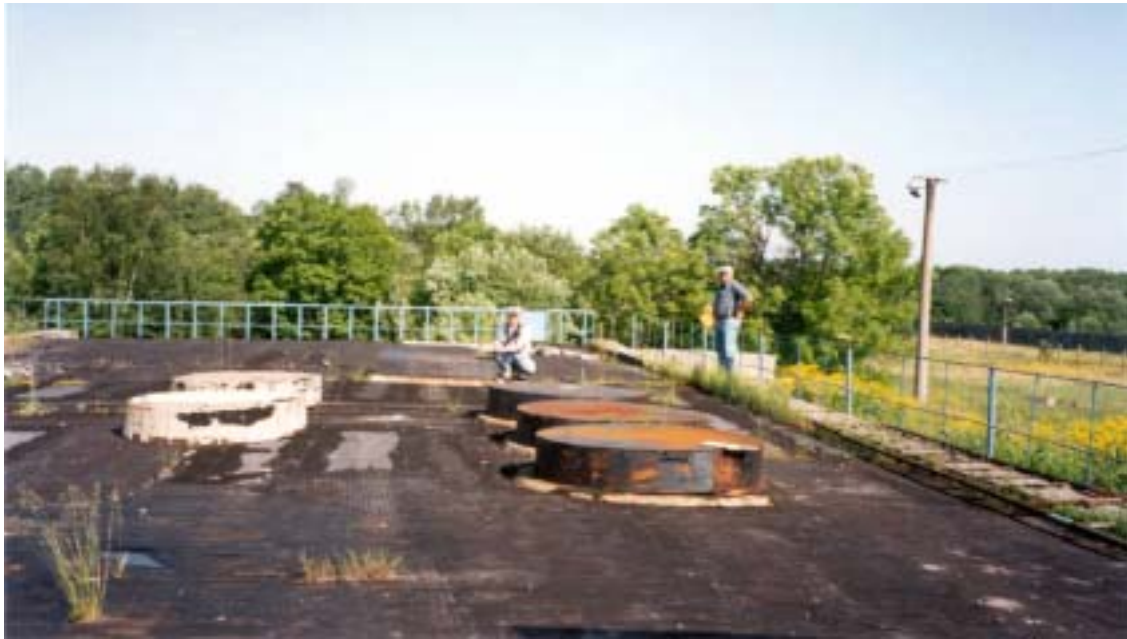
**Fig.3. The roof of SWS**

1995 the geographic position for SWS (building 307) is determined by GPS equipment.

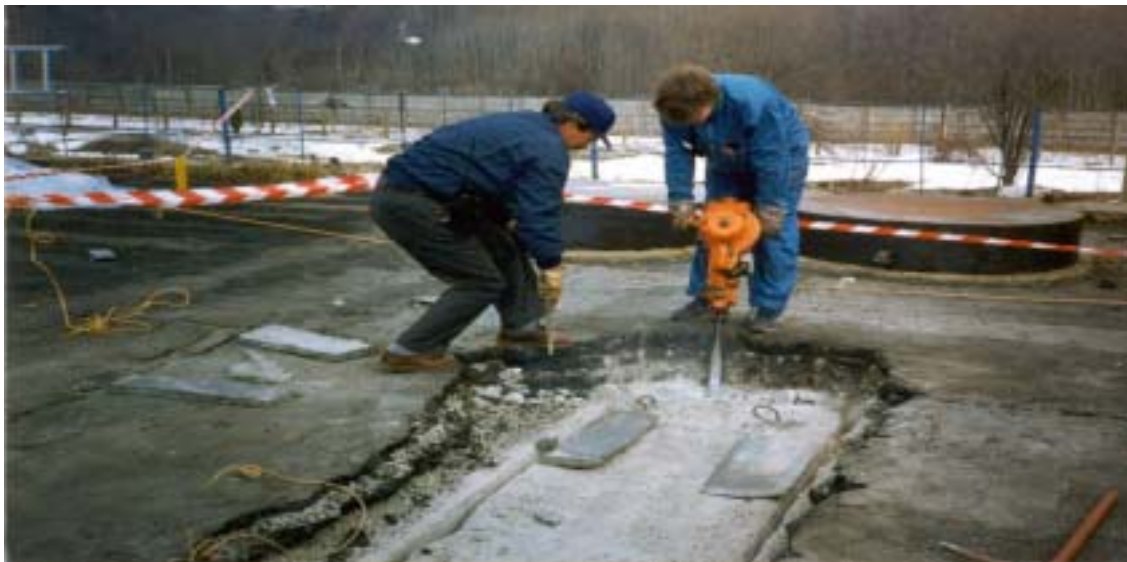
**Fig.4. Two Estonians open a slab.\**

Preparation for investigation of SWS start with two Estonians working to open a slab above cell #1.

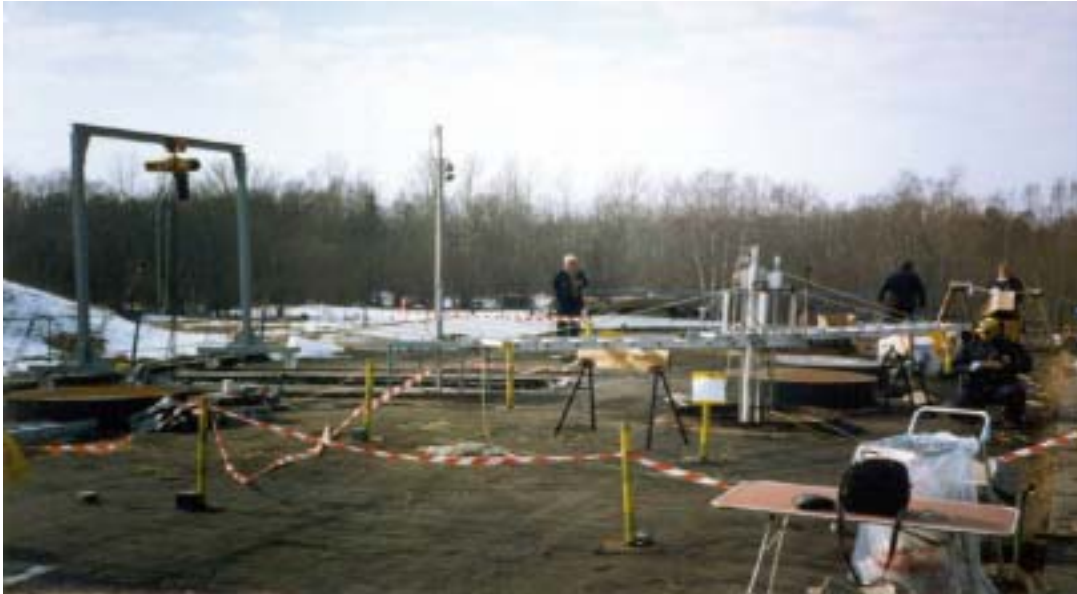
**Fig. 5 Waste characterisation in April 1996**

- The waste characterisation was done in April 1996 jointly by Estonian (AS ALARA), Swedish (Studsvik RadWaste AB and SKB) and US (DOE Idaho Operations Office) experts.

- The aim of the work:
  - Locate the control rods and other highly active items
  - Investigate if spent nuclear fuel was stored in the cells
  - Determine the gamma and neutron dose rates and the loose surface contamination in the cells
  - Qualify a nuclide content of the waste.
- Only three cells: 1, 4A and 5 were used for the storage of radioactive waste
- 20 control-rods was stored in cell 1 and 5
- 8 steam-generators was found in cell 1
- No spent nuclear fuel was indicated
- Some contamination was detected in cell 5 presumably caused by damaged control rods
- Estimated waste volume is about 200 m<sup>3</sup>
- Estimated total activity is about 3.7 TBq.

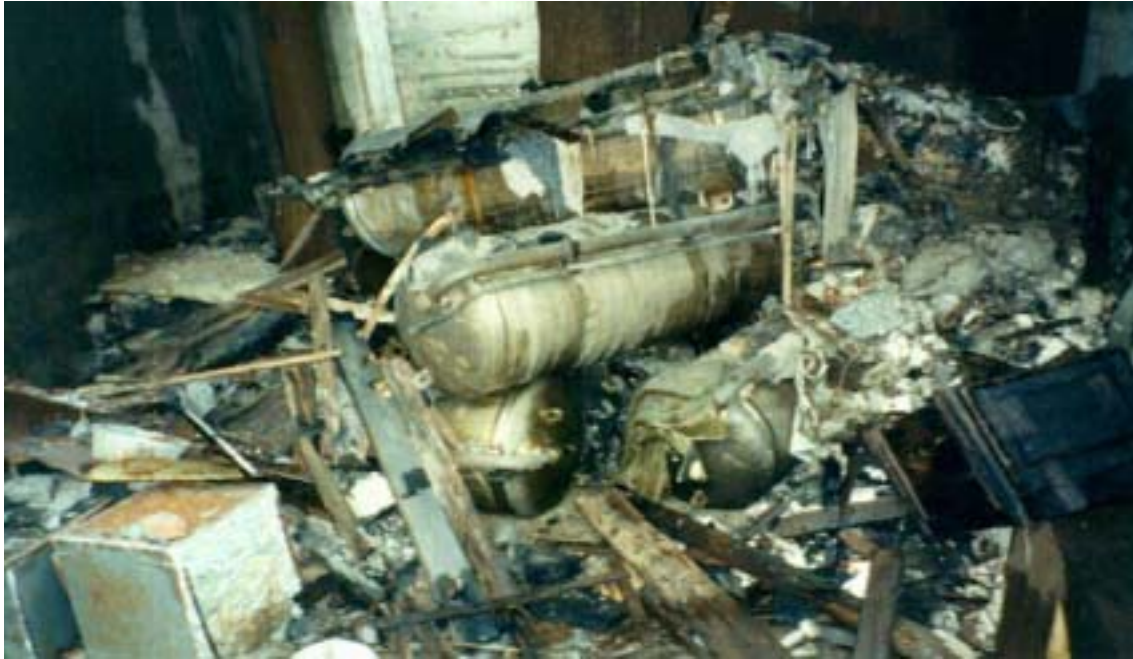
**Fig. 6. View inside cell #1**

Cell #1 contained among other things 8 steam-generators and 9 control rods from the rebuilding of reactor #1 connected with the refuelling in 1981.

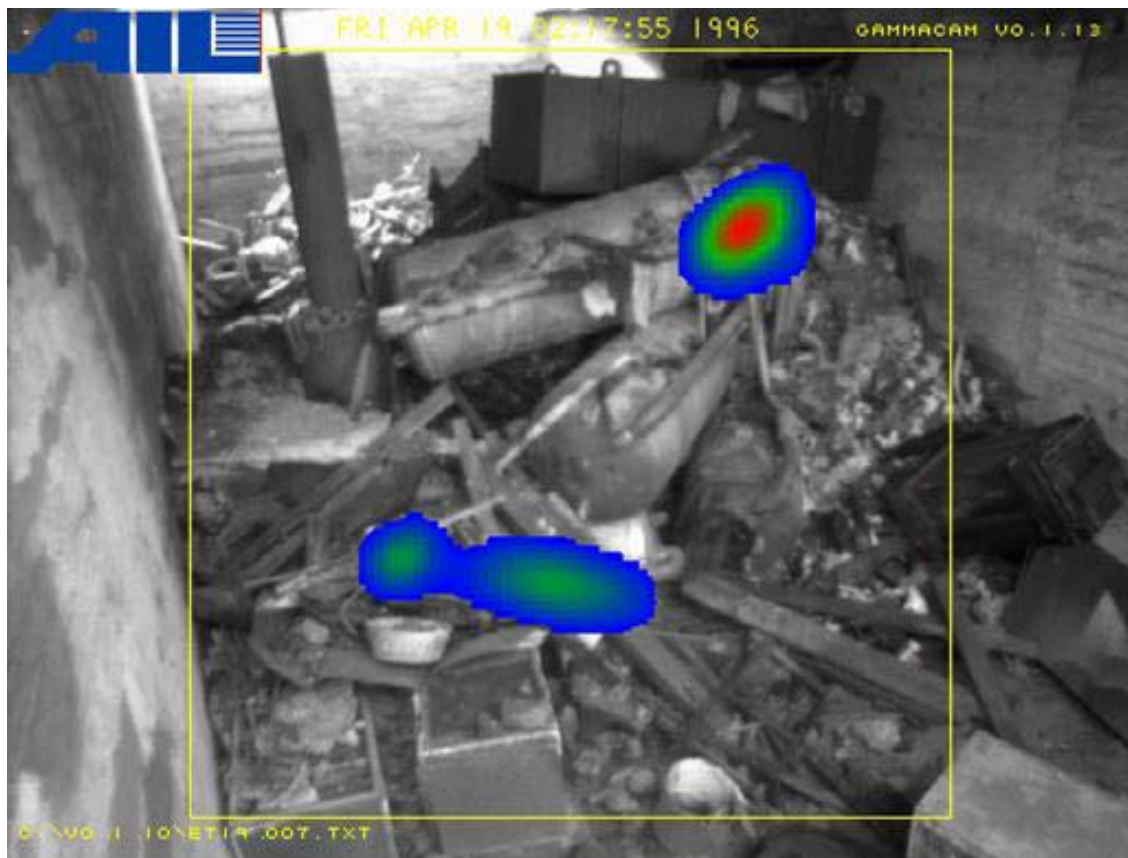
The coloured parts of this picture show the radioactive parts and the level of activity. Indicated activity originates from control rods, more or less shielded by steam generators and other inactive waste.

- No neutrons were detected in SWS
- The dose rate in **cell 4A** did not exceed 20  $\mu\text{Sv/h}$  -  $^{137}\text{Cs}$  and  $^{60}\text{Co}$  was indicated
- The dose rate in **cell 1** was in the range of 5-9 mSv/h. The gamma spectrometric data shows  $^{60}\text{Co}$ ,  $^{152}\text{Eu}$  and  $^{154}\text{Eu}$
- The dose rate in **cell 5** was more than 10 000 mSv/h in the bottom of the cell and 200 mSv/h at the roof level.  $^{60}\text{Co}$ ,  $^{152}\text{Eu}$  and  $^{154}\text{Eu}$  were indicated.

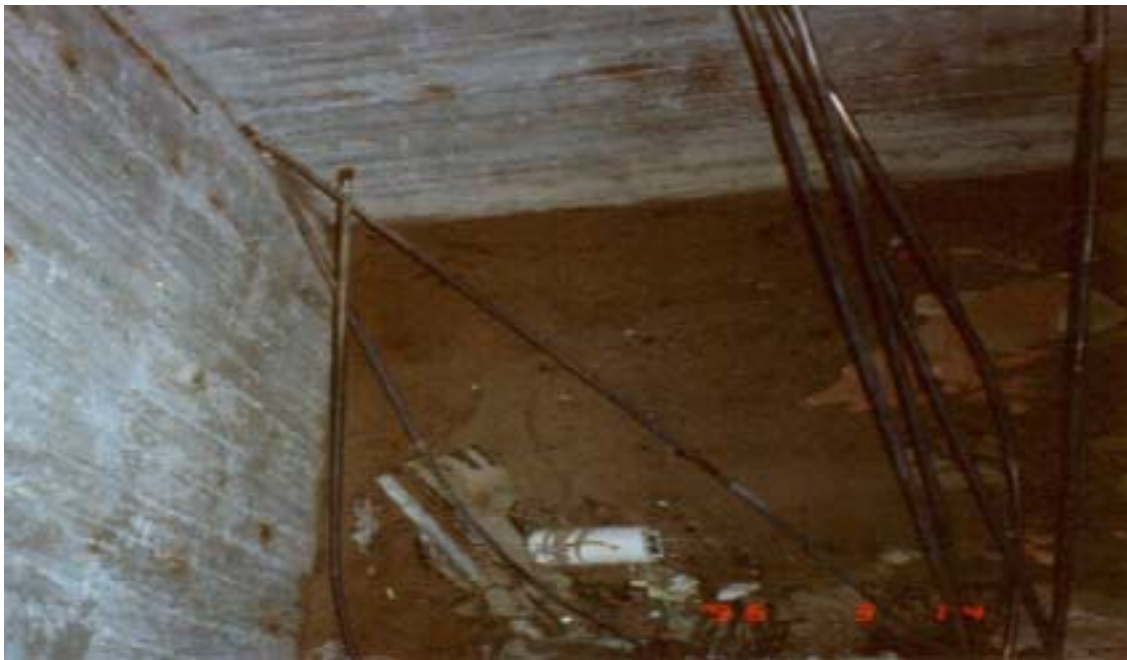
**Fig. 8. Control rods and sources in cell #5**

Cell #5 contained, among lots of other waste, 11 control rods from reactor 1 plus varying sources. A source of significant high radioactivity is marked,  $\approx 10\,000$  mSv/h.

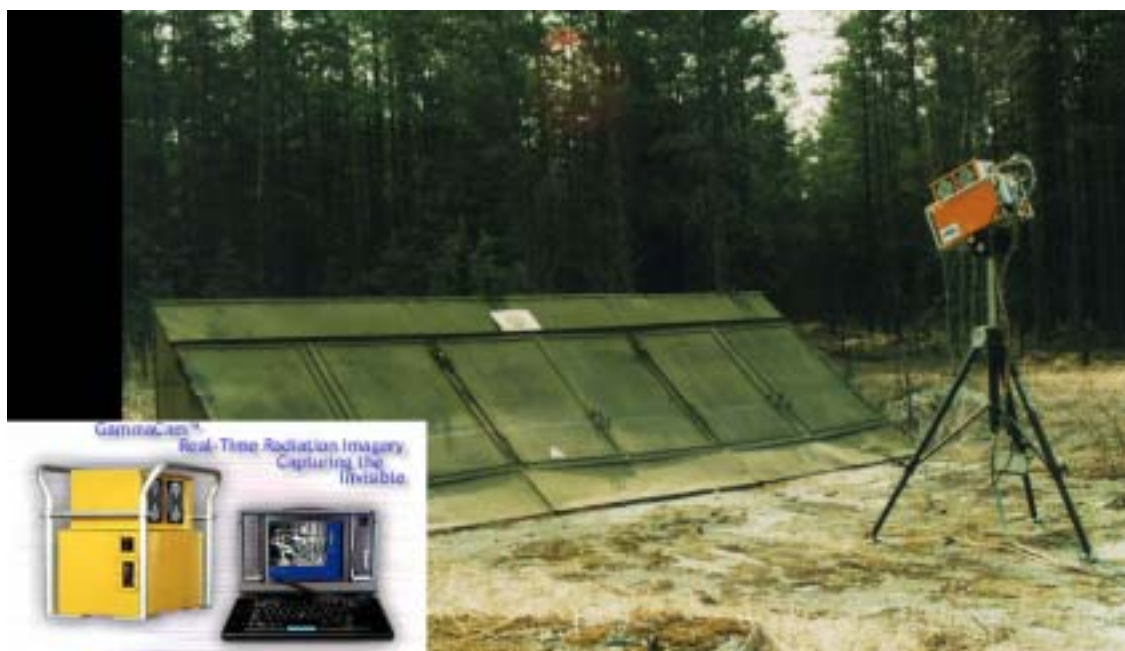
**Fig. 10. The GammaCam detection head placed on a tripod outside the Tammiku RMI storage**

- *Spectral Range* < 50 keV to > 1.3 MeV
- *Detector* High density terbium-activated scintillating glass
- *Detection Head Weight*: 60 Pounds,  
Size: 19 in. Length,  
10 in. Width,  
15 in. Height,  
Tripod Mountable
- *System Power* 215 Watts, 110 - 240 VAC 50/60 Hz.

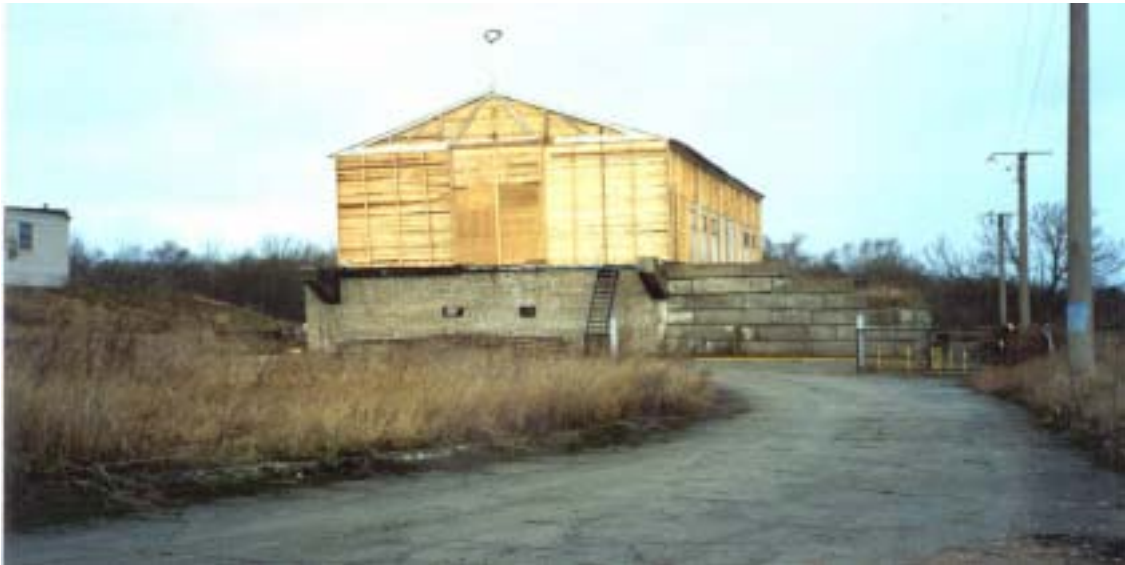
**Fig. 11. The shelter building on top of SWS**

To protect from weather and wind and from spreading activity a simple shelter was built above the main part of the SWS.

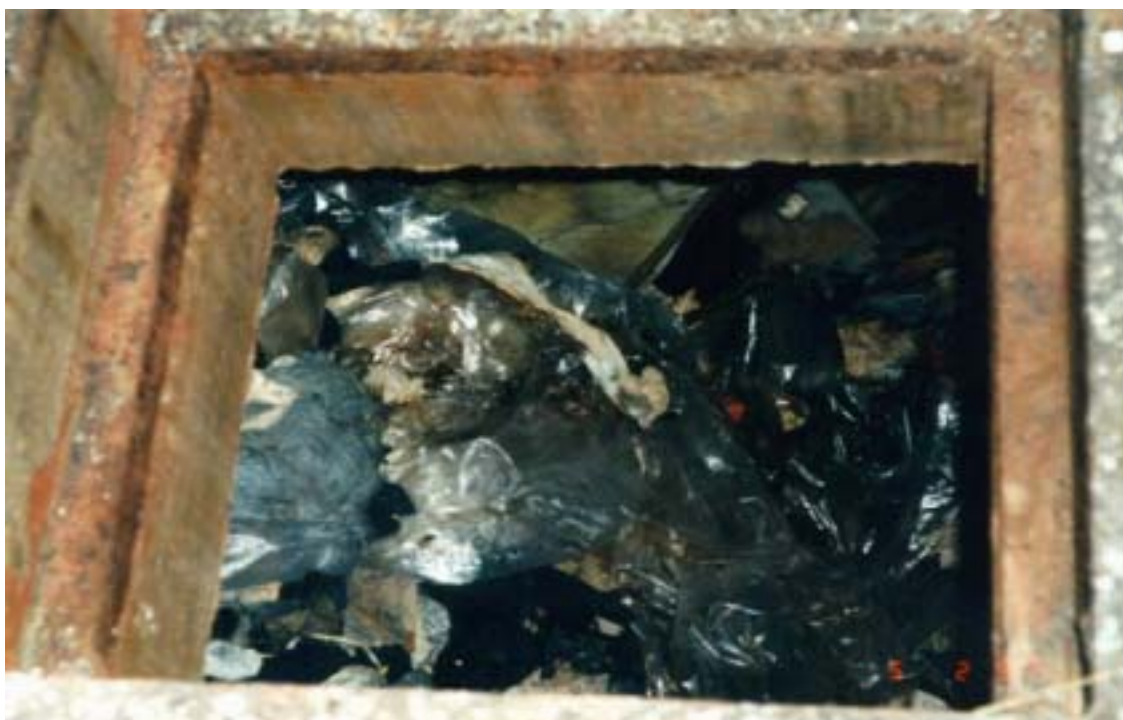
**Fig. 13. Compactable waste in cell #4A**

The cell #4 is top filled by compactable waste. The dose rate is below 20  $\mu\text{Sv/h}$ . The low levelled waste in cell #4A was retrieved by hands of the Estonian personnel. The waste was packed in plastic bags and later placed in 200 litre drums.

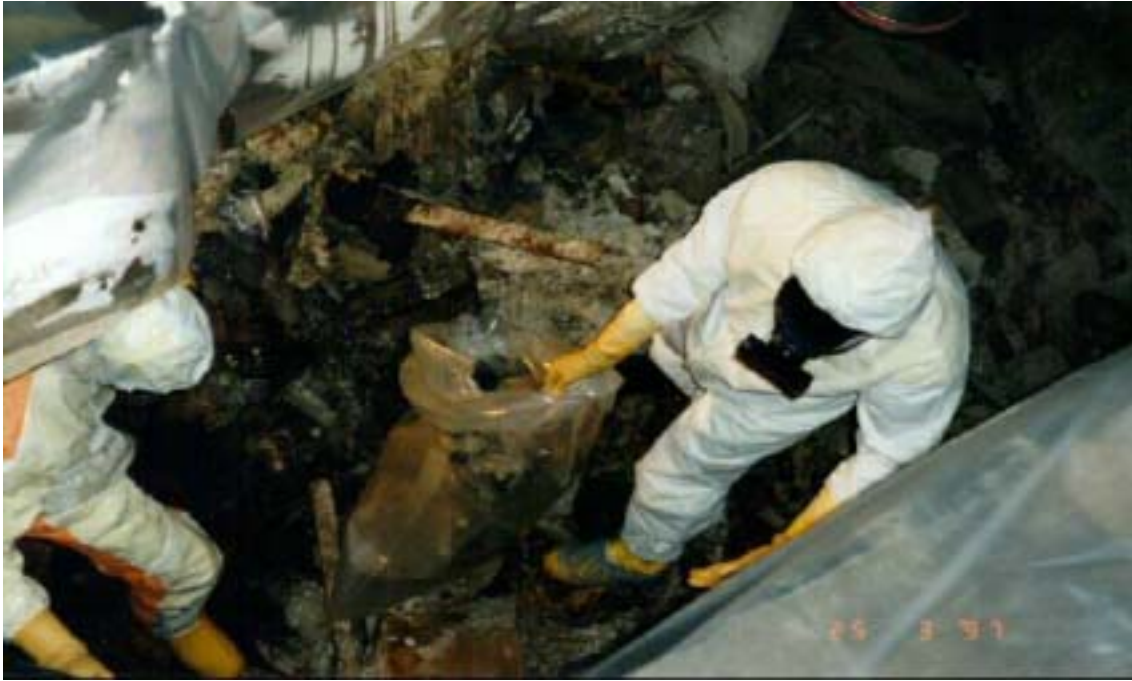
**Fig. 14. Manual work in cell #4A**

The compressible waste from cell #4A, filled in plastic bags, was compacted in an in drum compactor. Compaction rate about 3:1.

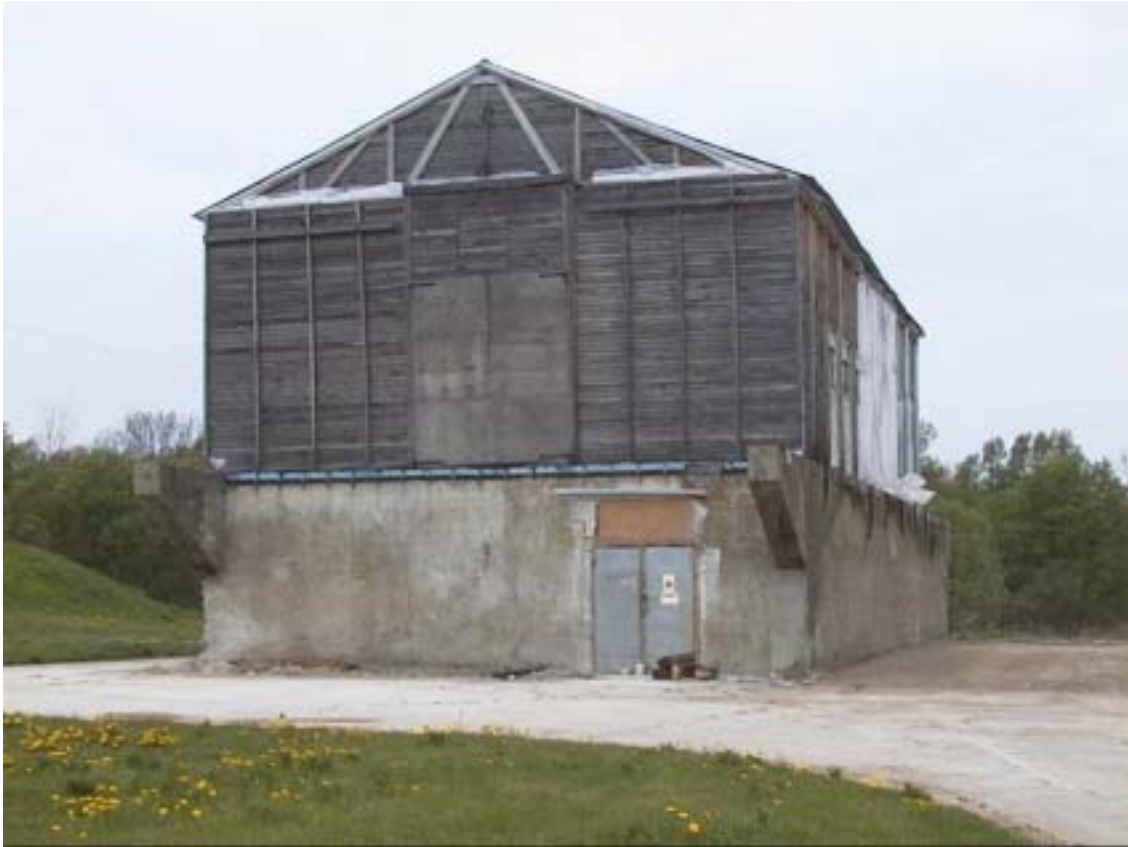
**Fig. 16. The opening in the ground wall**

To bring material in and out to the SWS an opening was sawed in the ground wall. An airlock was arranged inside.

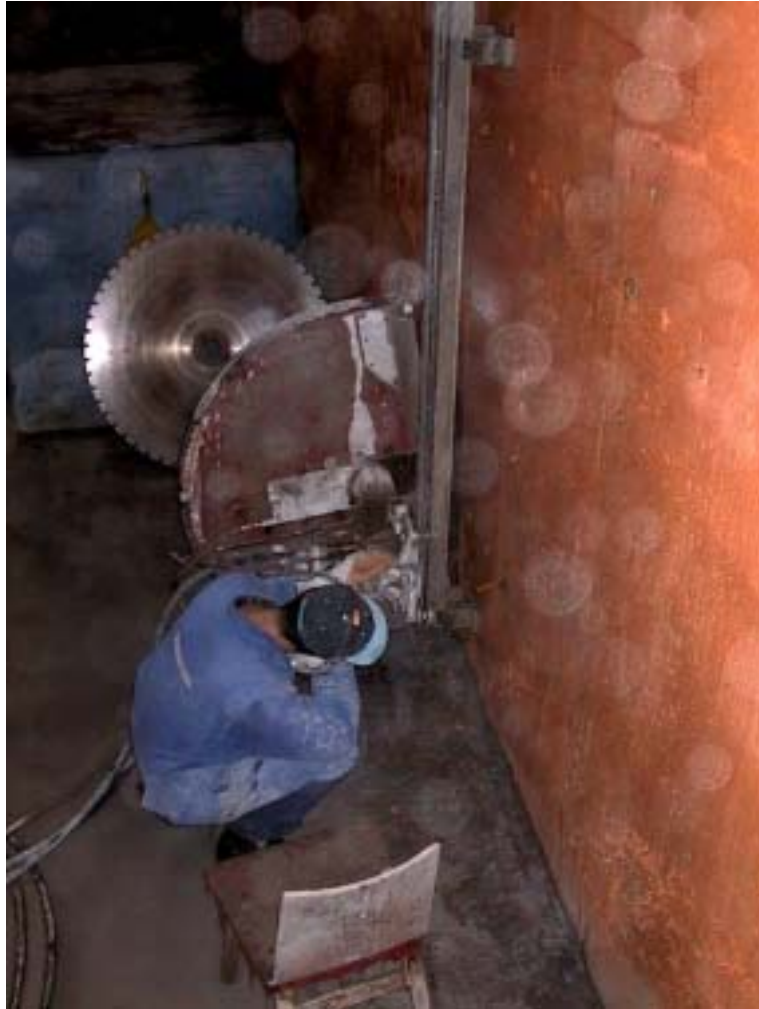
**Fig. 17** The concrete saw, mounted vertical, cutting an opening through a wall.

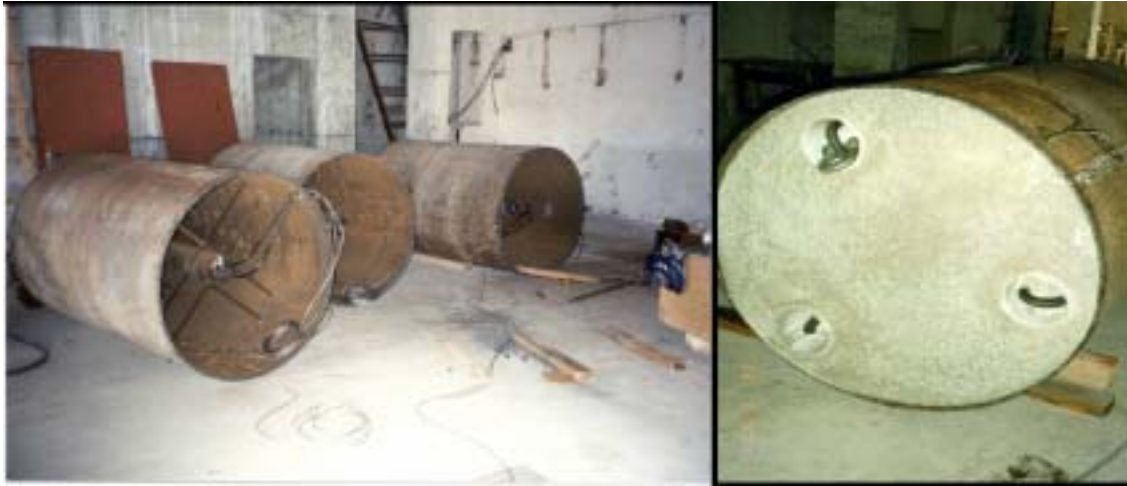
**Fig. 23. Manufacturing of control rod containers**

The most active parts from the control rods were placed in three special designed containers, manufactured at the site from pipes for cooling water, outer diameter approximately 1.2 m. In the centre a small pipe with a diameter of about 0, 2 m was placed, the interspace was filled with concrete for radiation shielding.

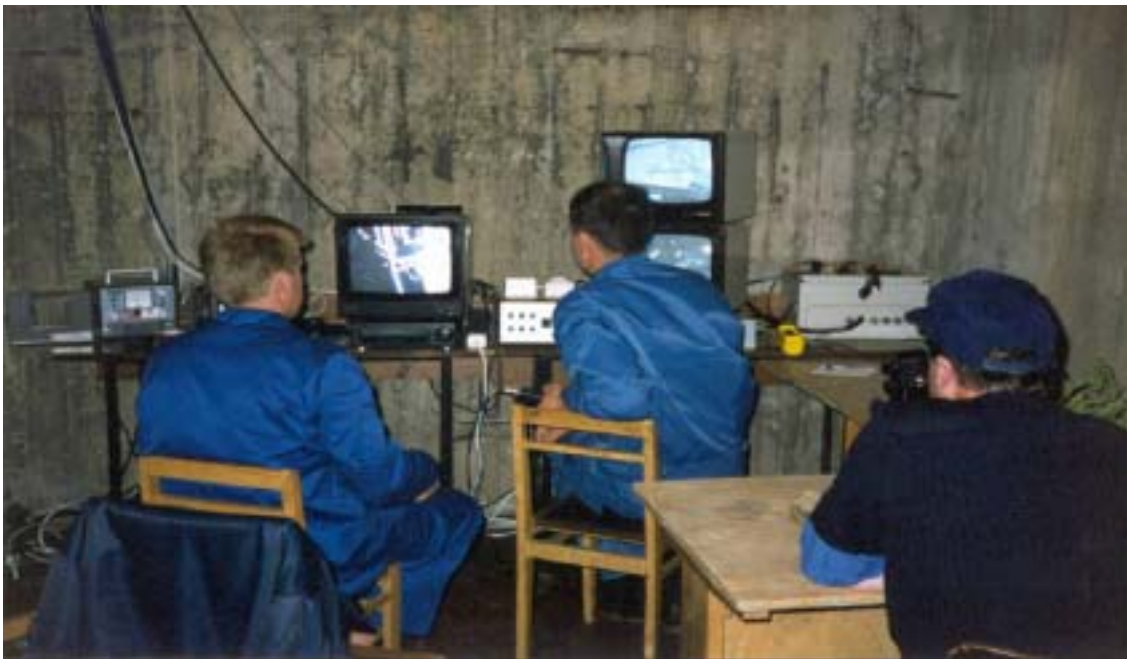
**Fig. 24. The control room**

All equipment, booth the cranes, the hydraulic shear, the TV-cameras, lights, dose rate detectors etc. was operated from a shielded control room arranged in one of the empty compartments.

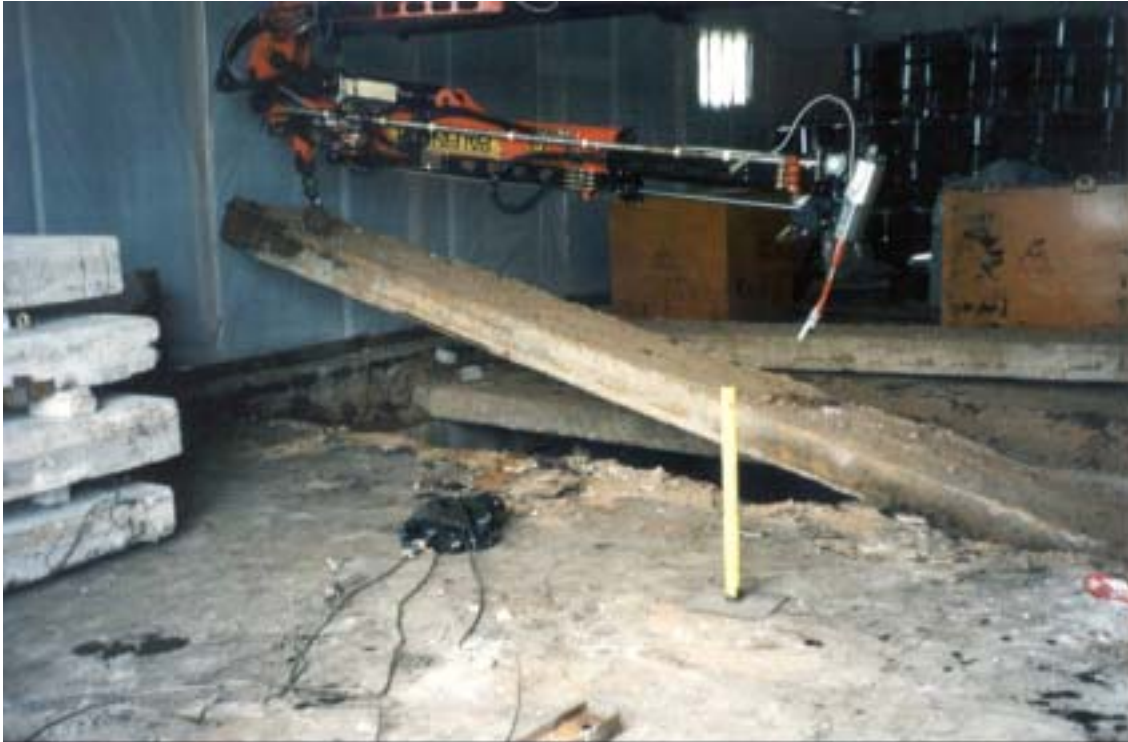
**Fig. 25. The main crane with jib and gamma probe**

The main crane with jib and gamma probe was used when lifting the concrete planks covered cell #1.

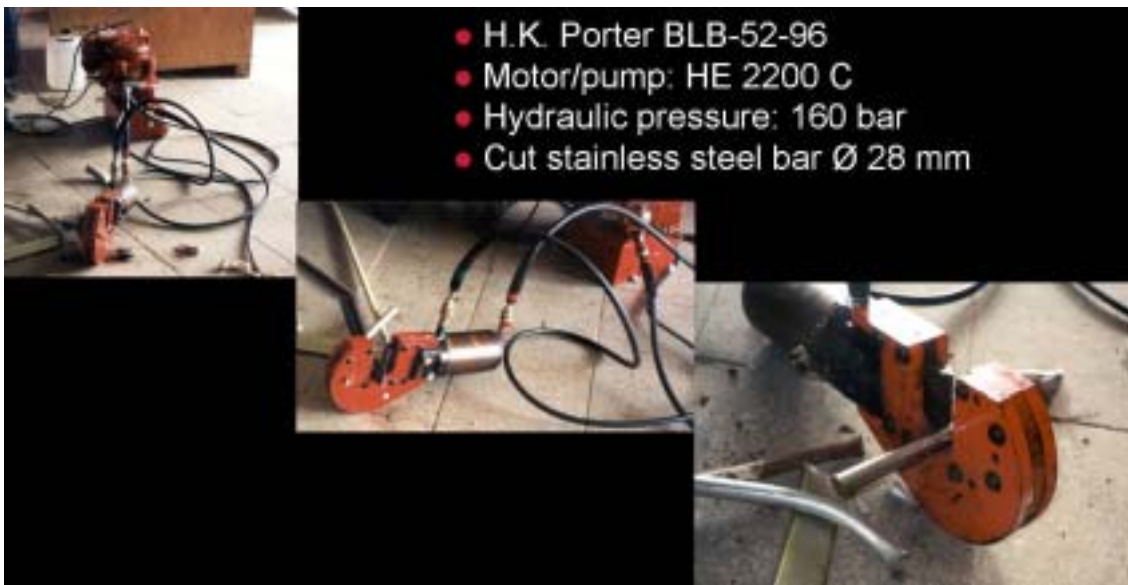
**Fig. 26. The hydraulic shear**

The hydraulic shear mounted at the end of a square tube and lowered down into the cells.

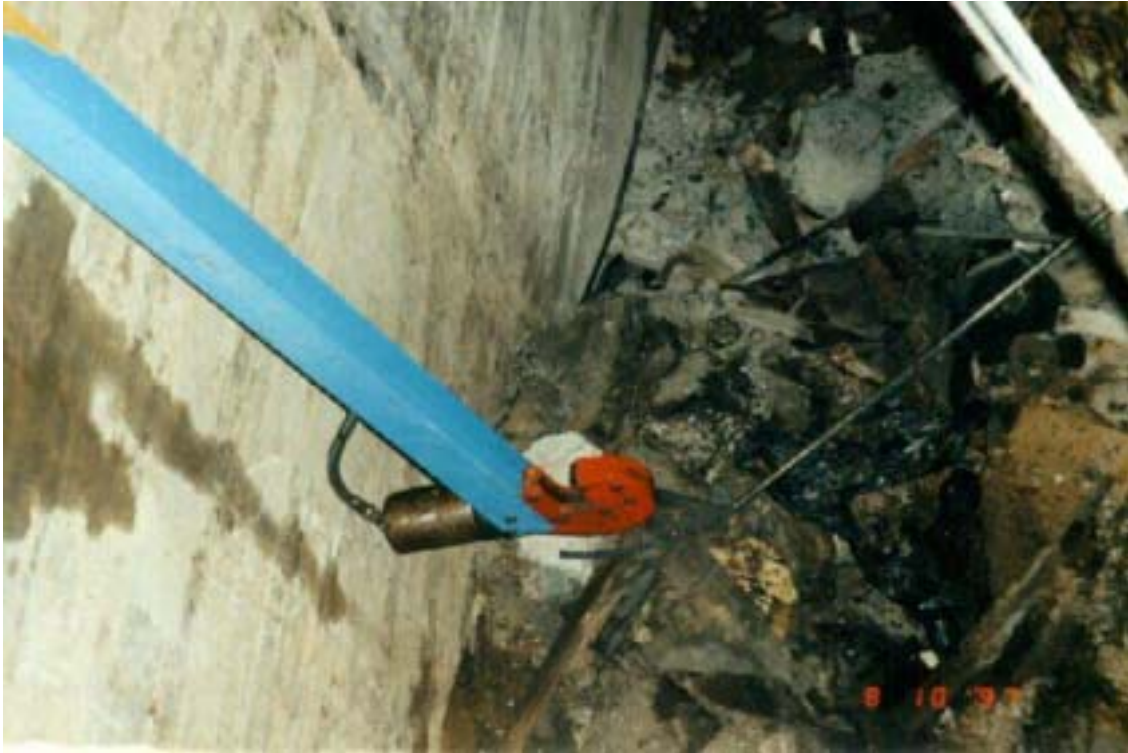
**Fig. 27. The hydraulic shear in cell #1**

Each control rod was cut in length of approximately 1 meter.

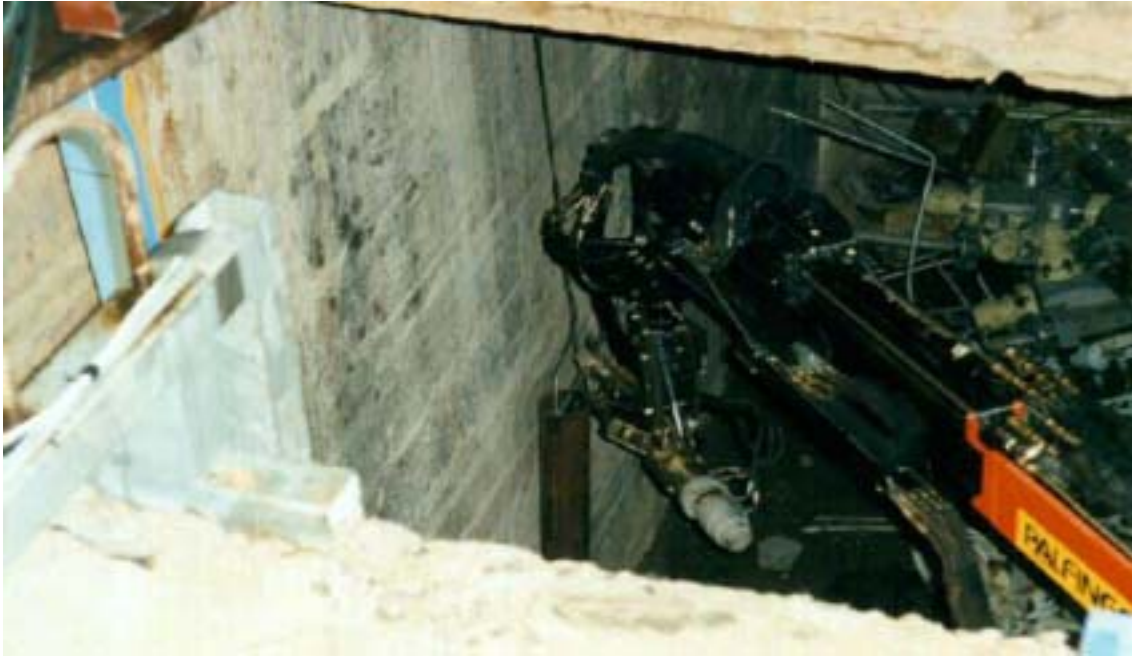
**Fig. 29. Loading the quiver**

Cut control rods are put into the “quiver” which, after been filled, was hoisted up into the control rod container.

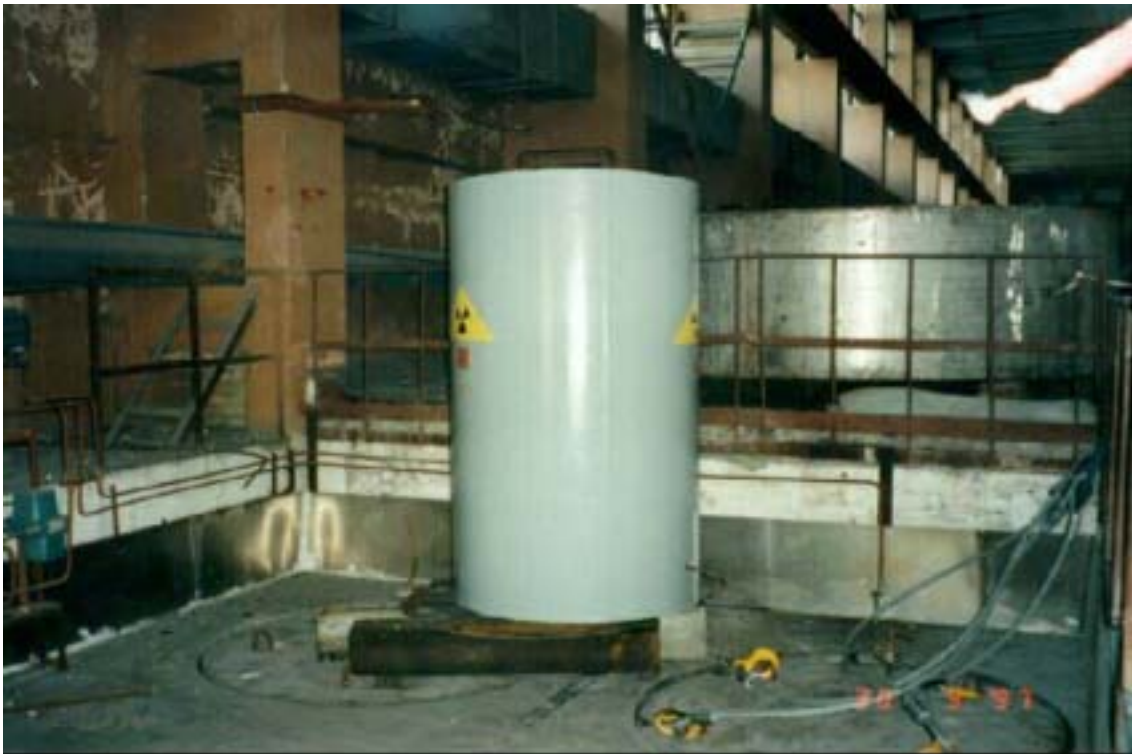
**Fig. 30. One CRC waiting for storing**

The three CRCs are stored in empty pools in the Main technological Building.

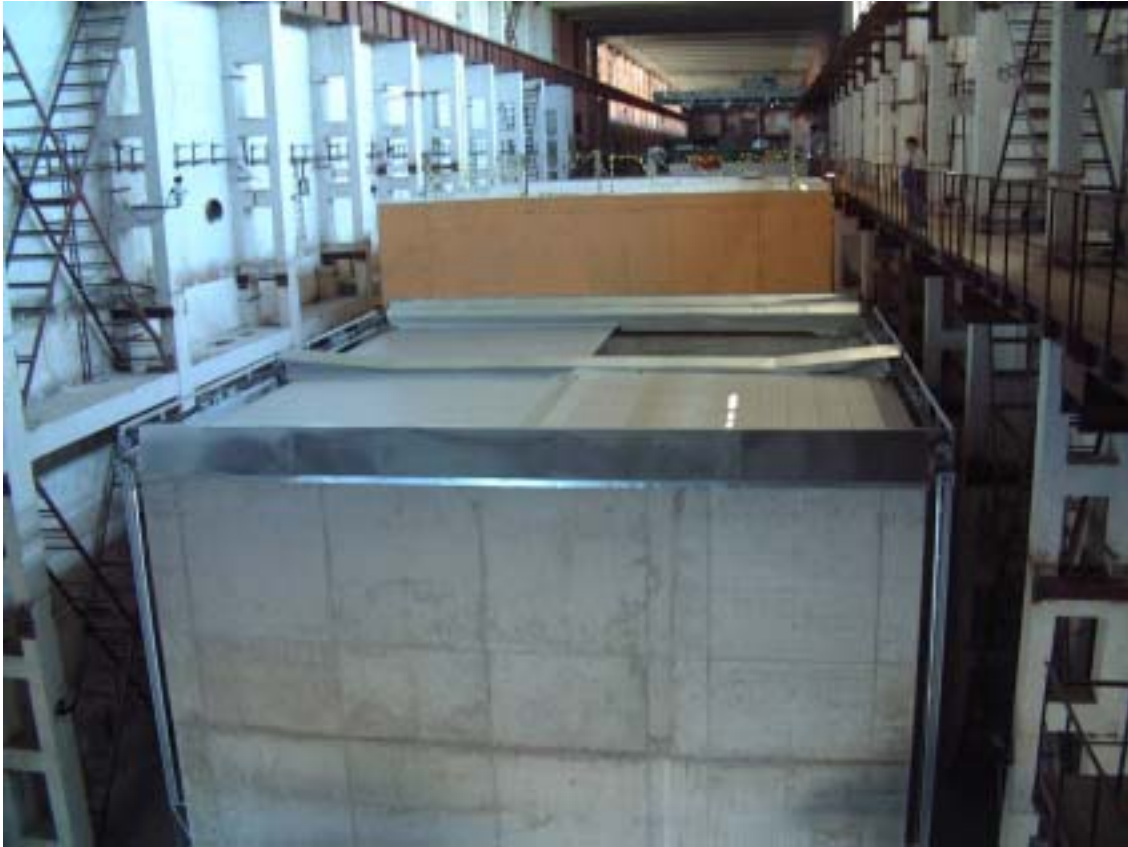
**Fig. 31. The new interim store**

A new interim store is built in connection to the sarcophagus #2 in the northern end of the Main Building. Concrete containers are remotely placed in the interim store by an overhead crane and a special designed lifting tool.

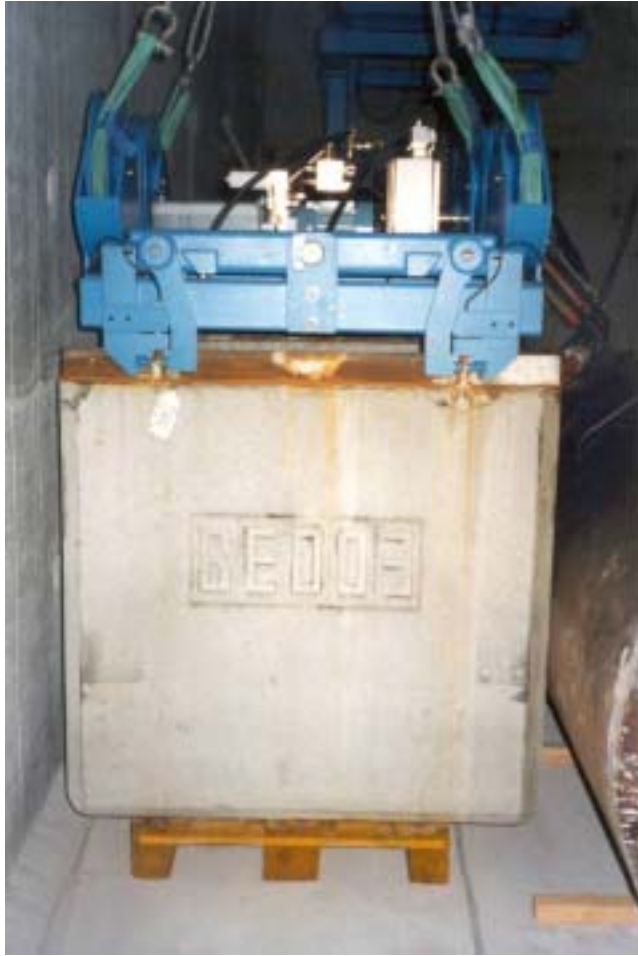
**Fig. 33. The lifting tool gripping a container**

The special lifting tool for the waste containers was constructed to fit the old overhead crane in the building. The tool has replaced the hook in the 10 ton crane and is remotely operated by radio.

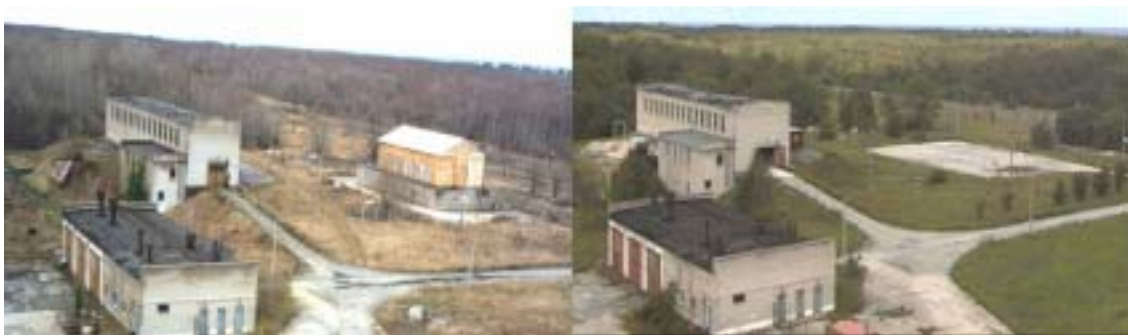
**Fig. 34. The NE corner year 1997 respectively year 2000**

In 1997 the SWS and the shelter building was situated in the NE corner of the site. Three years later, year 2000, booth the SWS and the shelter building had been demolished and the area is cleaned.

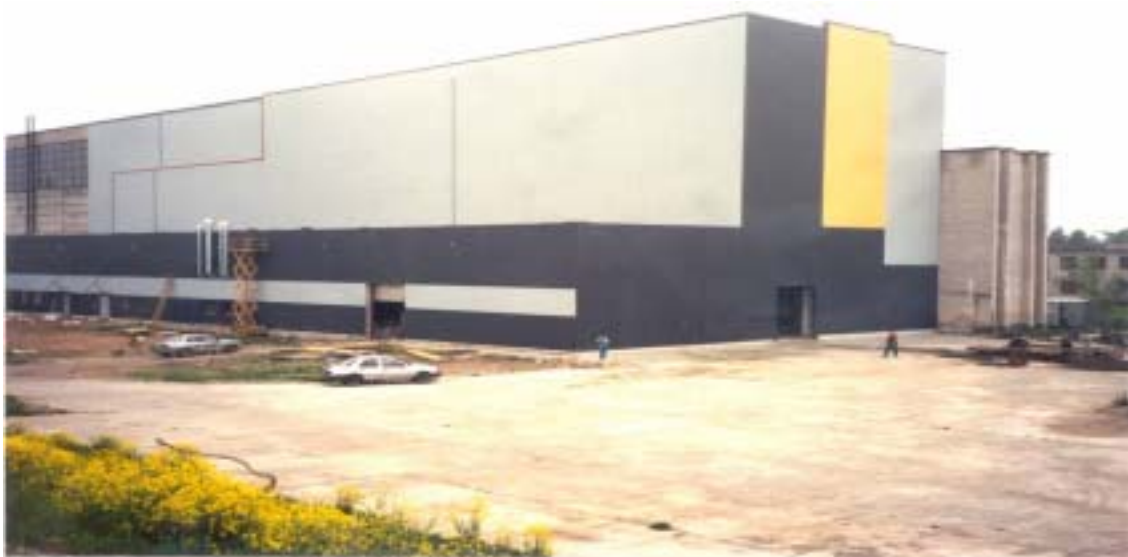
**Fig. 35. Main Technological Building with Annex building**

In parallel with retrieving the solid waste the Main Technological Building was renovated and partly modernised. A new office and waste handling area was constructed.

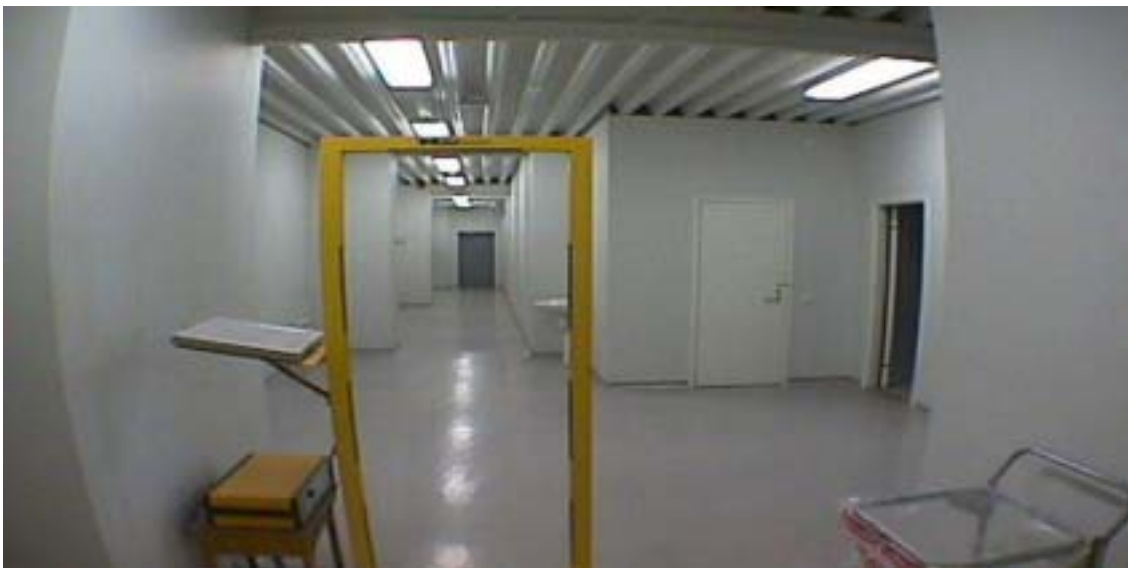
**Fig. 36. Portal monitor LEAB**

The portal monitor is installed at the entrance to the zoned area in the new annex building and building 302. The laundry in the annex building is equipped with an industrial wash machine and dryer.

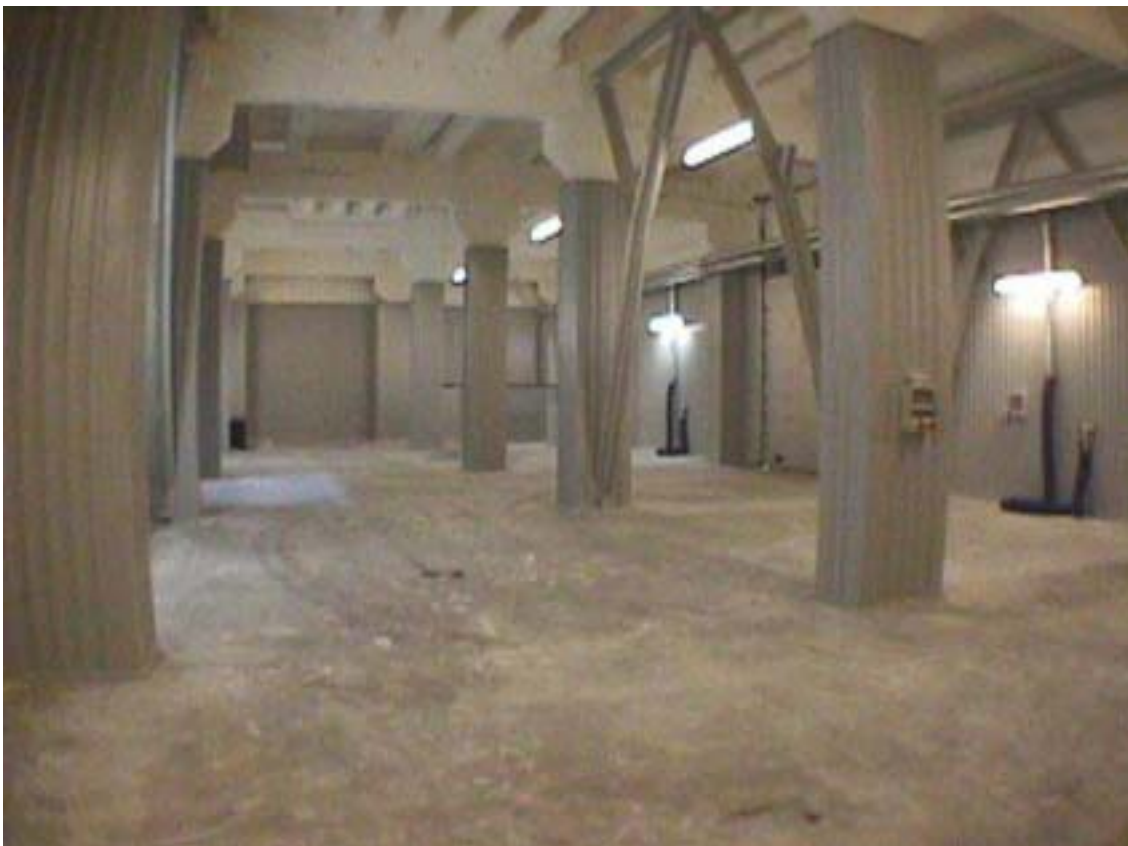
**Fig. 38. Waste handling area in the annex building**

The northern part of the annex building is planned for waste handling. This area shall house equipment for nuclide measuring, concrete mixing, tools for segmentation and decontamination etc.

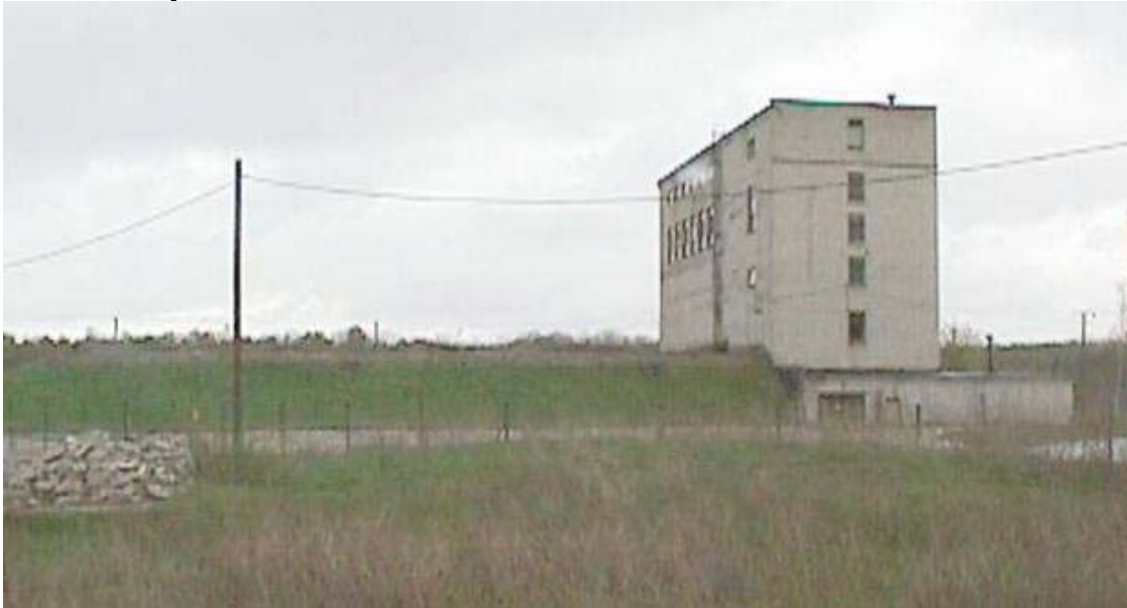
**Fig. 39. Building 303, Liquid Waste Treatment Building, and Tank farm**

The Liquid Waste Treatment Building and the Tank farm are built in direct connection to each other. The building raises six floors high. The exactly position of all larger components is shown on the 3-D X-ray drawing of Building 303 with the tank farm.

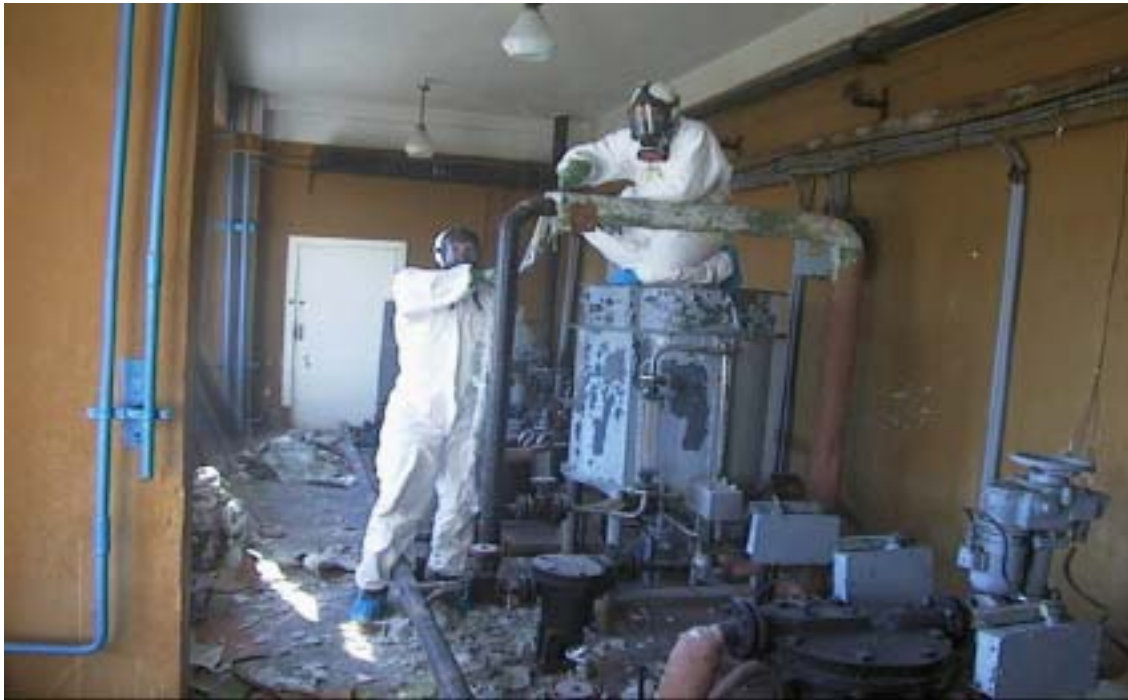
**Fig. 41. Removal of asbestos**

It was a hard and time-consuming work to remove asbestos insulation from a great part of the installations. Luckily there was almost no contaminated asbestos insulation.
