## Swedish experiences on remediation projects in the Baltic region

*Bo Nirvin, Project Manager, SKB International Consultants AB, Sweden*

### **PALDISKI - FORMER SOVIET TRAINING BASE FOR NUCLEAR SUBMARINE CREWS**

RETRIEVAL, CONDITIONING, DEMOLITION AND ENVIRONMENTAL RESTORATION

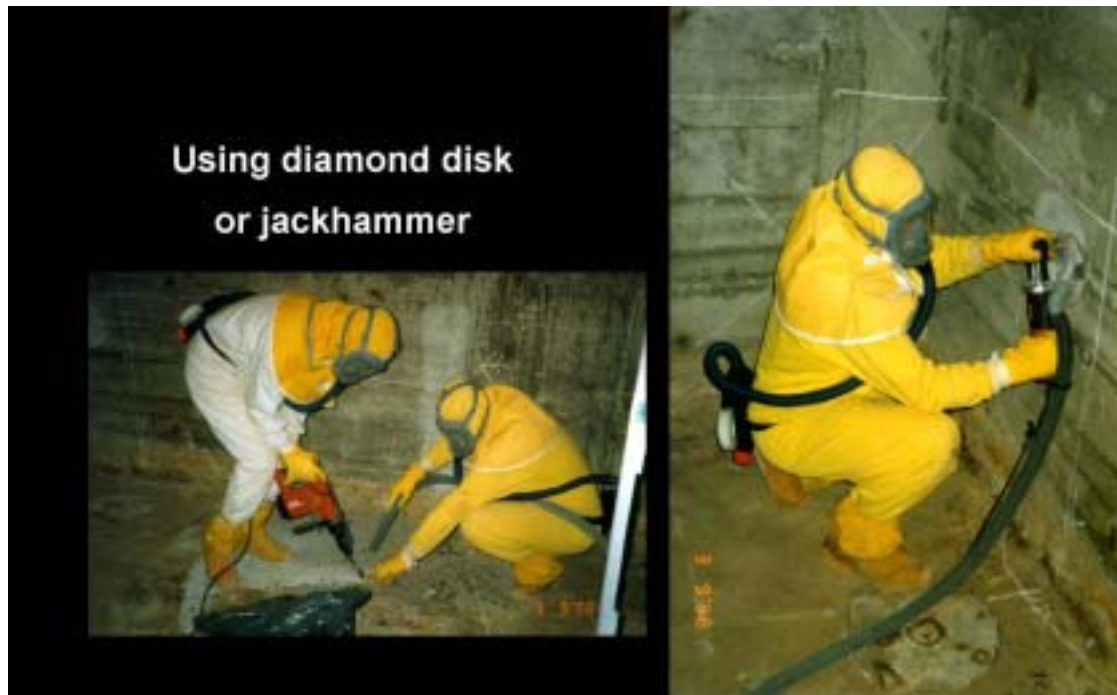
**Fig. 42. Concrete decontamination work**

A grid, 1 x 1 meter, was marked on all surfaces. Every square was surveyed and found contamination marked. Using diamond disk or jackhammer connected to an industrial vacuum cleaner all areas were decontaminated step by step. After the decontamination was finished you could find the building ragged and penetrated but clean from radioactivity.

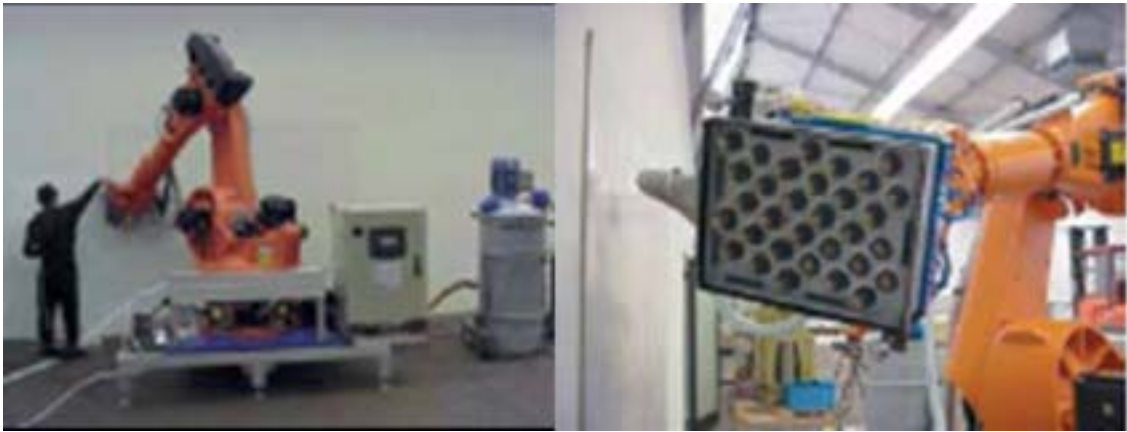
**Fig. 44. Decontamination robot, BOLERO, from Studsvik SINA**

BOLERO is a robot for decontamination and free release.

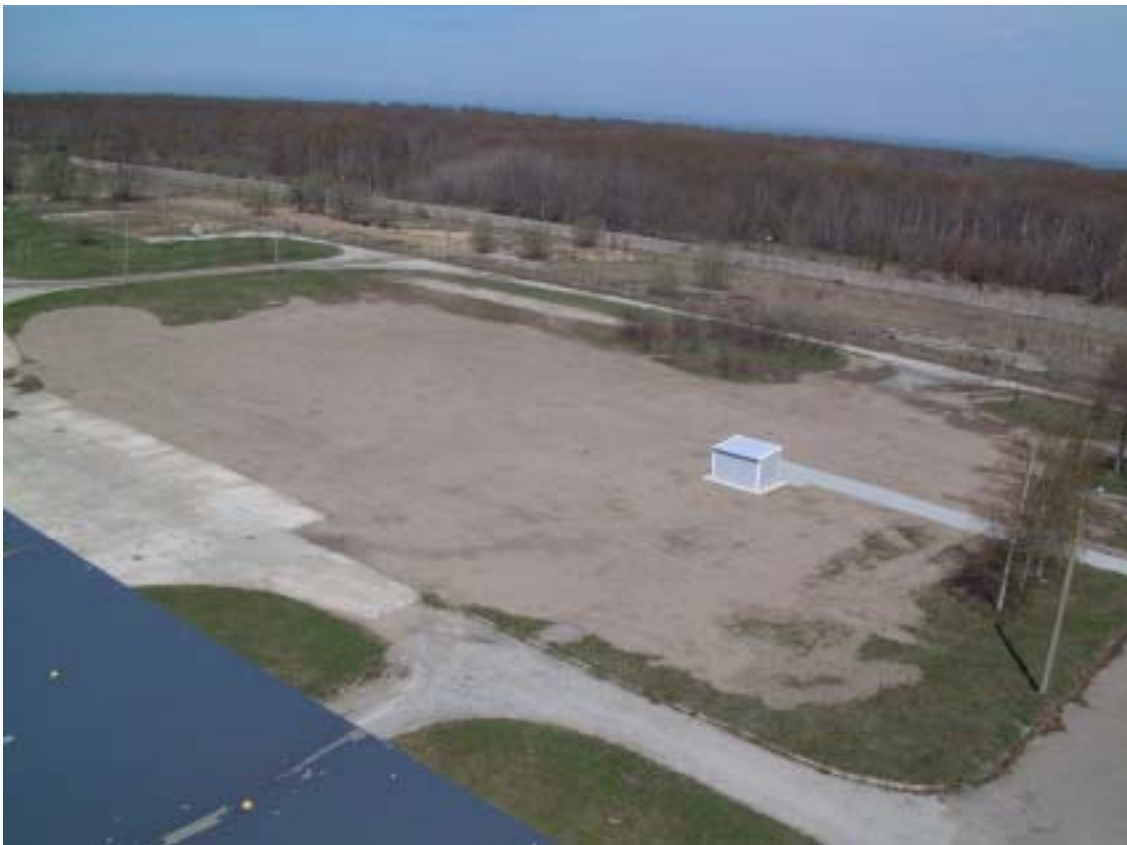
**Fig. 45. Cleaned area from building 303**

Building 303 and the tank farm are demolished. Remaining is only a small house containing pipe connections and valves.

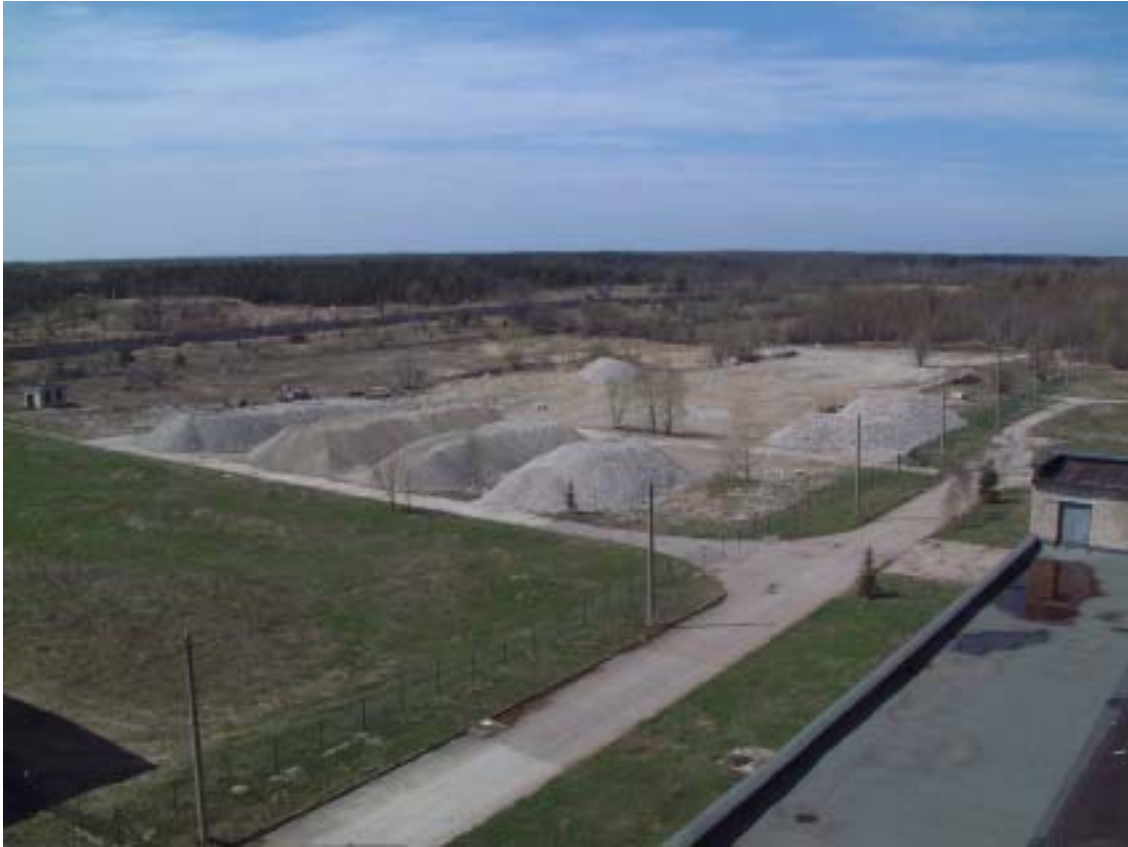
**Fig. 46. Piles of crushed concrete.**

Crushed concrete from the demolition of buildings are piled in different fractions to be used at road constructions.

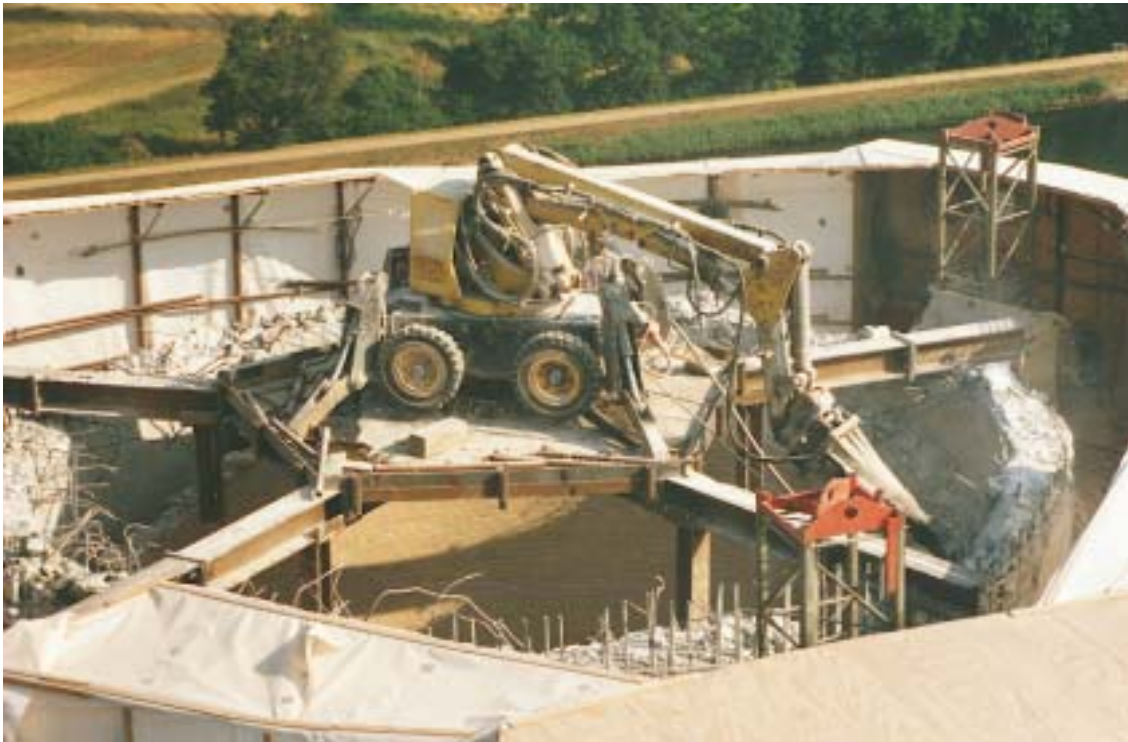
**Fig. 47. A BROKK demolition robot**

The BROKK-family offers several efficient and robust demolition robots. The smallest is small enough to pass through a normal door opening; the biggest one has the highest capacity, of demolition robots, in the world.

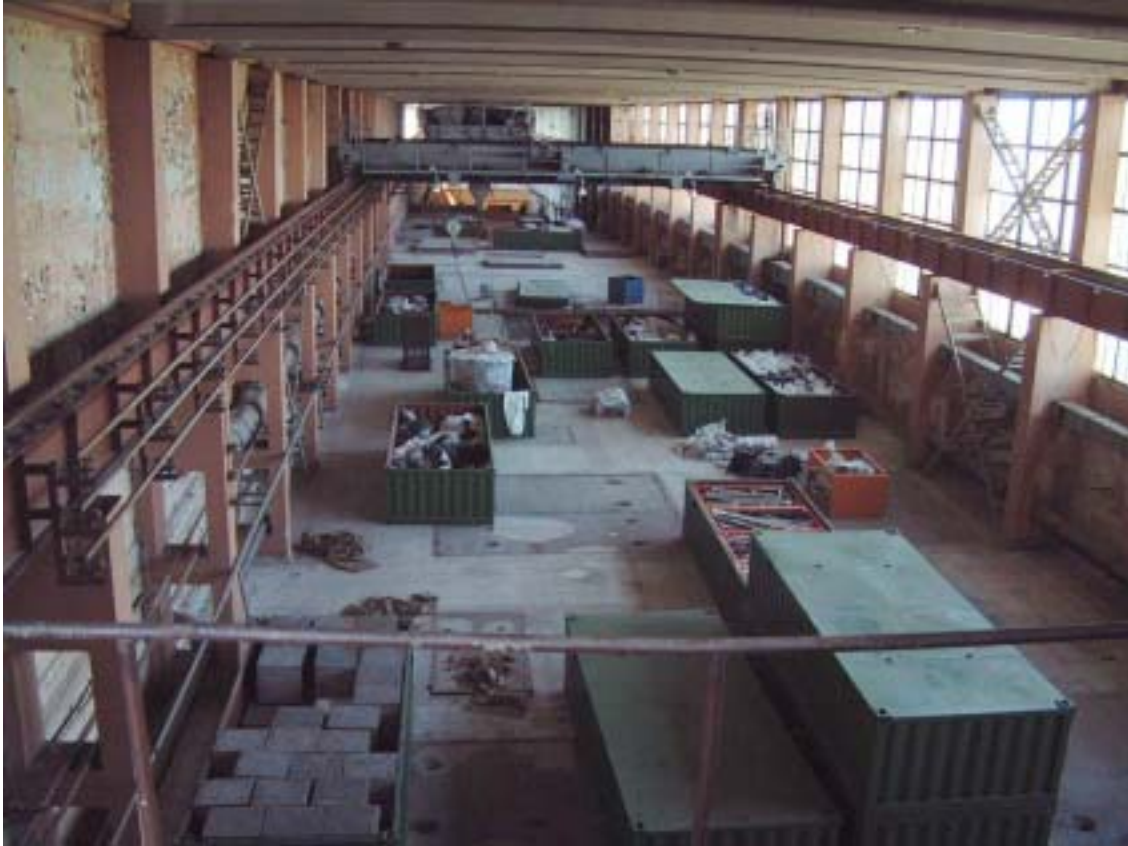
**Fig. 48. Temporary container storage**

The decontamination will require large resources and long time why an interim store of contaminated scrap in 20-foot ISO-containers is recommended.

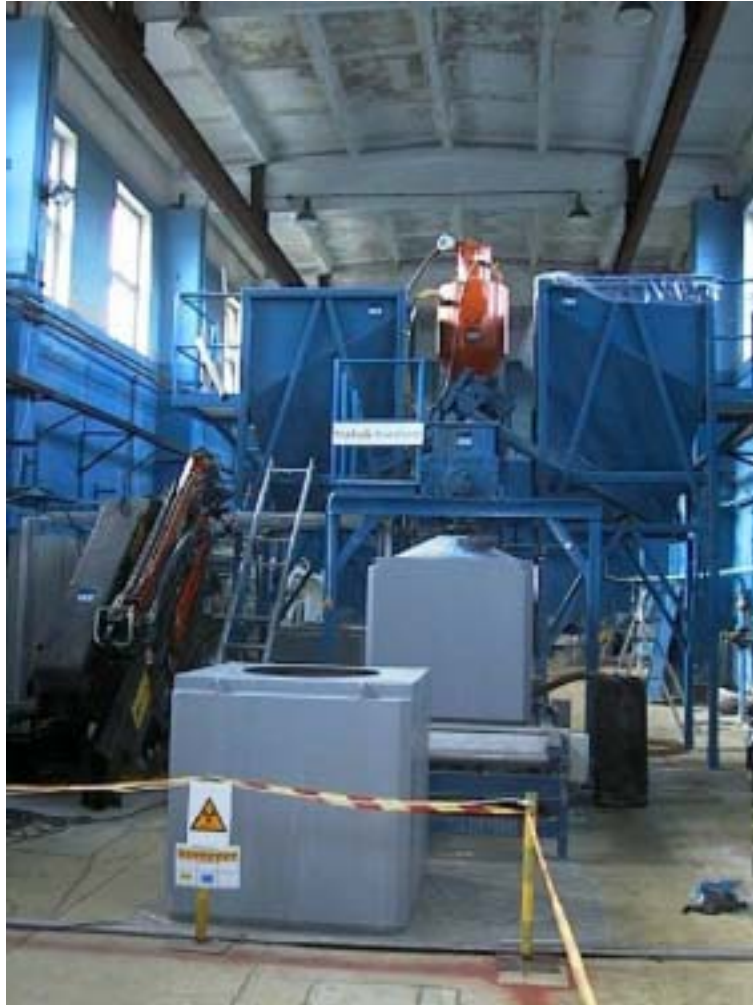
**Fig. 49. Cement mixer**

In building 306 a cement mixer, complete with fittings for emptying the storage tanks and grouting the waste in containers, was installed. The containers were placed on a vibrating roller conveyor for the best filling up of cement around the waste in the containers.

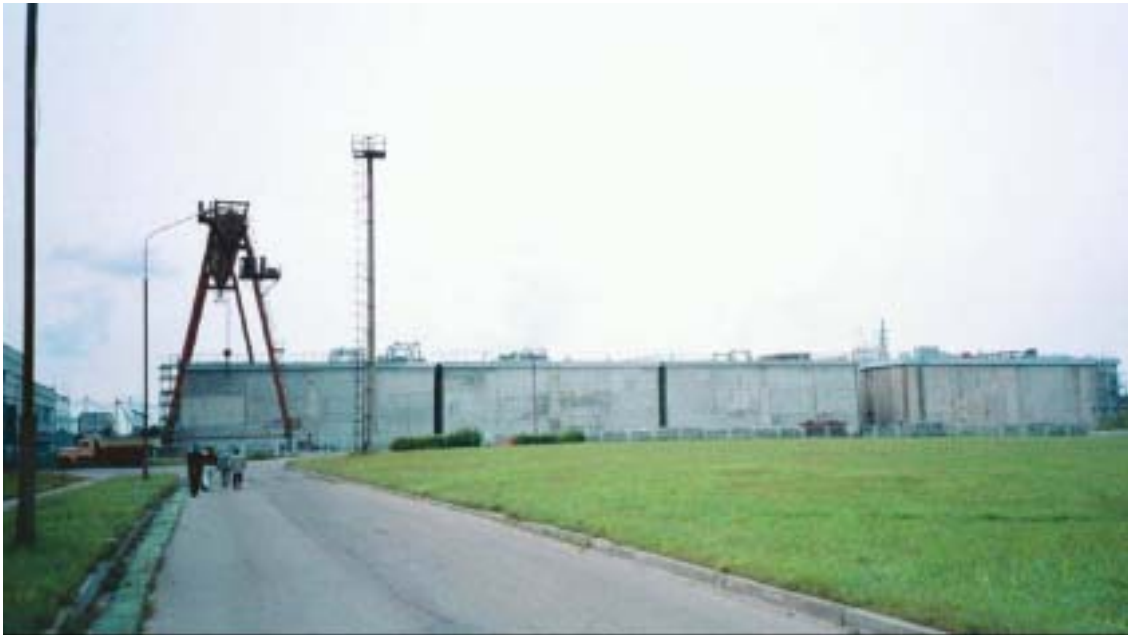
**Fig. 50. Buildings 157 and 157/1**

Waste storage buildings 157 & 157/1 with the portal crane covering the whole storage.

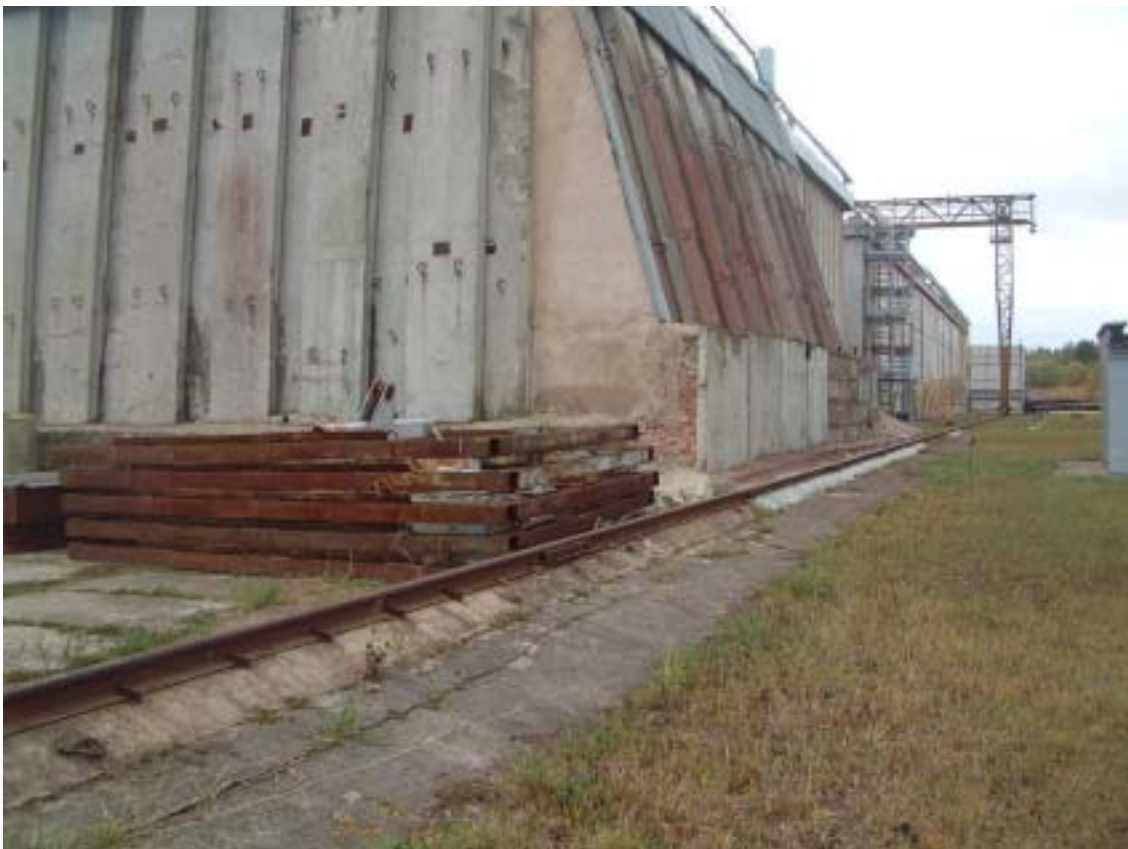
**Fig. 51. Strengthening of building 157 SE corner**

Outside the SE corner of building 157 the walls are completed with extra shielding because of the Group 3 waste high radiation. The storage building for bituminised waste is divided into 12 compartments to where the bituminised waste is pumped.

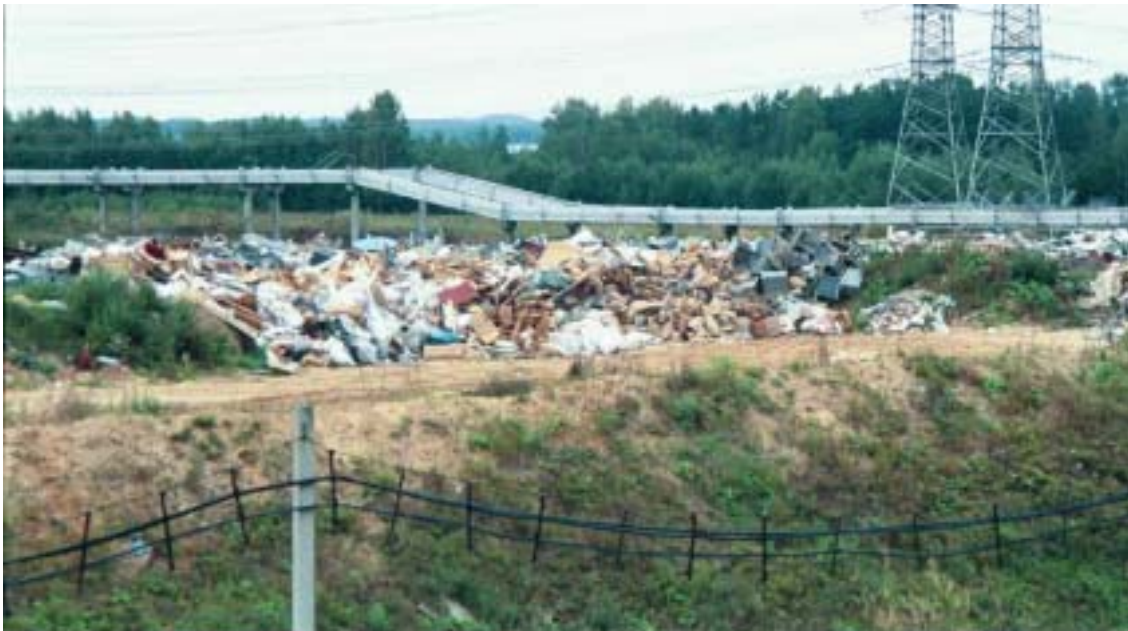
**Fig. 53. Waste stored at the ground**

NE of building 155 lots of waste is dumped, just like a landfill repository.

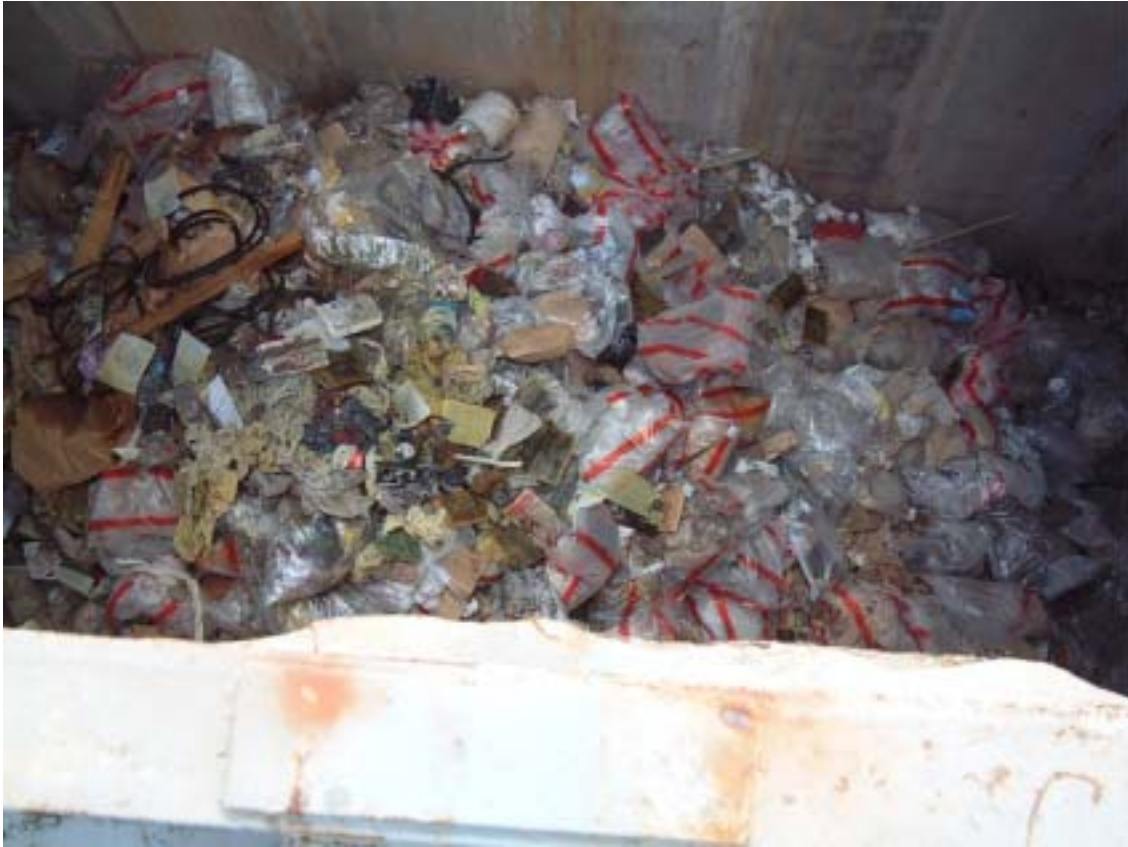
**Fig. 54. Group 1 waste at INPP**

The Group 1 waste is unsorted dumped in different cells in the SWS building.

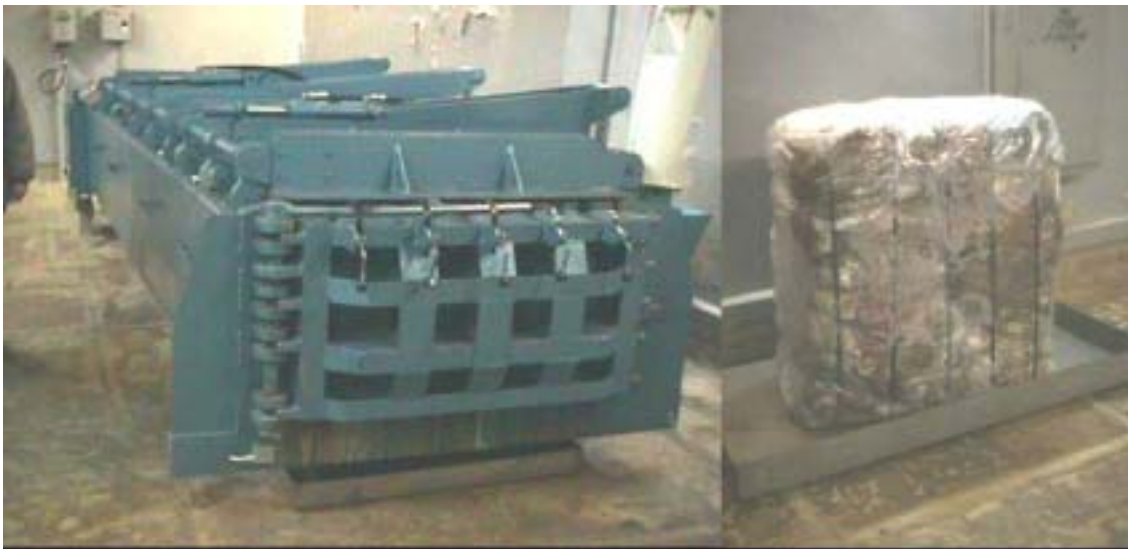
**Fig. 55. Hedberg compactor and a compacted bale**

A compactor, Hedberg HDx50; was earlier delivered as a gift from Sweden. The compaction rate for the waste classified as compactable is about 3:1. The bales are wrapped in plastic. A wrapping machine is planned to be installed.

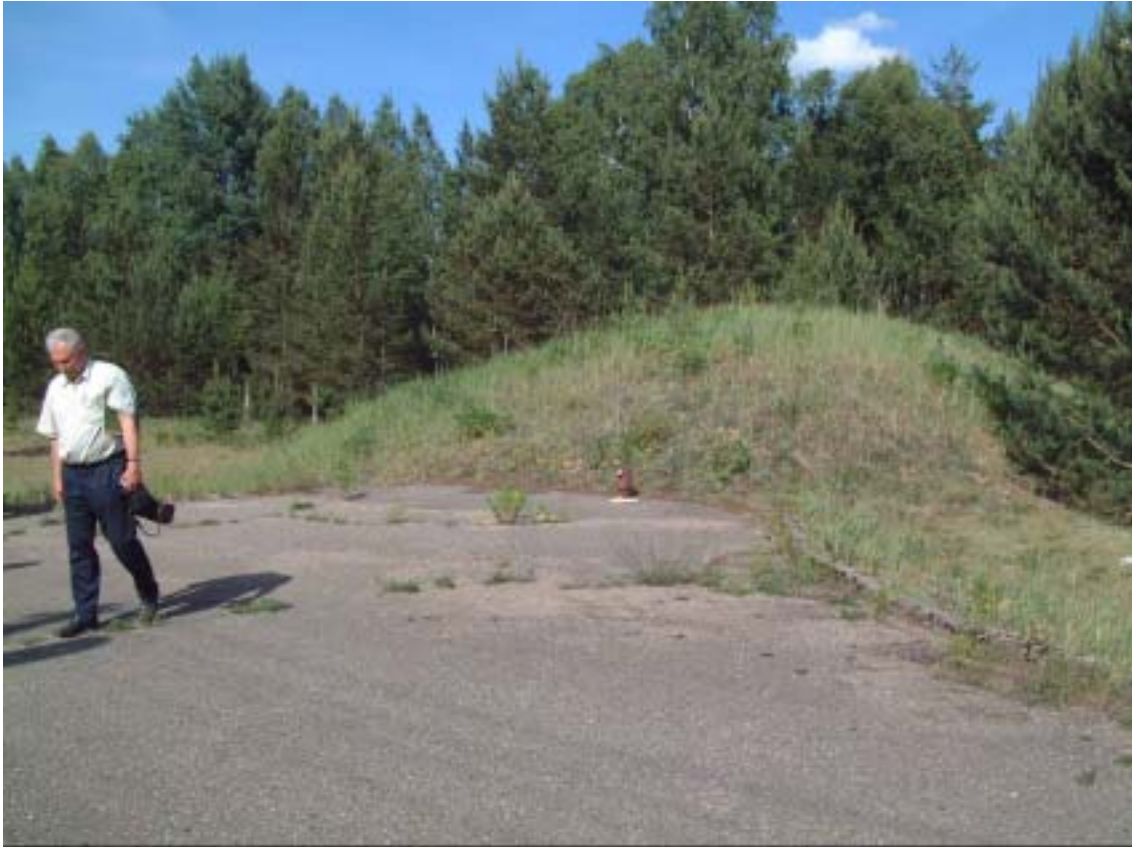
**Fig. 57. Maišiagala repository**

The repository consists of a grouted concrete trough divided by wooden planks in three cells. The waste is placed in the cells and grouted around by concrete.

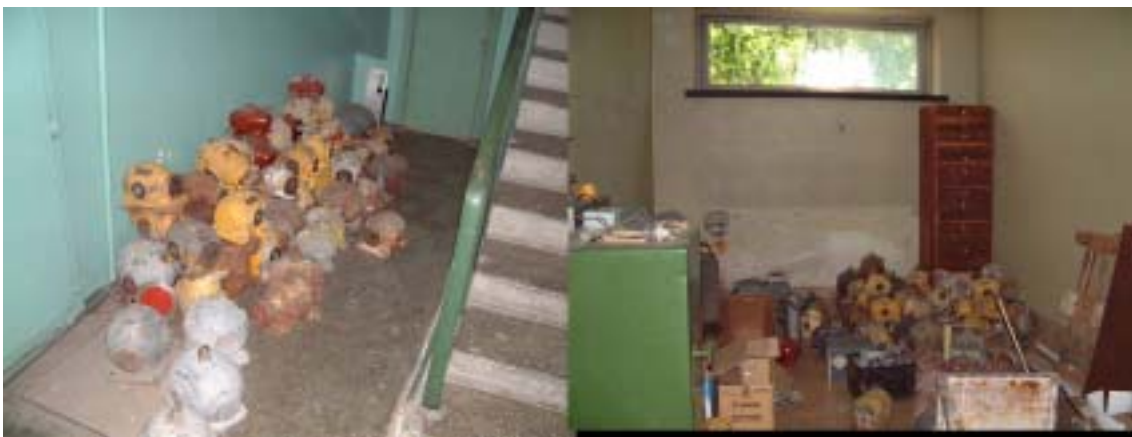
**Fig. 58. Spent Sealed Sources**

At the Institute of Physics we found Spent Sealed Sources stored in a stairwell. Other SSS was on the floor in a small room in the cellar.

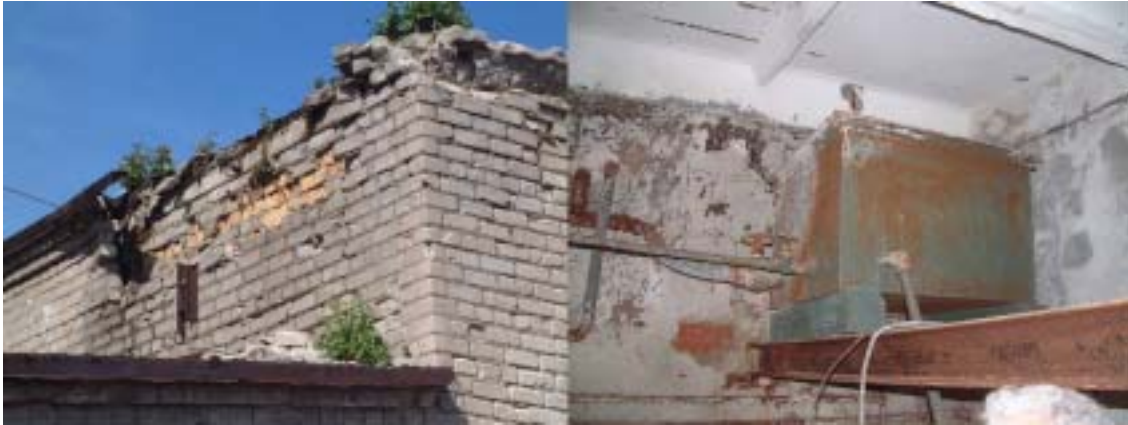
**Fig. 59. Old buildings at Maišiagala**

The condition of the buildings at the Maišiagala site is poor. New building(s) must be constructed to have modern and qualified areas approved for the handling and storing of the RMI waste.
