(3) Situation of Fukushima Dai-ni Nuclear Power Station

1) Outline of Fukushima Dai-ni Nuclear Power Station

(4) Situations at other NPSs

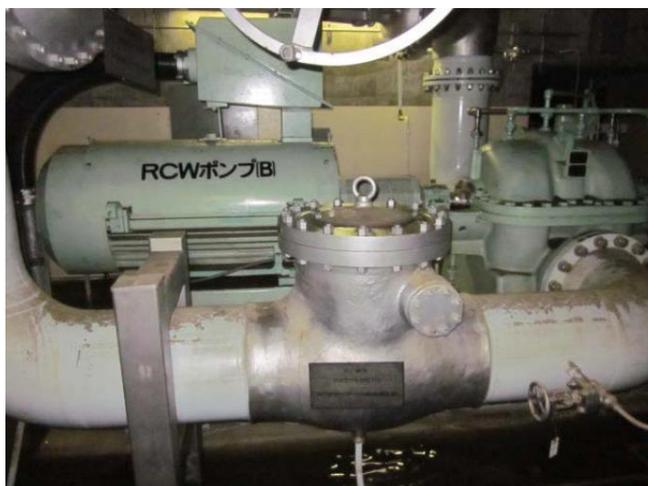
RCW pump (B) (after seawater was drained)

- Repair work has been undertaken on penetrations for pipes and cable trays from the seawater pump room to the trench.
- In the future, the water-tightness of building doors will be improved and tide embankments/barriers will be constructed.

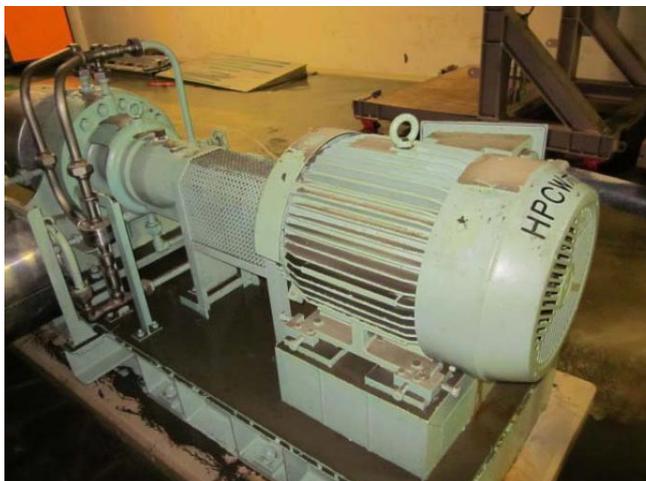
HPCW pump (after seawater was drained)

- (4) Seawater that had flown into RCW heat exchanger (B) room leaked through the watertight door to flow into HPCW heat exchanger room. (Water inflow to HPCW heat exchanger room; inundation of HPCW pump)

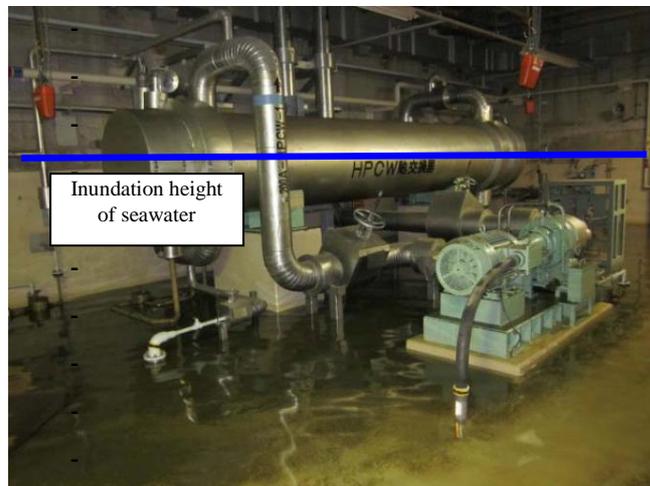
- Fig. II-2-143 Seawater flooding condition

Seawater flooding in the HPCW heat exchanger chamber

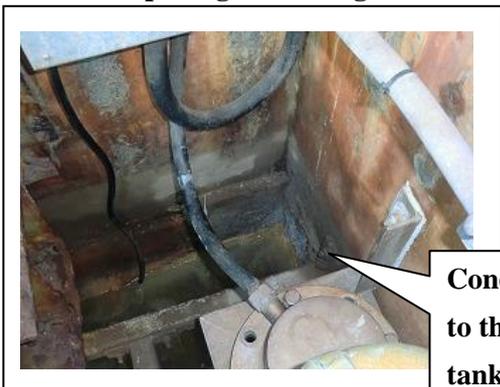
Concrete was placed to the northern pump tank area side.

Measure 2: Ensuring water tightness by concrete placement to cable pit
