# Events and highlights on the progress related to recovery operations at TEPCO's Fukushima Daiichi Nuclear Power Station

December 2019

The Government of Japan

## Section 1: Summary of updates from July 2019 through October 2019

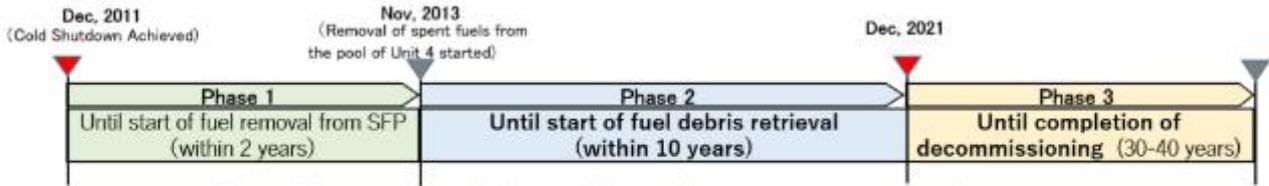
Figure. Milestones described in the “Mid-and-Long Term Roadmap”

Mid-and-Long-Term Roadmap towards the Decommissioning of TEPCO’s Fukushima Daiichi NPS (revised on September 26, 2017)

<b>Contaminated water management</b>	Suppress contaminated water generation to about 150 m <sup>3</sup> / day. Storage of all water generated by treatment of highly contaminated water in welded-joint tanks	Within 2020 FY 2018	Completed in Mar. 2019
<b>Stagnant water treatment</b>	① Separation of connection between Units 1 and 2 and between Units 3 and 4	Within 2018	Completed in Sep. 2018
	② Reduction of radioactive materials in stagnant water in the buildings by one-tenth of the 2014 year-end.	FY 2018	*
	③ Completion of treatment of stagnant water in buildings	Within 2020	
<b>Removal of spent fuels</b>	① Start of spent fuel removal at Unit 1	FY 2023 (an outlook)	
	② Start of spent fuel removal at Unit 2	FY 2023 (an outlook)	
	③ Start of spent fuel removal at Unit 3	Mid FY2018	Started in Apr. 2019
<b>Retrieval of fuel debris</b>	① Decision on the method for fuel debris retrieval from the 1st implementing Unit	FY 2019

② Start of fuel debris retrieval from the 1 <sup>st</sup> implementing Unit	Within 2021	
<b>Solid Radioactive waste</b>	Establishment of a technical perspective on measures of treatment / disposal and on safety.	Around FY2021

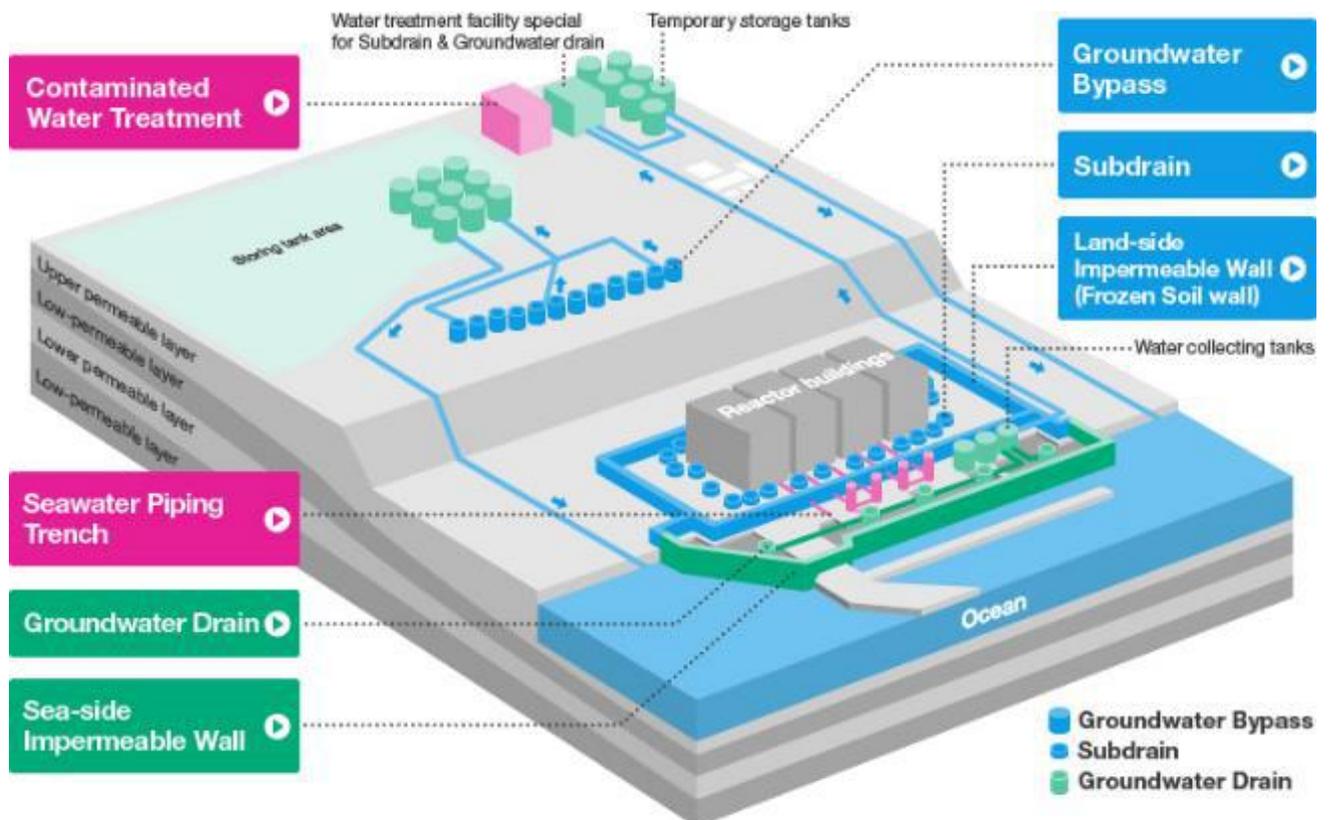
The preventive and multi-layered measures against contaminated water issue are implemented based on the three principles; “ Removing contamination sources”, “ redirecting ground water from contamination source” and “ Preventing leakage of contaminated water”.

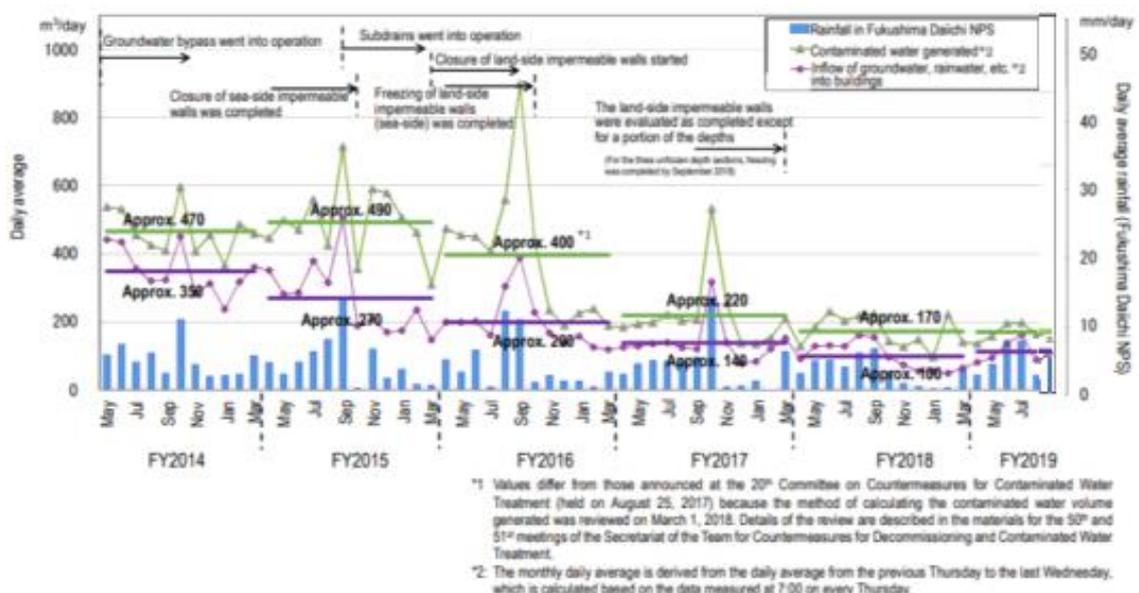
Subsequently, the generation of contaminated water decreased from approx. 470 m<sup>3</sup>/day (in FY2014) to approx. 170 m<sup>3</sup>/day (in FY2018).

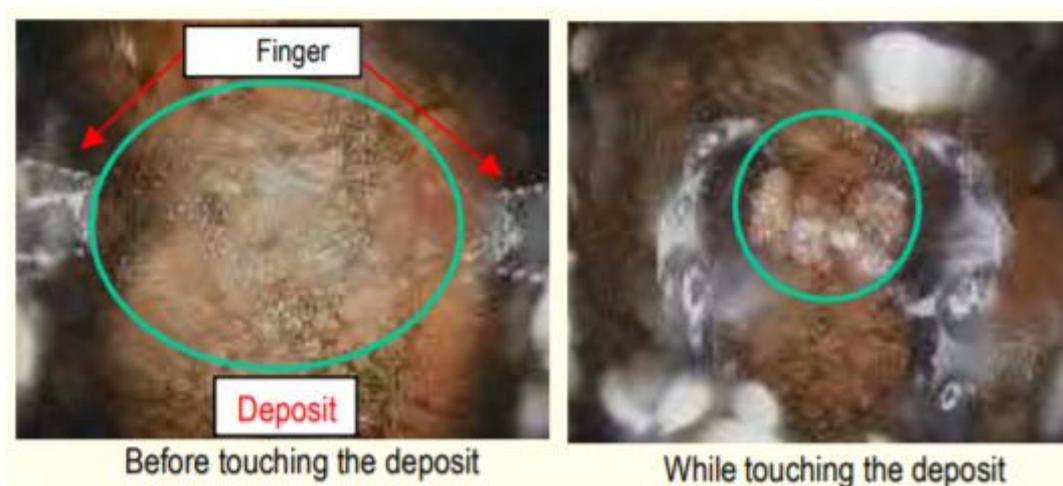
On February 13, 2019, a contact investigation on the detected deposits inside the PCV was conducted to determine their characteristics (hardness, fragility, etc.). This contact investigation confirmed that the pebble-shaped deposits, etc. could be moved and that hard rock-like deposits that could not be gripped may exist. In addition, images of radiation dose and temperature data that would help determine the contour and size of the deposits could be collected by moving the investigative unit closer to the deposits. The result of this investigation will be utilized in the internal investigation in the second half of FY 2019, examination of the retrieval method.

Image: Before and while touching the deposit at the investigation of Unit 2

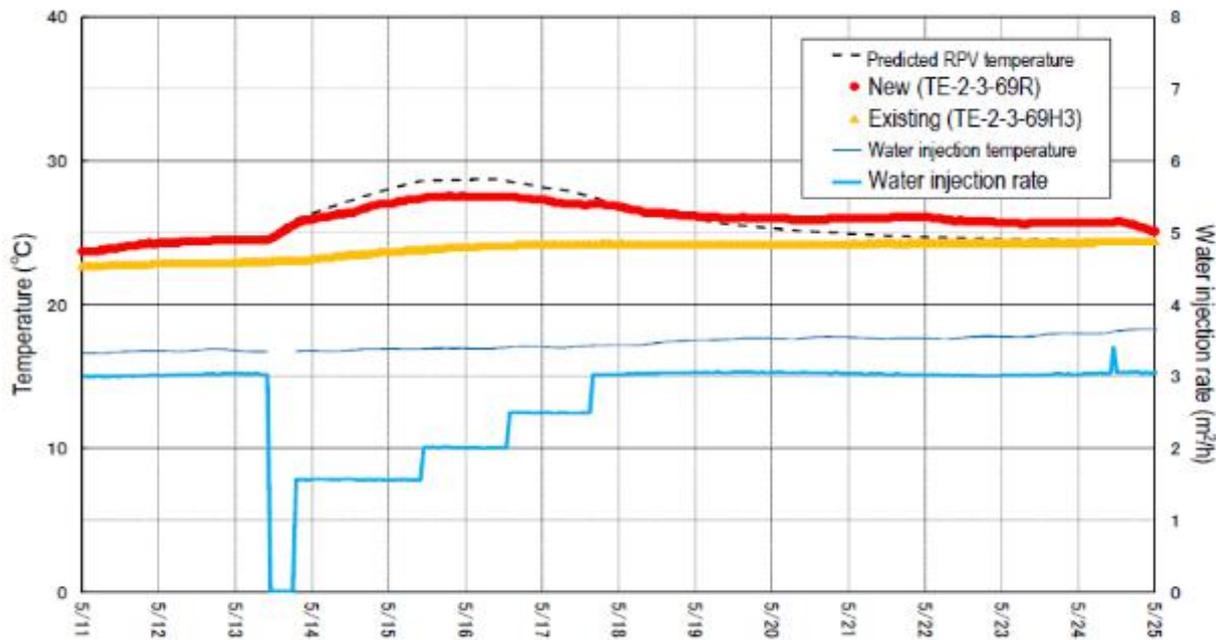
To optimize the emergency response procedures, a test (STEP 2) involving temporarily suspending water injection to the reactor (3.0 to 0.0 m<sup>3</sup>/h) was conducted on May 13 2019 (and terminated on May 24 2019). The graph below shows the changes in RPV bottom temperature during the test to suspend water injection to the reactor. The test confirmed that the temperature increase rate at the RPV bottom was at the same level of 0.2°C/h or less as predicted and that the temperatures at the RPV bottom and inside the PCV during the test also varied almost within expectations. No abnormality was detected in other parameters such as the dust density. The difference between the prediction data and the test data and the behavior variation depending on the location where the thermometer was installed will be evaluated to utilize the results in optimizing emergency response procedures.

Figure. Changes in PRV bottom temperature during the test to suspend water injection

For the purpose of optimizing emergency response procedures, etc., a test of temporary suspension of water injection at Unit 1 was implemented from October 15 to October 17, with a total suspension time of about 49 hours. During the test, the temperature of the bottom of the Reactor Pressure Vessel increased by 0.2 °C and that of the Primary Containment Vessel increased by 0.6 °C. And all other parameters showed no abnormality.

Japan also reported that water injection suspension test was conducted at Unit 1 during the period of 15 - 19 October 2019 for a total duration of about 49 hours. A slight increase in the temperatures of the Reactor Pressure Vessel (RPV) and the PCV was observed as expected and no abnormalities in other investigated parameters were observed.
