Laguna Verde - A Photo Story

A substantial component contributing to safety in a nuclear power plant is the containment. The following photos of Laguna Verde, Mexico's first nuclear power station being constructed at Alta Lucero in Vera Cruz, give an impression of how strong this concrete and steel containment actually is. Laguna Verde consists of two 600 MWe units and the plant is scheduled for commercial operation in 1982. Construction began in 1974. Both units are boiling-water reactors.

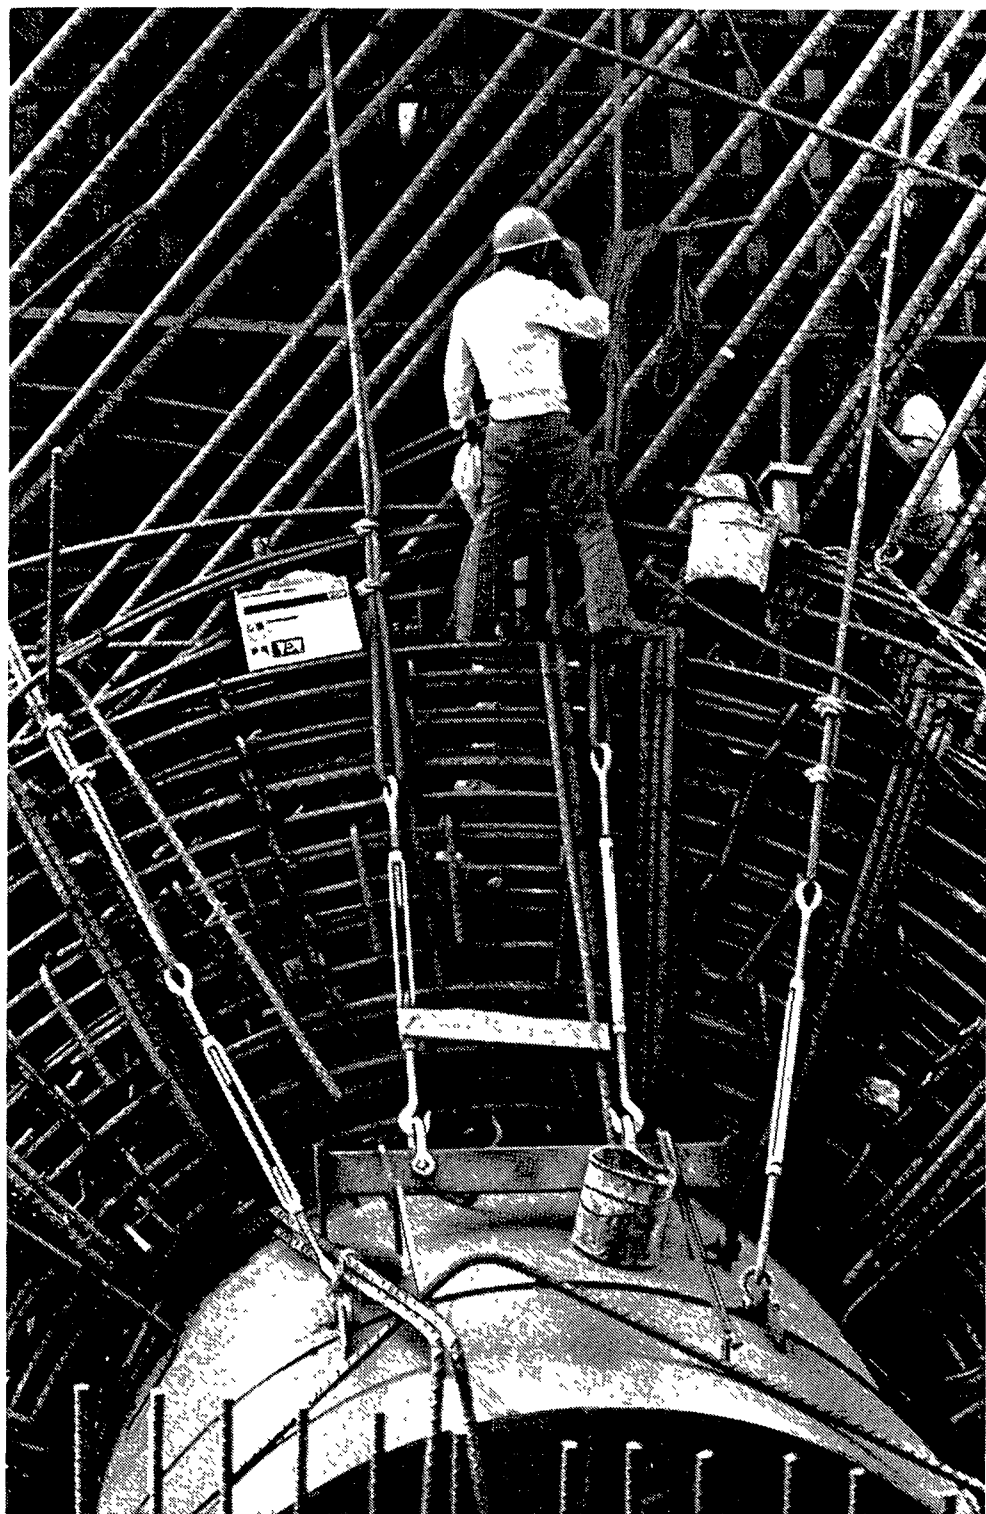
Photos 6, 7, 8. Additional reinforcing bar being mounted in place around the provisional personnel lock.

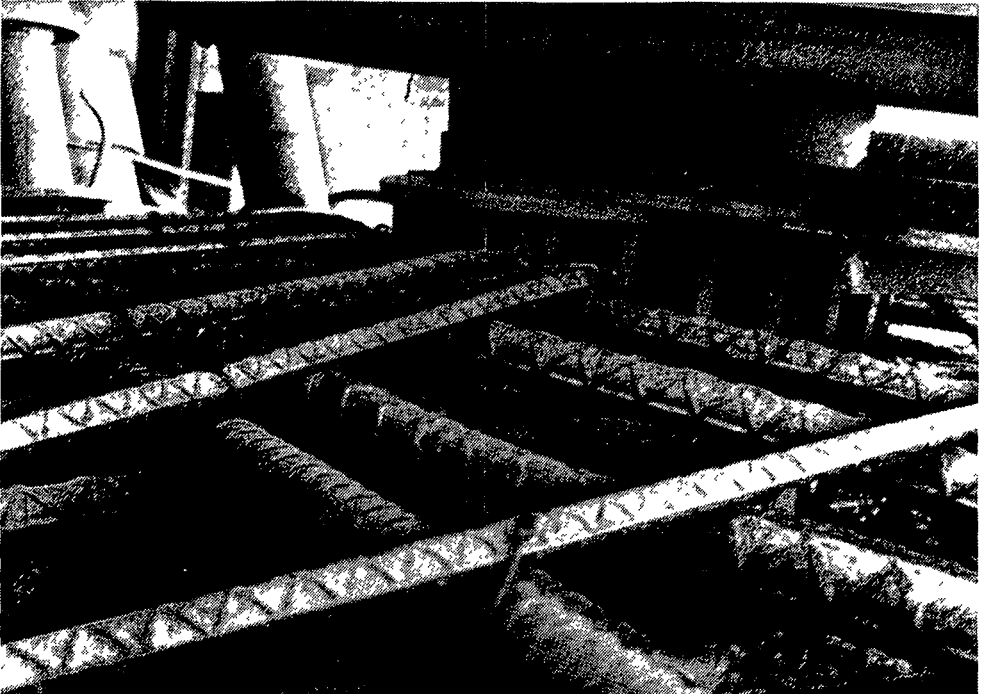
Photo 10. Crisscrossing arrays of rolled steel bars ready for concrete pouring.
