Flow Accelerated Corrosion Programme in Angra NPP Units 1 and Angra 2

April / 2009

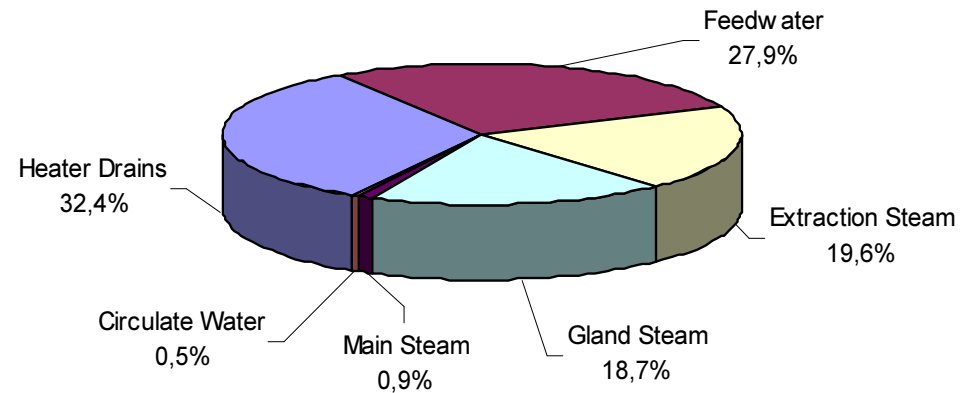
Inspected elements by system

Inspected Elements	
System	Total
Heater Drains	528
Feedwater	455
Extraction Steam	320
Gland Steam	304
Main Steam	15
Circulate Water	8
Total	1630

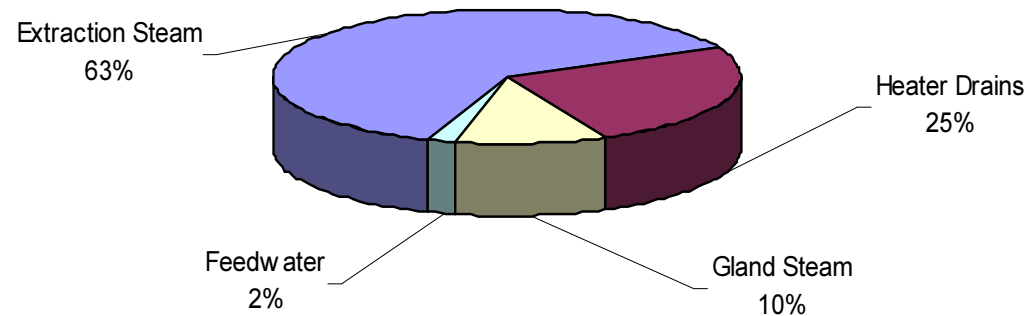
Replaced elements by system

Replaced Elements	
System	Total
Extraction Steam	30
Heater Drains	12
Gland Steam	5
Feedwater	1
Total	48

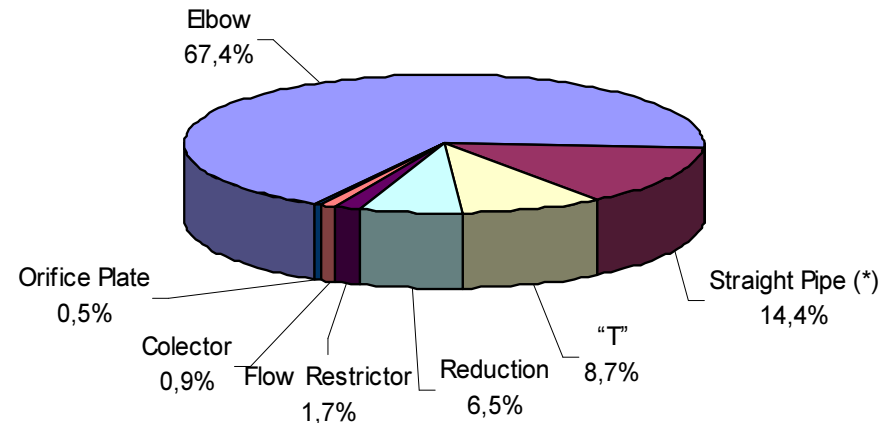
Inspected elements by type

Inspected elements	
Type	Total
Elbow	1098
Straight Pipe (*)	235
"T"	141
Reduction	106
Flow Restrictor	28
Collector	14
Orifice Plate	8
Total	1630

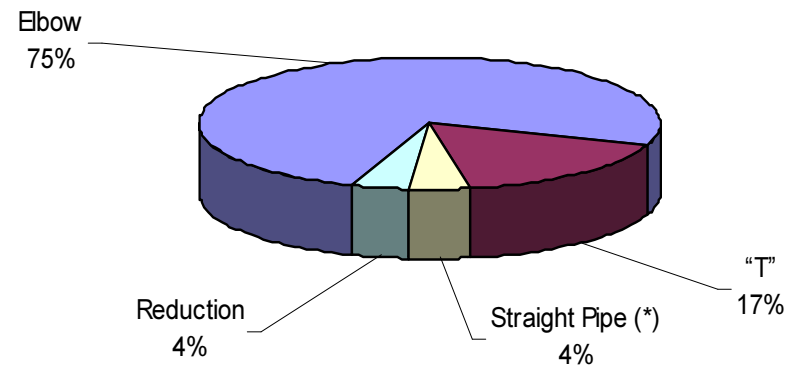
Replaced elements by type

Replaced Elements	
Type	Total
Elbow	36
"T"	8
Straight Pipe (*)	2
Reduction	2
Total	48

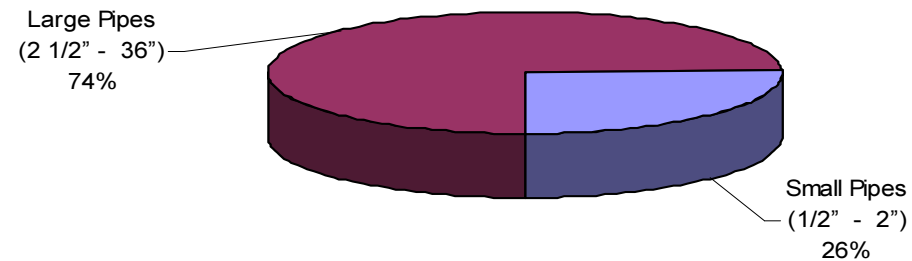
Inspected elements by size

Inspected elements	
Size	Total
Small Pipes (1/2" - 2")	416
Large Pipes (2 1/2" - 36")	1214
Total	1630

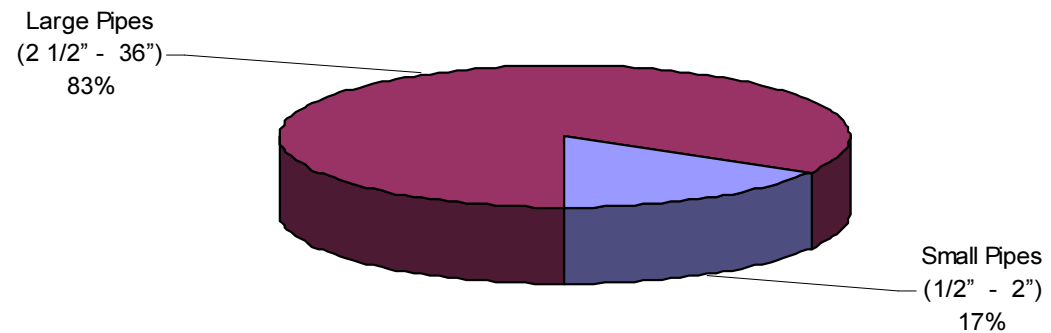
Replaced elements by size

Replaced elements	
Size	Total
Small Pipes (1/2" - 2")	8
Large Pipes (2 1/2" - 36")	40
Total	48

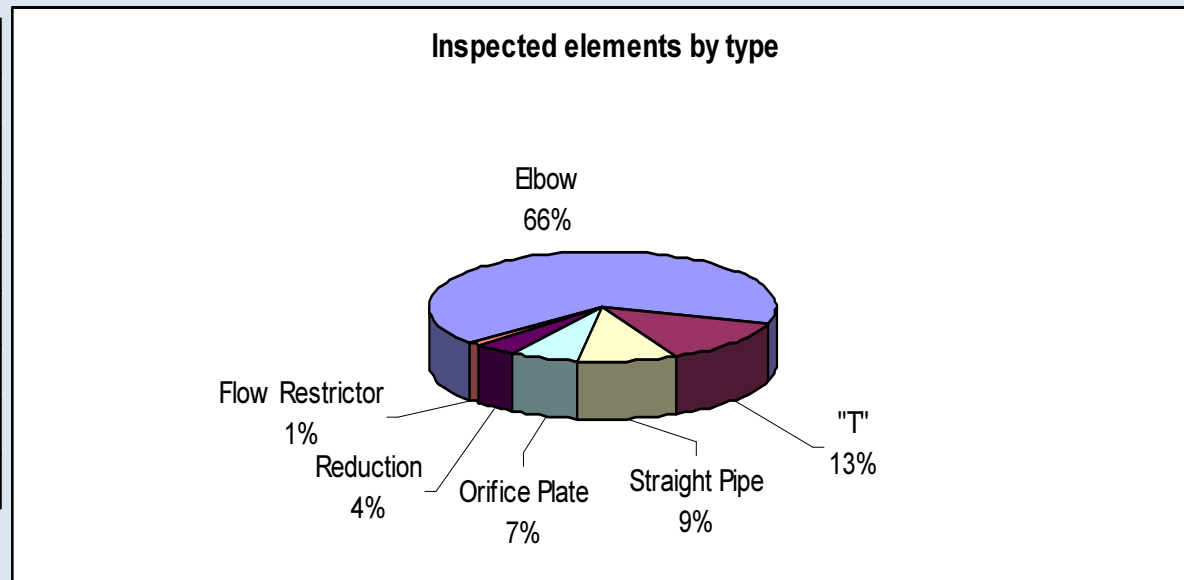
Inspected Elements	
Type	Total
Elbow	319
"T"	64
Straight Pipe	43
Orifice Plate	32
Reduction	19
Flow Restrictor	6
Total	483

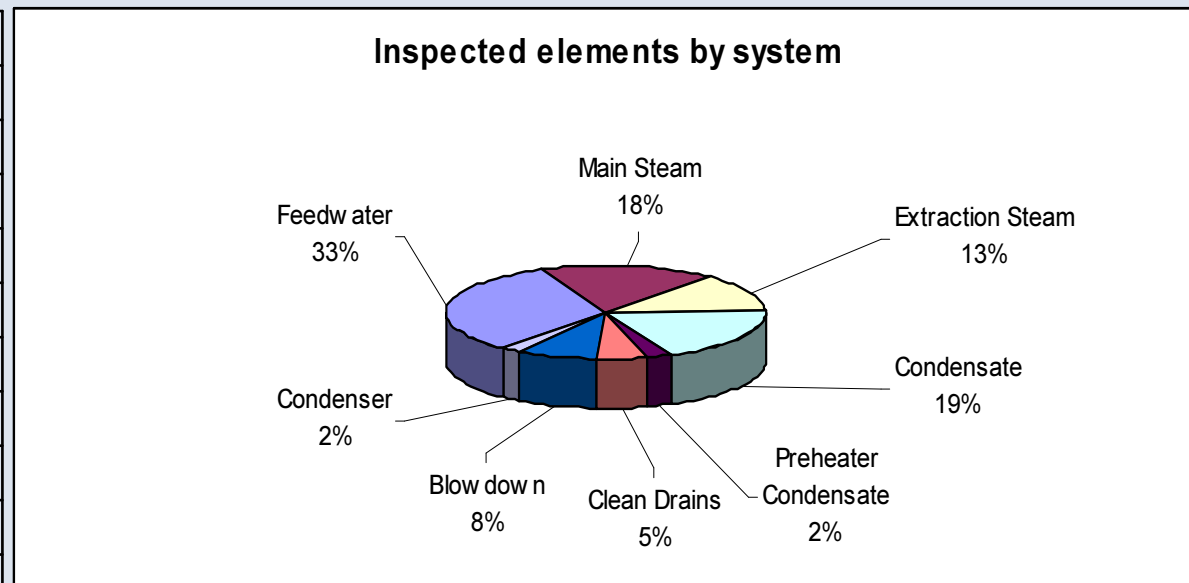
Inspected Elements	
System	Total
Feedwater	156
Main Steam	87
Extraction Steam	61
Condensate	93
Preheater Condensate	12
Clean Drains	25
Blowdown	40
Condenser	9
Total	483

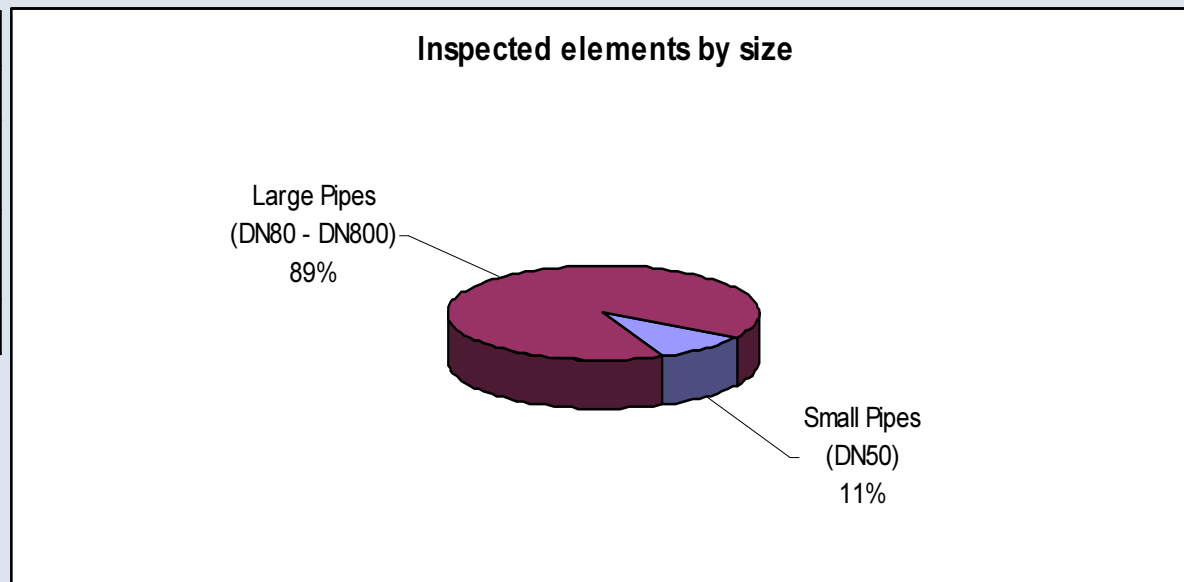
Inspected Elements	
Size	Total
Small Pipes (DN50)	51
Large Pipes (DN80 - DN800)	432
Total	483
