Flow accelerated corrosion in cooper-nickel 90-10 in sea water

Carlos R. Arganis-J. (1), Miguel Gachuz M.(1) and Veronica Vergara(2)

(1) Instituto Nacional de Investigaciones Nucleares. Mexico
carlos.arganis@inin.gob.mx

(2) Comisión Federal de Electricidad. Mexico.

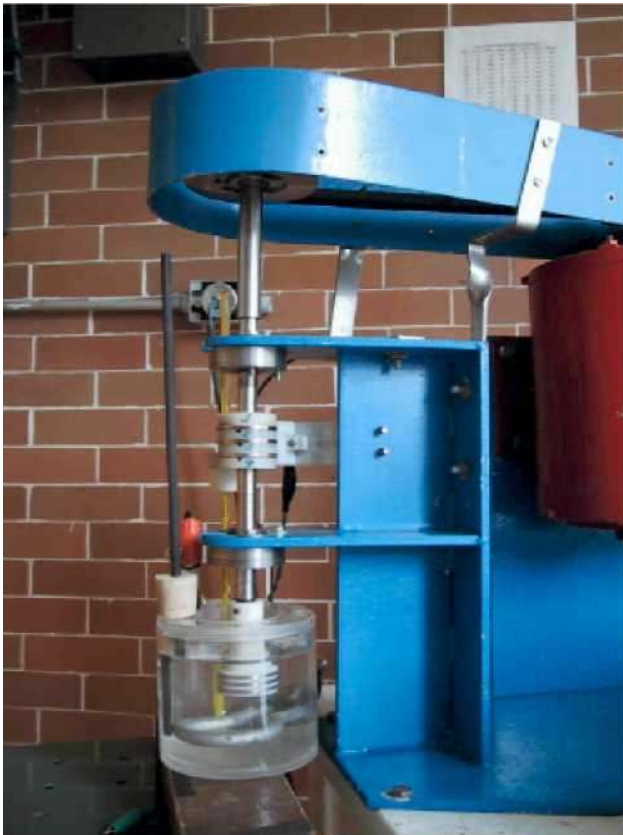
Effects of flow rate

rpm	Ω rad/s	Re cilindro	τ kg/ms ² (Pa)	τ , psi	Corrosion rate mm/year
0	0	0	0	0	0.115
84	8.70	69.21	9889.63	1.434	0.145
204	21.36	168.73	77780.20	11.28	0.181
306	32.04	253.10	197900.28	28.70	0.5644
408	42.72	337.47	383536.78	55.62	1.132
612	64.08	506.20	974575.80	141.350	1.511
1209	126.60	995.35	4615383.73	669.404	2.877

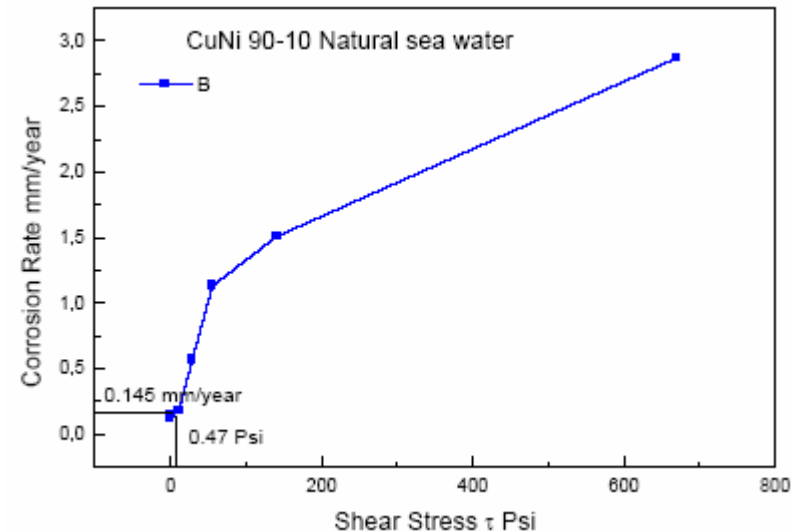
- Modeling of Corrosion Acceleration by Shear Mechanism in the Tee. 0.15 mm per year

Both model not could explain the loss of material of 0.2 inches in 1.5 year (3.38 mm per year)

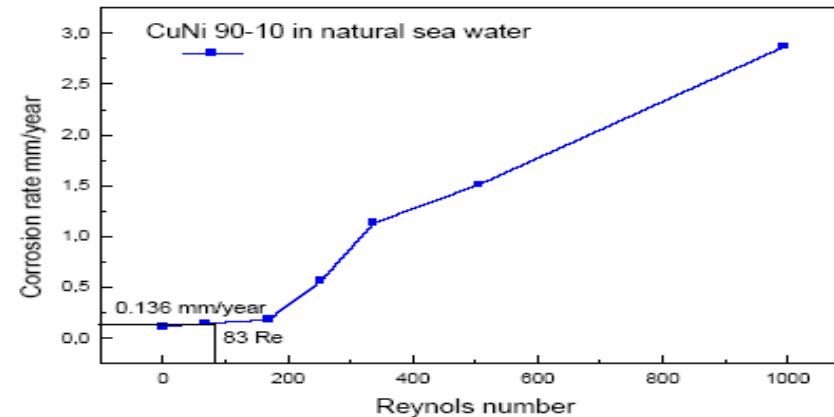
Modeling of Corrosion Acceleration by Convective Mass Transfer using the mass transference coefficient K of the Tee, 0.136 mm per year.
