II. Further developments of the nuclear accident since that time

1. The Tohoku District-Off the Pacific Ocean Earthquake and the resulting tsunamis

(1) Investigation of the causes due to the occurrence of the earthquake and tsunamis

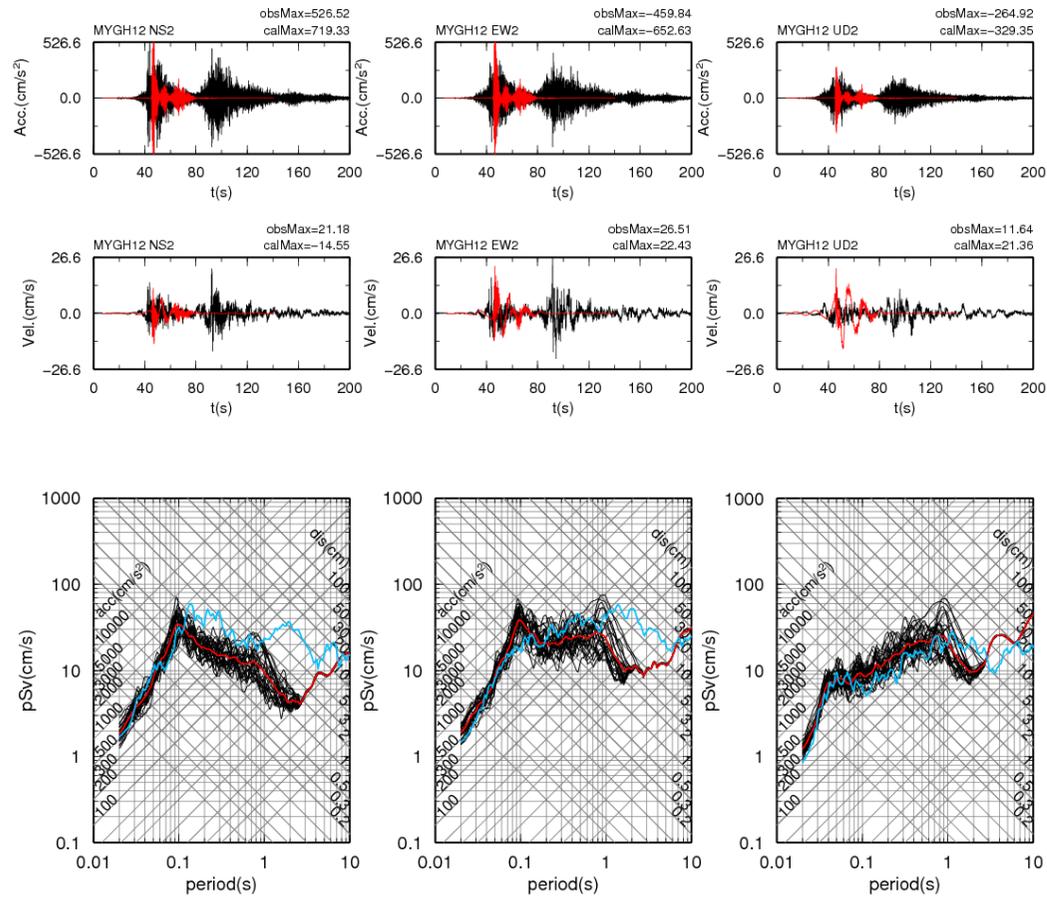
Fig. II-1-11 Comparison of waveforms at Shizugawa station (MYGH12).

Upper figure: black and red lines show observed acceleration of main quake and predicted accelerations from the scenario earthquake (Miyagiken-oki earthquake), respectively.

Lower figure: black lines and red line show predicted response spectra and average of them, respectively. Blue line shows observed response spectrum.

Left, middle and right columns: the north-south, east-west and vertical components, respectively.

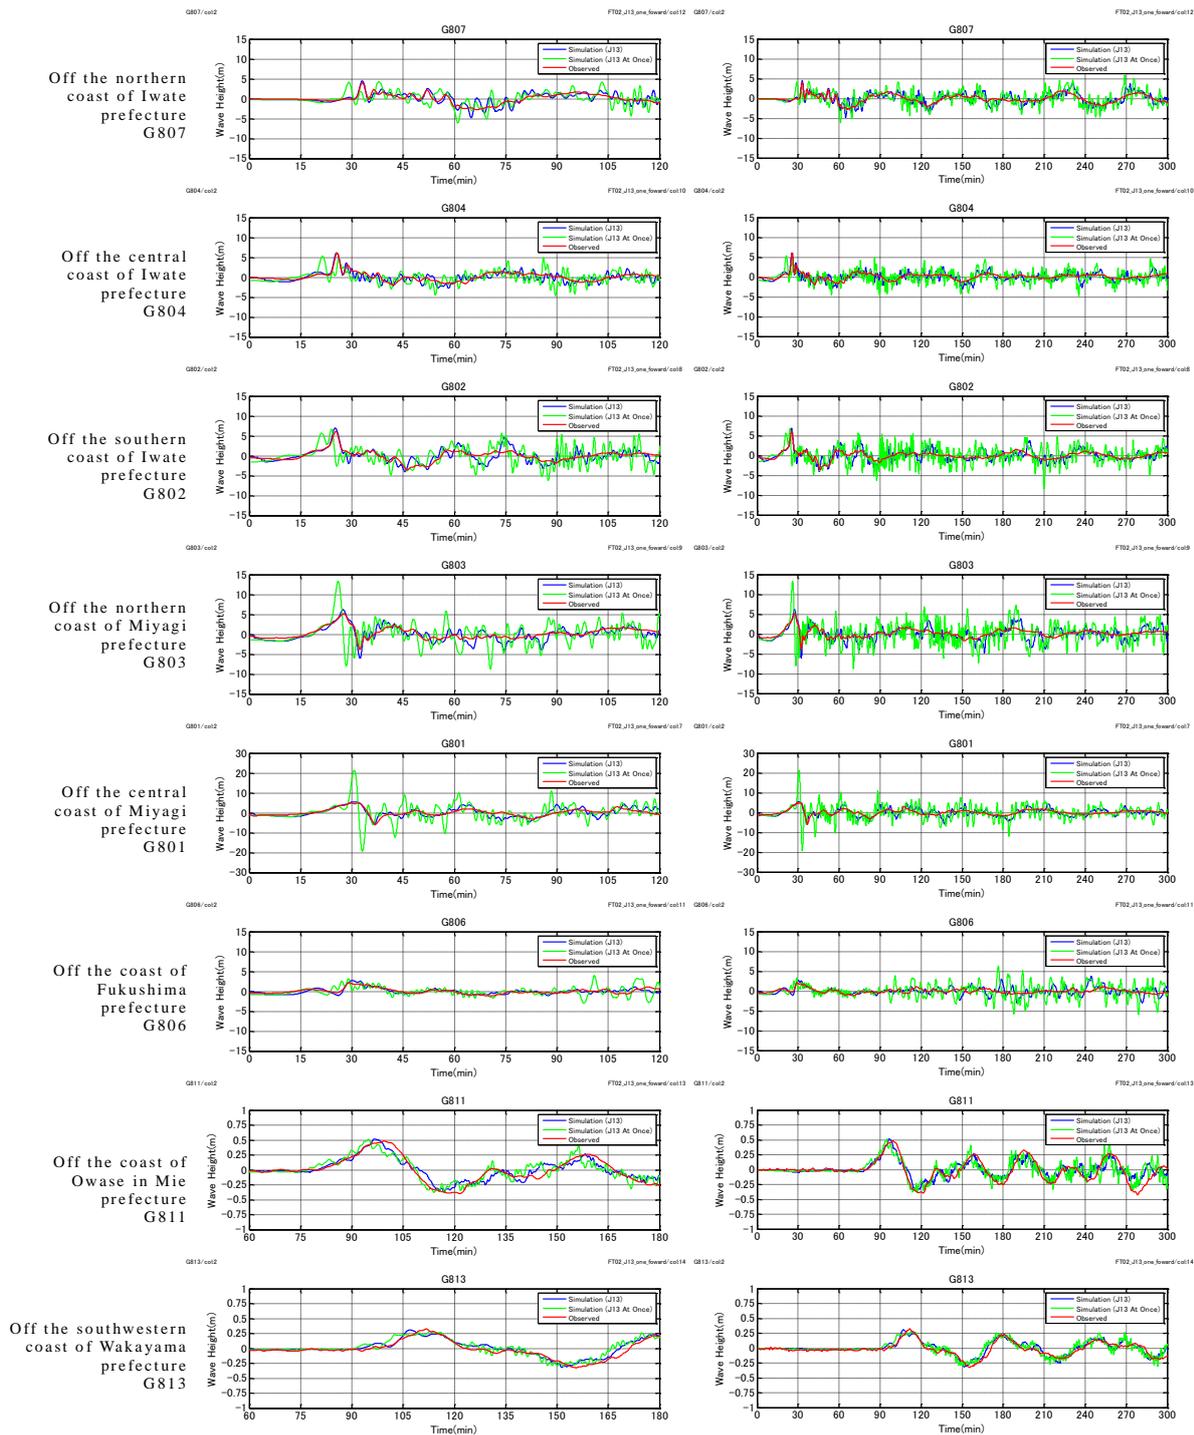
Fig. II-1-23 Effect of rupture start time and source duration time in tsunami source model on simulated tsunami waveform (the left column shows the data for two hours; the right column shows the data for five hours).

- An investigation into causes of the tsunami source rupture process of the tsunamis resulting from the Tohoku earthquake should be further refined and also, the effects of the difference in rupture start time among multiple seismic sources and the duration time on tsunami water level should be studied through detailed analysis.

(red line: observed tsunami waveform, blue line: expected tsunami waveform based on tsunami source model takes into consideration the difference in rupture start time and the duration time, green line: expected tsunami waveform based on tsunami source model establishes the aggregate slips all at once.)

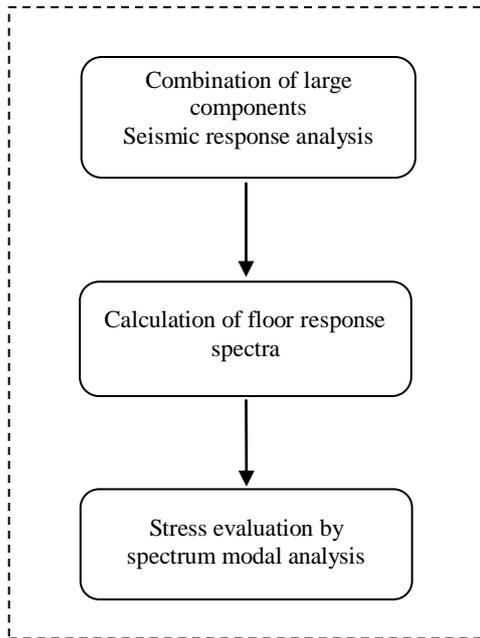
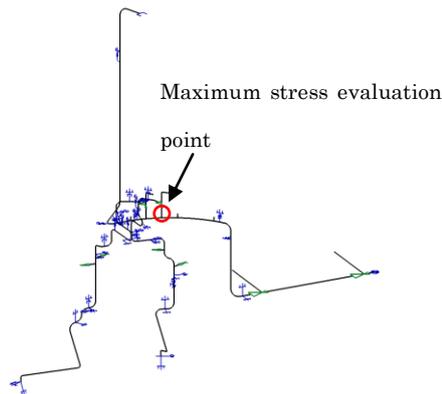
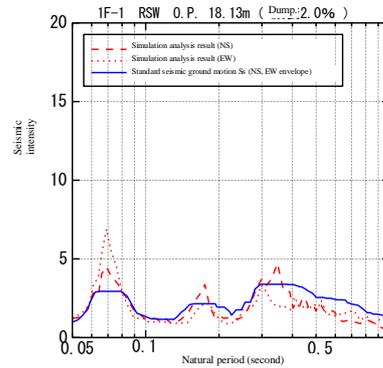
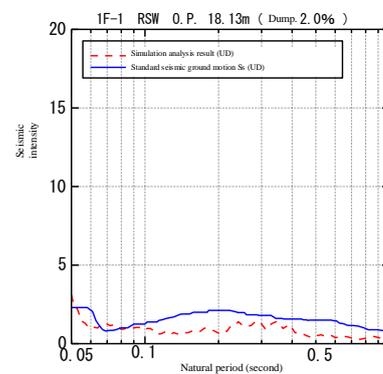
Scheme of Evaluation

Floor Response Spectra

*: The horizontal floor response spectra of this earthquake is greater than that of standard seismic ground motion Ss in part of the periodic band, whereas the vertical floor response spectra of this earthquake is generally less than that of standard seismic ground motion Ss. Accordingly, it is thought that the calculated values for this earthquake were less than those of standard seismic ground

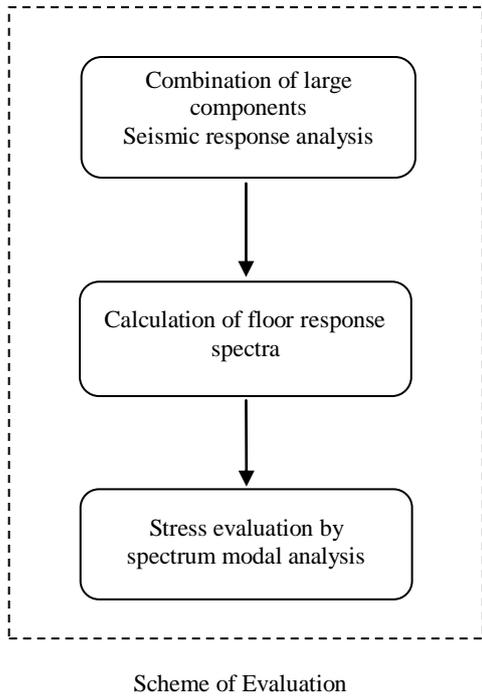
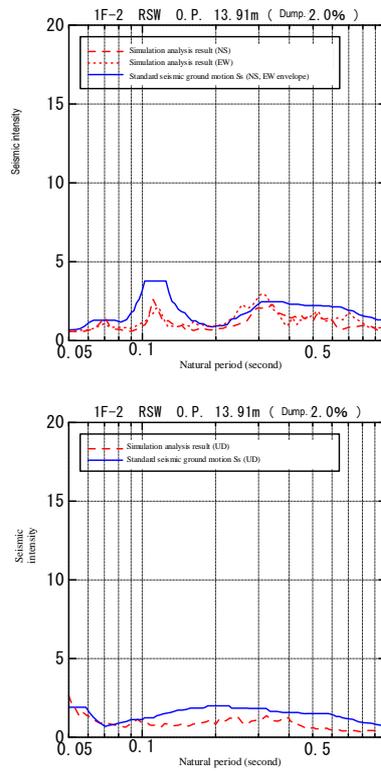
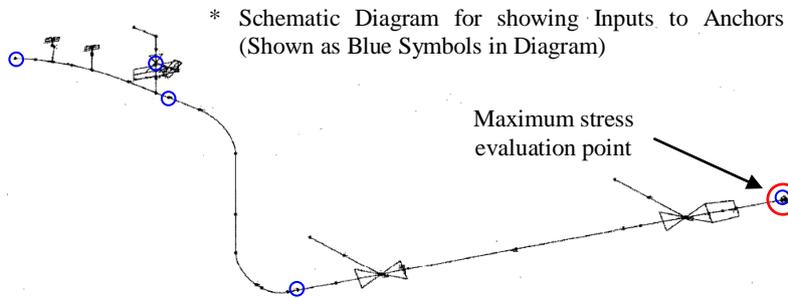
Table II-2-8 Outline of Seismic Evaluation (Example of Main Steam System Piping)
(Fukushima Dai-ichi NPS, Unit 1)

Floor Response Spectra

The floor response spectra of this earthquake are generally less than those of standard seismic ground motion Ss. It is in part of the periodic band that the floor response spectra of this earthquake are greater than those of standard seismic ground motion Ss.

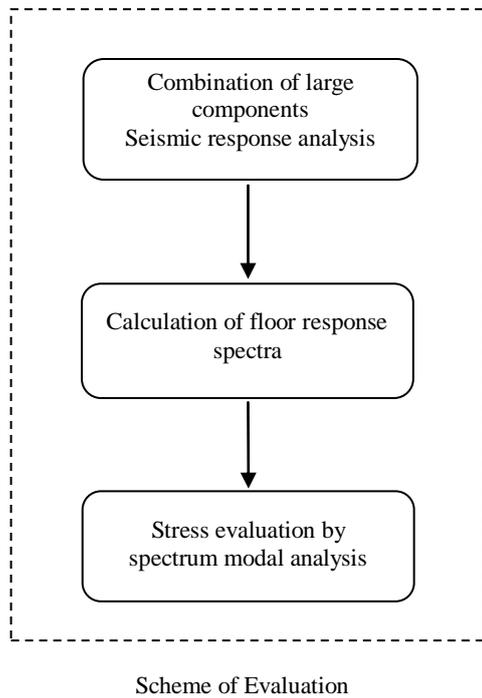
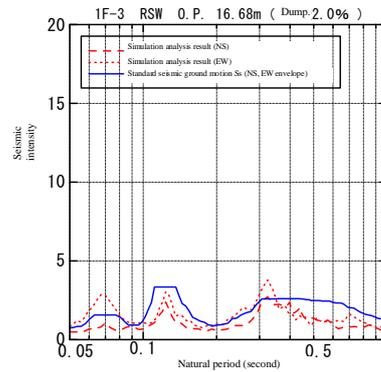
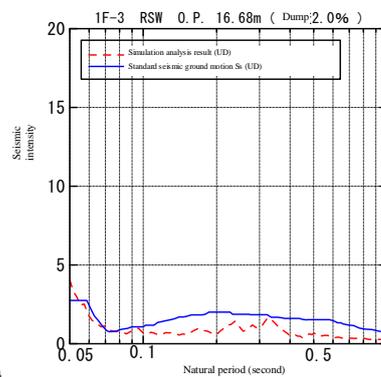
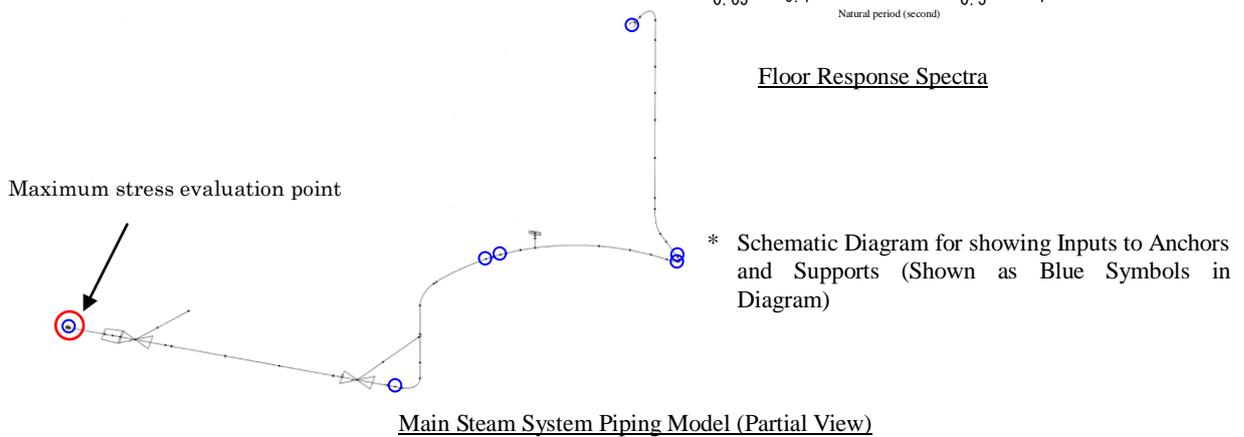
Table II-2-9 Outline of Seismic Evaluation (Example of Main Steam System Piping)

Floor Response Spectra

Results of Structural Strength Evaluation

Equipment concerned	Evaluated portion	Standard seismic ground motion S _s				This earthquake			
		Stress classification	Calculated value (MPa)	Evaluation criteria value (MPa)	Evaluation technique	Stress classification	Calculated value (MPa)	Evaluation criteria value (MPa)	Evaluation technique
Main steam system piping	Main body of piping	Primary	183	417*	Details	Primary	151	378*	Details

*: The evaluation reference value for standard seismic ground motion S_s and that for this earthquake are different from each other because piping materials at their maximum stress evaluation points (locations with a minimum seismic margin) are different.

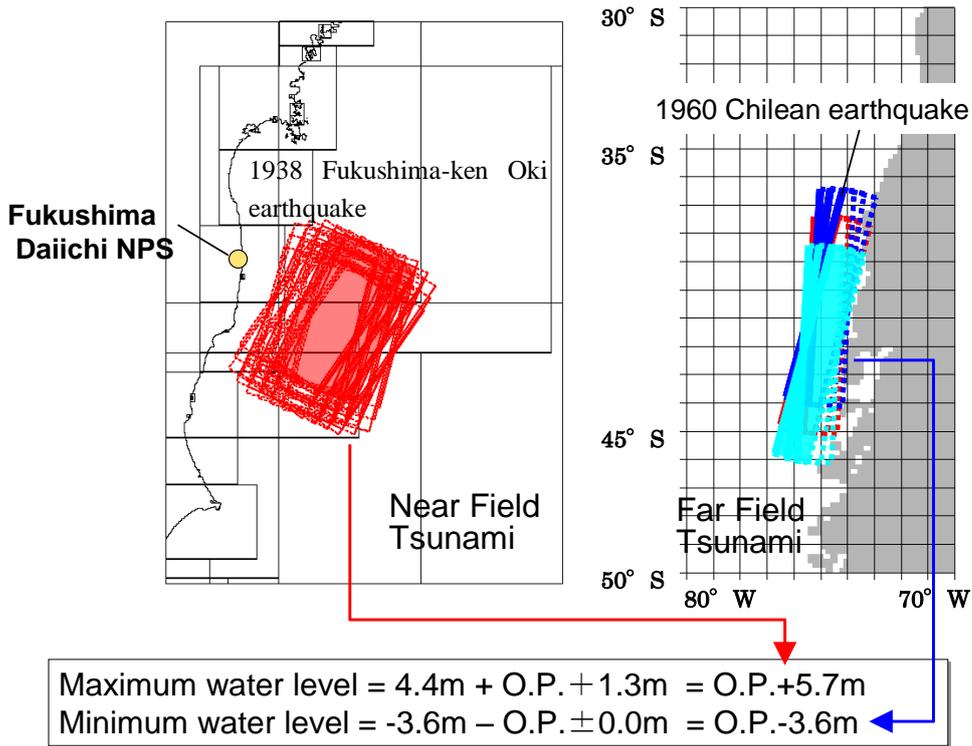
Figure II-2-21 Design Tsunami Level Evaluated by TEPCO for Fukushima Dai-ichi NPS

As for the relationship between the designed basis tsunami height and observed tsunami height, as shown in Figure II-2-21, in the application document for establishment permit, subject tsunami source is Chile earthquake (M9.5, 1960) and the design basis tsunami water level is O.P. +3.1 m. In 2002, based on the “Tsunami Assessment Method for Nuclear Power Plants in Japan (2002)” of the Tsunami Evaluation Subcommittee, the Nuclear Civil Engineering Committee, Japan Society of Civil Engineers [II2-1], TEPCO evaluated the tsunami height of each unit as O.P. +5.4 m to O.P. +5.7 m.

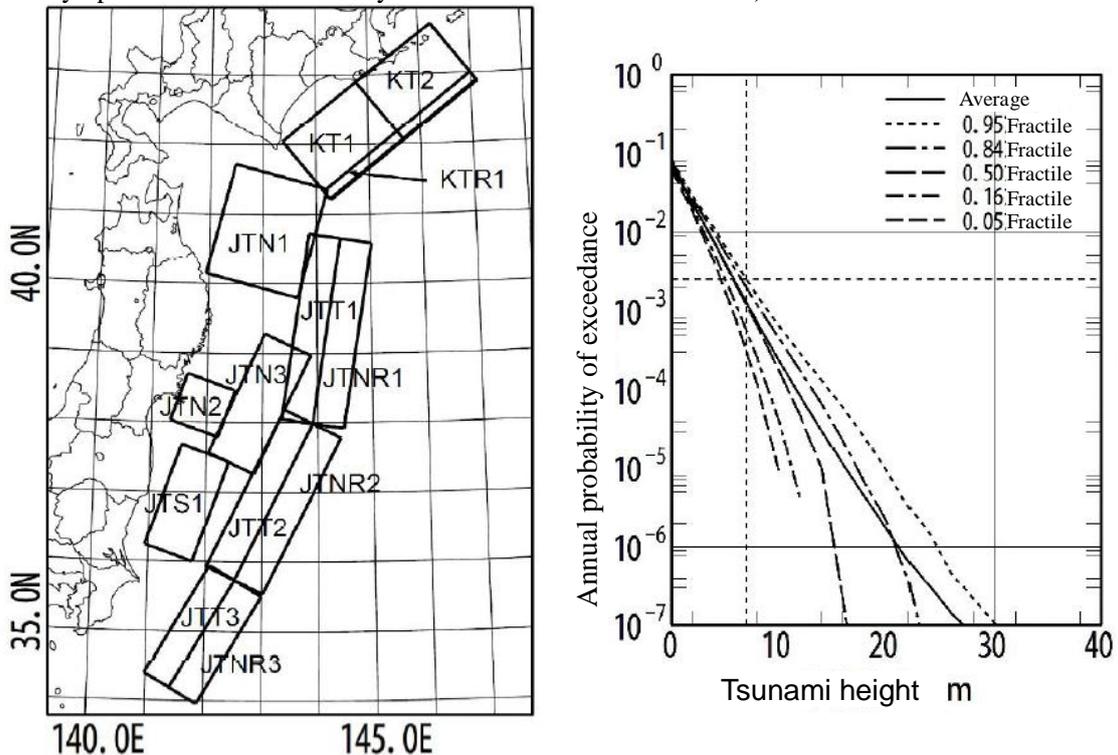
Figure II-2-22 Evaluation Results of Tsunami Hazard Curves Based on Near-and Far-field Tsunami Sources for Yamada Village, Iwate Pref., the Nuclear Civil Engineering Committee

Regarding probabilistic tsunami hazard evaluation and exceedance probability of design basis tsunami height, the Tsunami Evaluation Subcommittee of Japan Society of Civil Engineers is at work on consideration about probabilistic tsunami hazard analysis method. As a part of the consideration, the tsunami hazard assessment method and a result of the trial assessment of tsunami exceedance probability (Figure II-2-22) is already published [II2-2 to II2-4] but not yet completed. Other trial assessment of tsunami hazard is announced as well [II2-5].

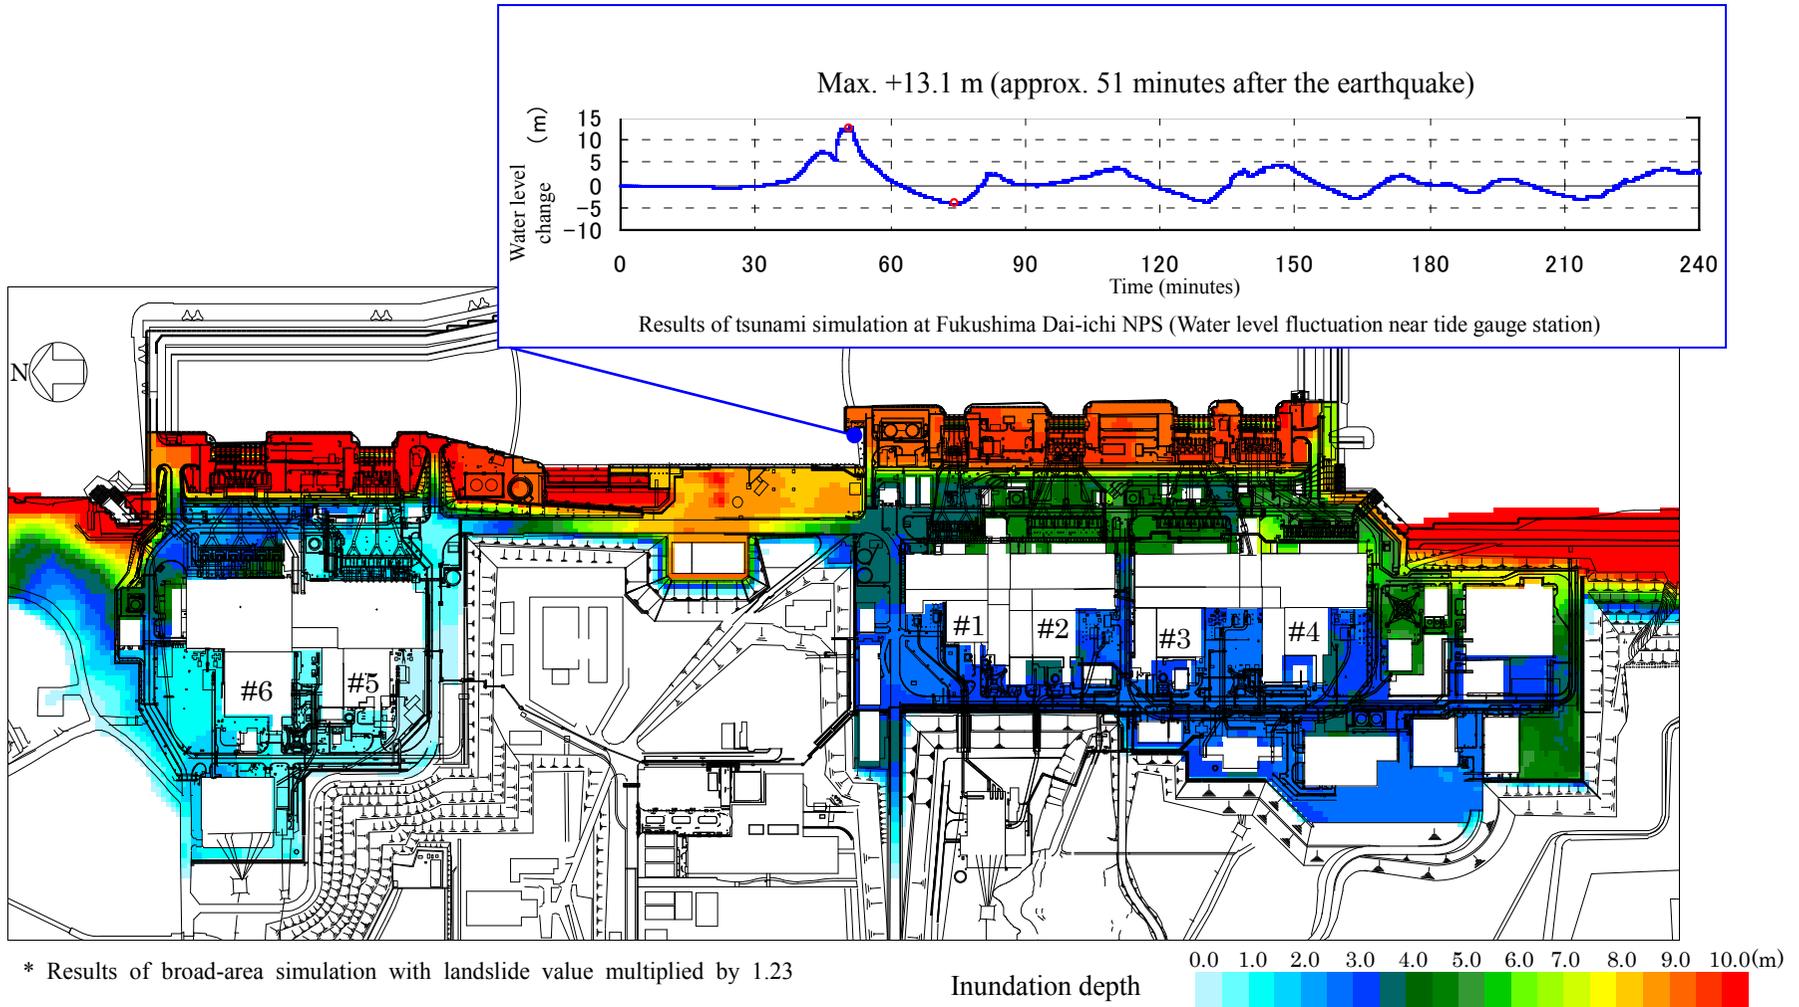
Figure II-2-24 Result of Tsunami Simulation at Fukushima Dai-ichi NPS (Inundation depth and inundated area)

In the investigation conducted by TEPCO, around major buildings in the site of O.P. +10 m and O.P. +13 m, almost all areas were estimated to be flooded due to the run-up of tsunami, but significant damage to the structure of main building, such as outer wall and pillars, etc. was not found.
