(2) Conditions of the Fukushima Dai-ichi NPS

This part overviews the current conditions of the Fukushima Dai-ichi NPS. Specifically, it introduces the current conditions of cooling the reactor and the SFP, the status of discharge of radioactive materials, contamination over on-site of the NPS, and the seismic safety in each Unit of the Fukushima Dai-ichi NPS.

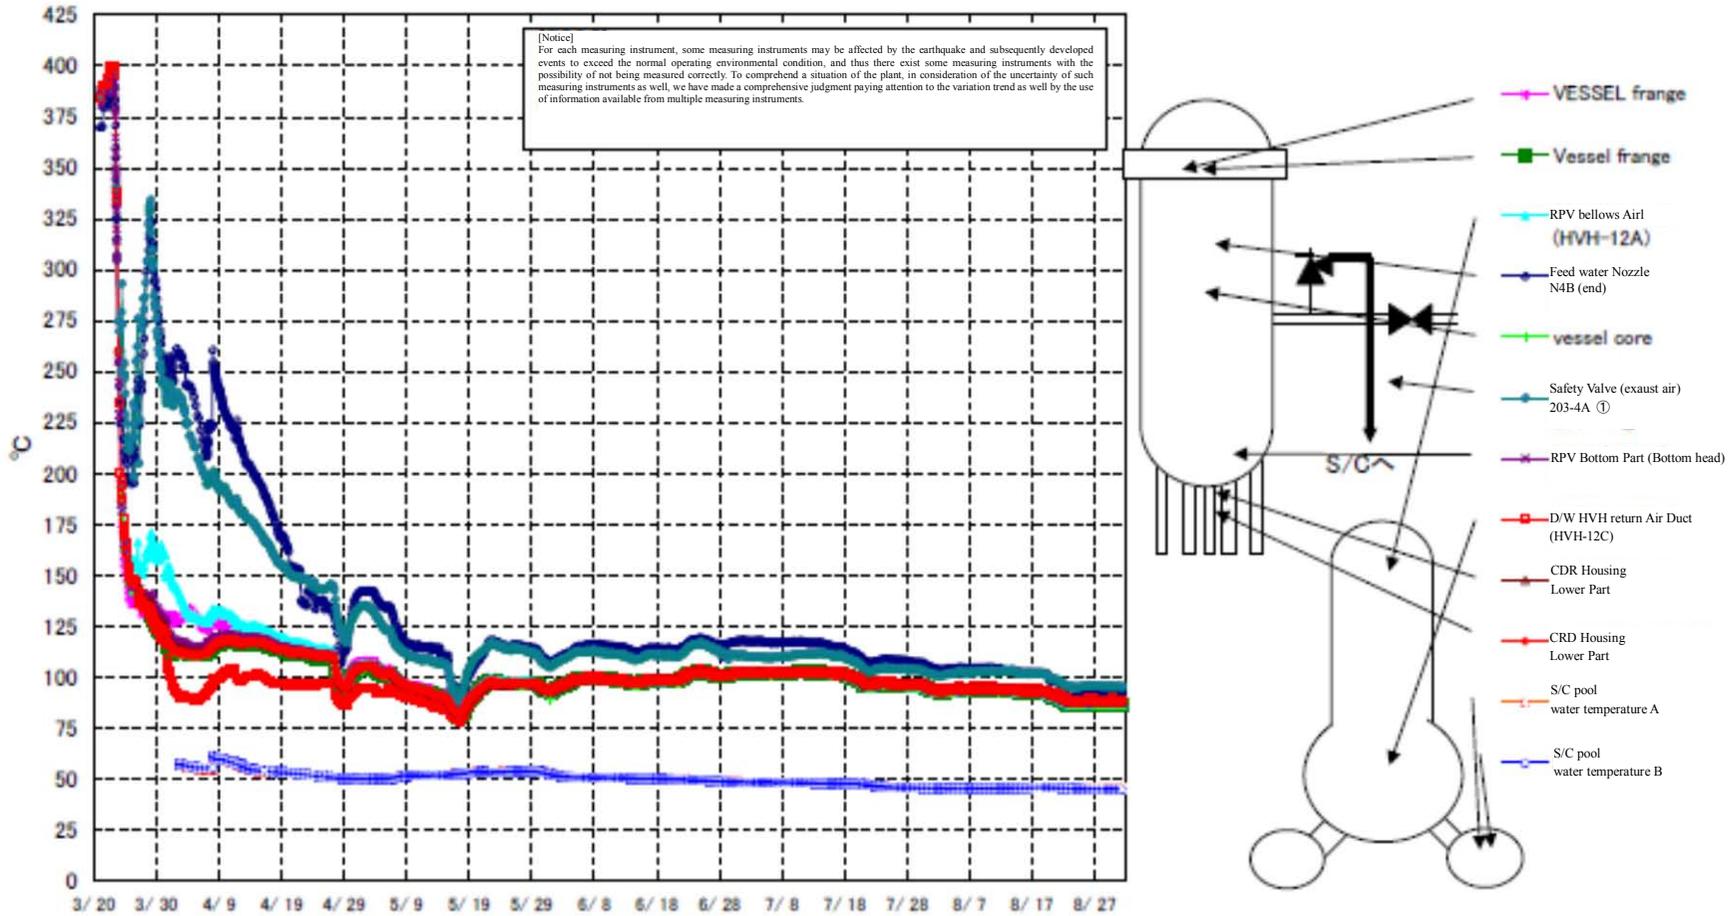
Figure II-2-28 Temperature Parameter, Unit 1, Fukushima Dai-ichi NPS

Temperature of the bottom of the RPV has not shown behavior of continuous increase of temperature over the last one month and stayed under 100°C, and the reactor has been enabled to be cooled sufficiently by means of a reactor water injection system (Figure II-2-28).

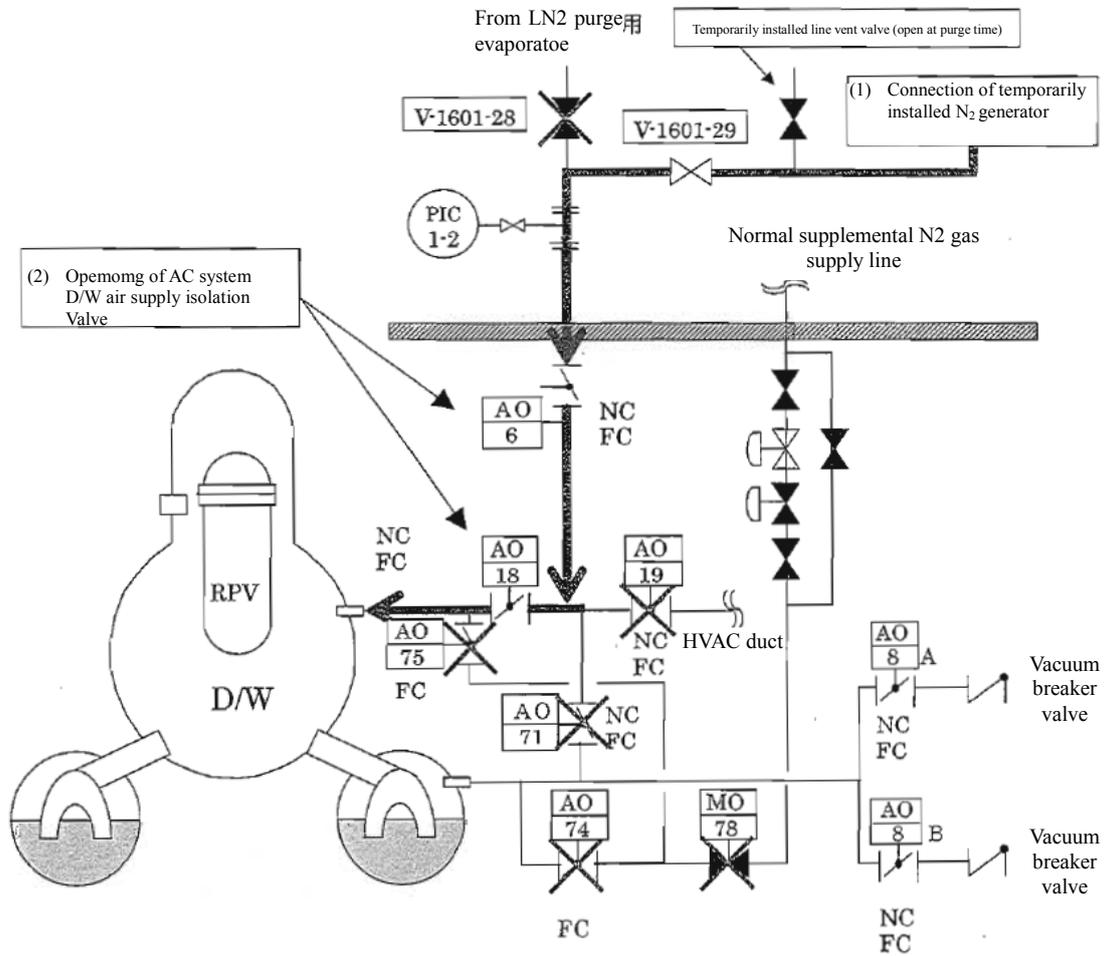
Figure II-2-29 Nitrogen Injection Line to Primary Containment Vessel, Unit 1, Fukushima Dai-ichi NPS

In Unit 1, on April 7, the injection of nitrogen into the PCV was started (Figure II-2-29), and it is still ongoing as of August 31.

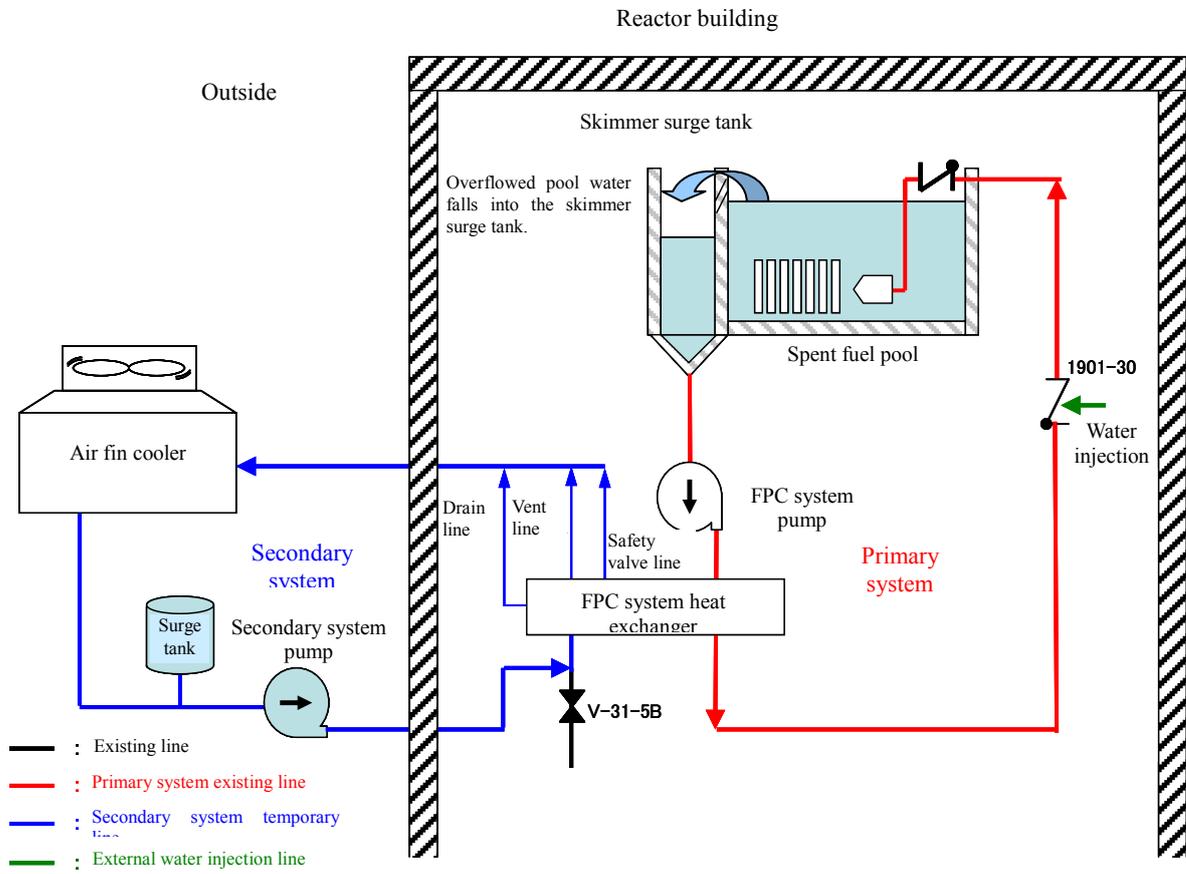
Figure II-2-38 Schematic Diagram of Alternative Cooling System

Pool water cooling by alternative cooling system (Figure II-2-38) was started on August 10. When the cooling was started, water temperature was 47°C (FPC pump inlet temperature), reached to steady condition approximately on August 27, water temperature has been stabilized around 30°C since then. Results of water injection to SFP are shown in Table II-2-15.

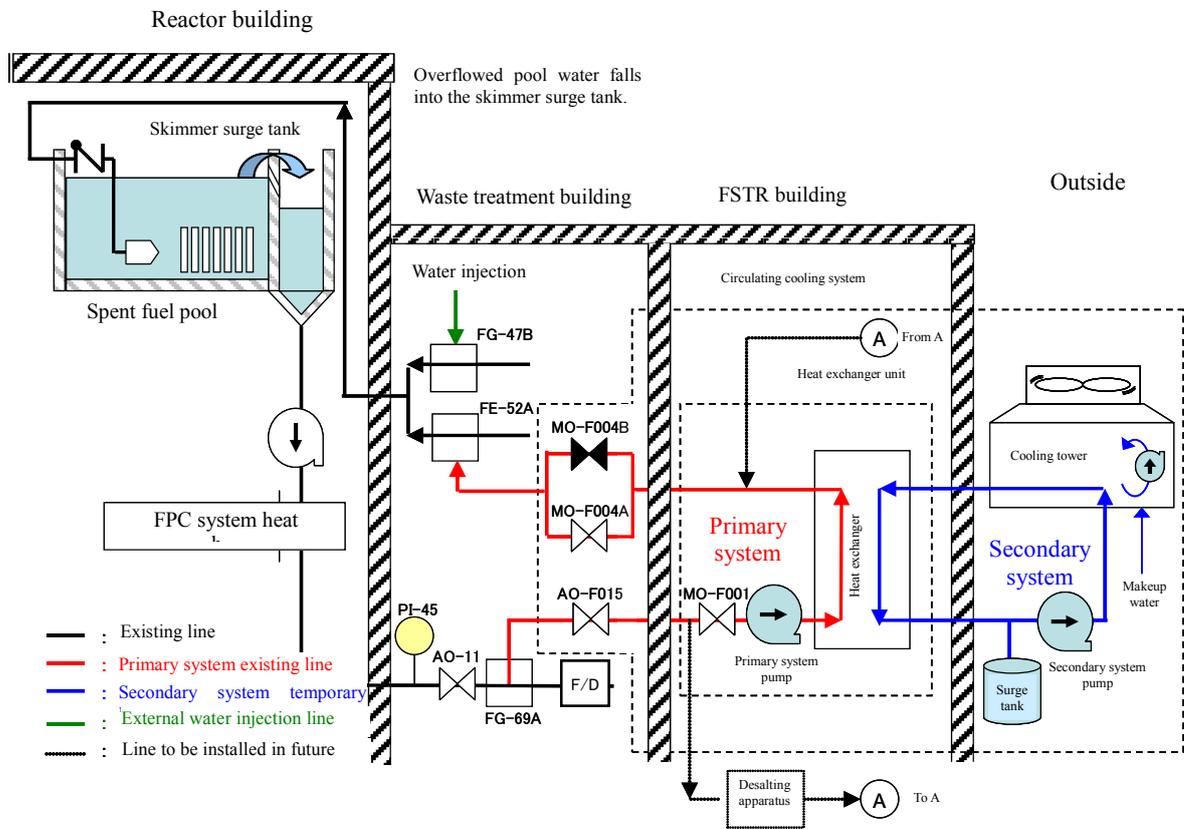
Figure II-2-39 Schematic Diagram of Alternative Cooling System

At 17:21, May 31, pool water cooling by alternative cooling system (Figure II-2-39) was started. When the cooling was started, water temperature was 70°C (SFP thermometer reading), reached to steady condition approximately on June 5, water temperature has been stabilized at around 30°C since then. Results of water injection to SFP are shown in Table II-2-17.

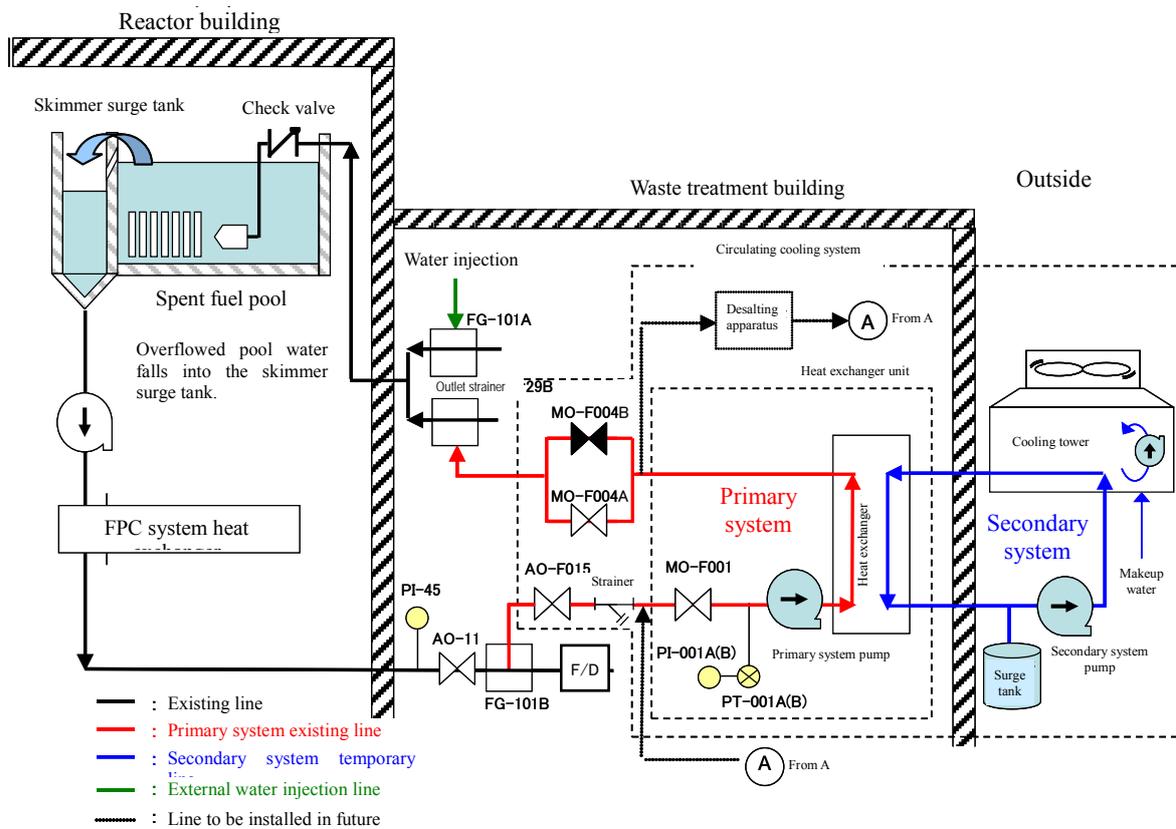
Figure II-2-40 Schematic Diagram of Alternative Cooling System

From the results of sampling, alkaline was detected from the pool water because of the elution of fallen rubbles' alkali metal (calcium etc.), alkaline corrosion of aluminum fuel racks was concerned. So, boric acid was injected to neutralize alkaline. By this, while pH11.2 (measured on May 8) of strong alkaline was shown before injection, pH9.0 (measured on July 7) of weak alkaline was shown after the injection. That's how water quality was improved.

On June 30, SFP cooling by alternative cooling system (Figure II-2-40) was started. Water temperature was around 62°C when the cooling was started (temperature at the inlet of alternative cooling system). It reached to steady condition on around July 7, and water temperature has been stabilized at around 30°C.

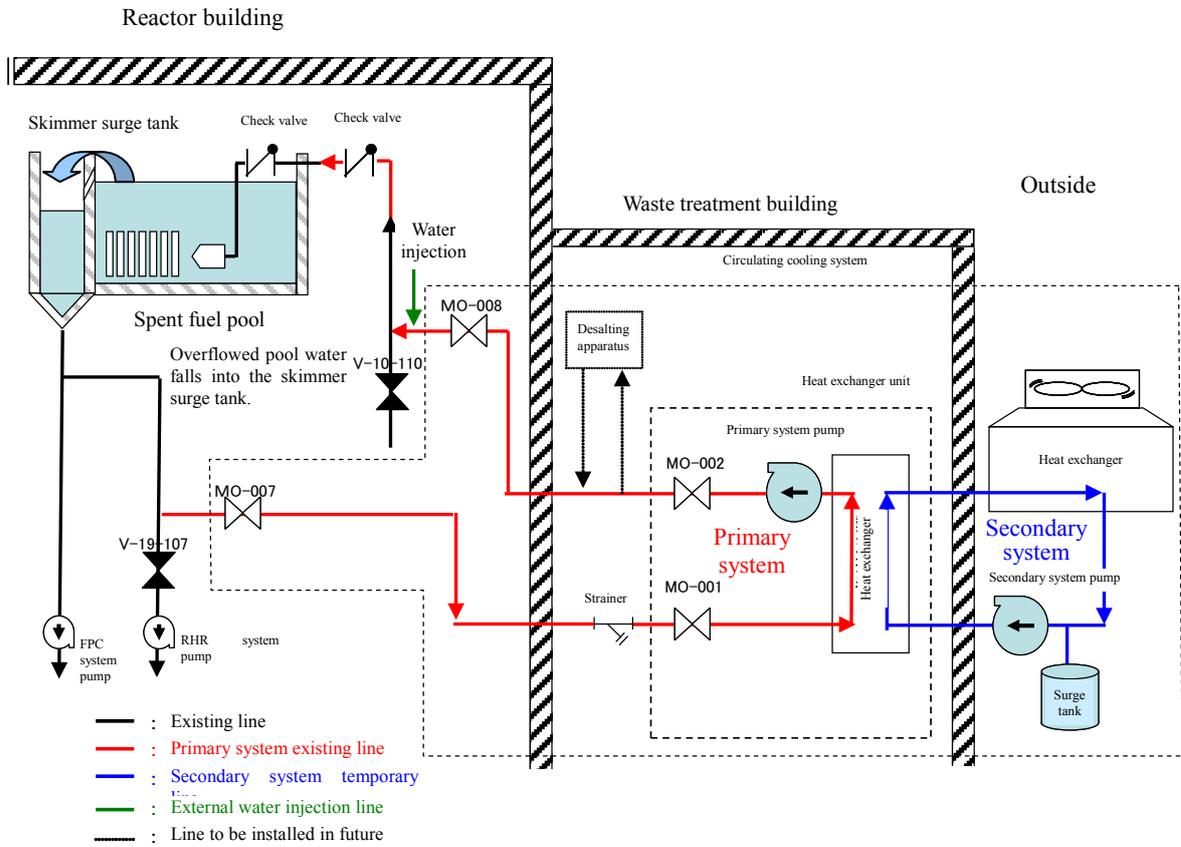
Figure II-2-42 Schematic Diagram of Alternative Cooling System

On June 31, pool water cooling by alternative cooling system (Figure II-2-42) was started. Water temperature was around 75°C when the cooling was started (temperature at the inlet of alternative cooling system). It reached to steady condition on around August 3, and water temperature has been stabilized at around 40°C. Results of water injection to SFP are shown in Figure II-2-21.

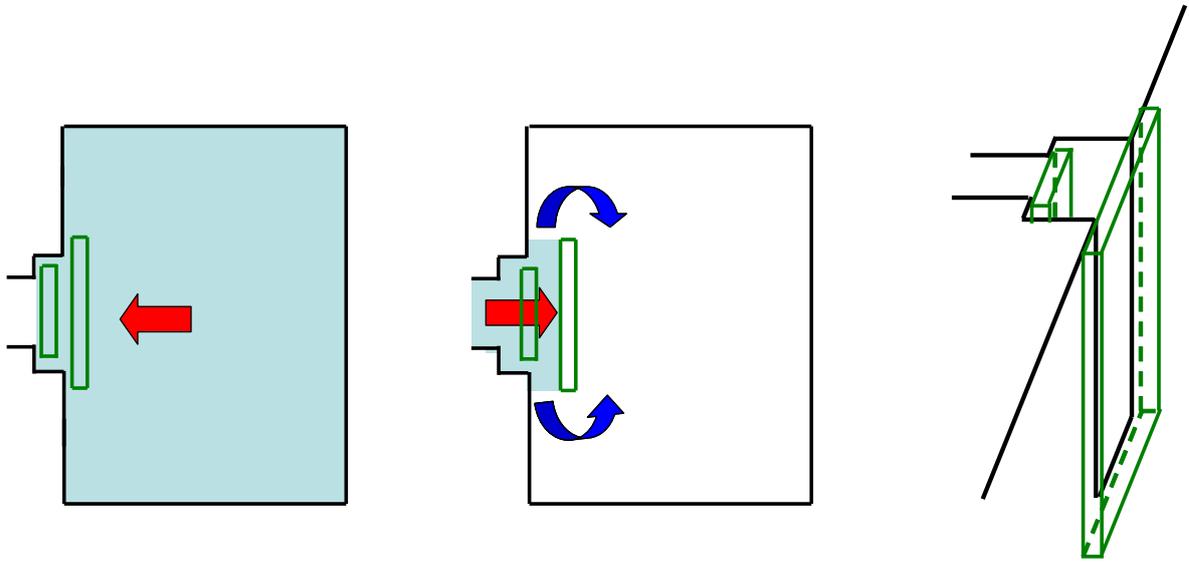
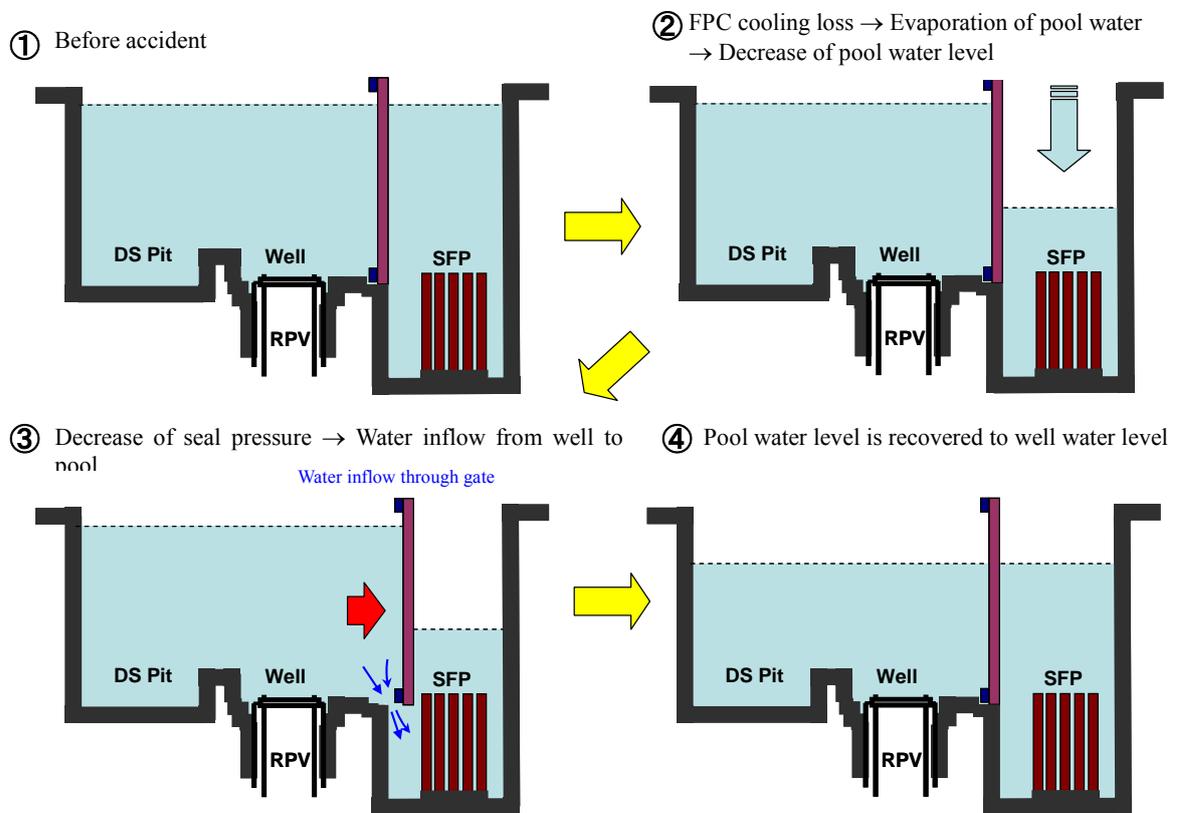
After reaching to full capacity at reactor well, decline of water level at reactor well side was observed, and increase of Skimmer Surge Tank Level at the time of reactor well injection was confirmed. So, water was considered to be poured into SFP side. Water injection only from reactor ICM piping has been conducted since July 1.

Figure II-2-44 Water inflow Mechanism through pool gate

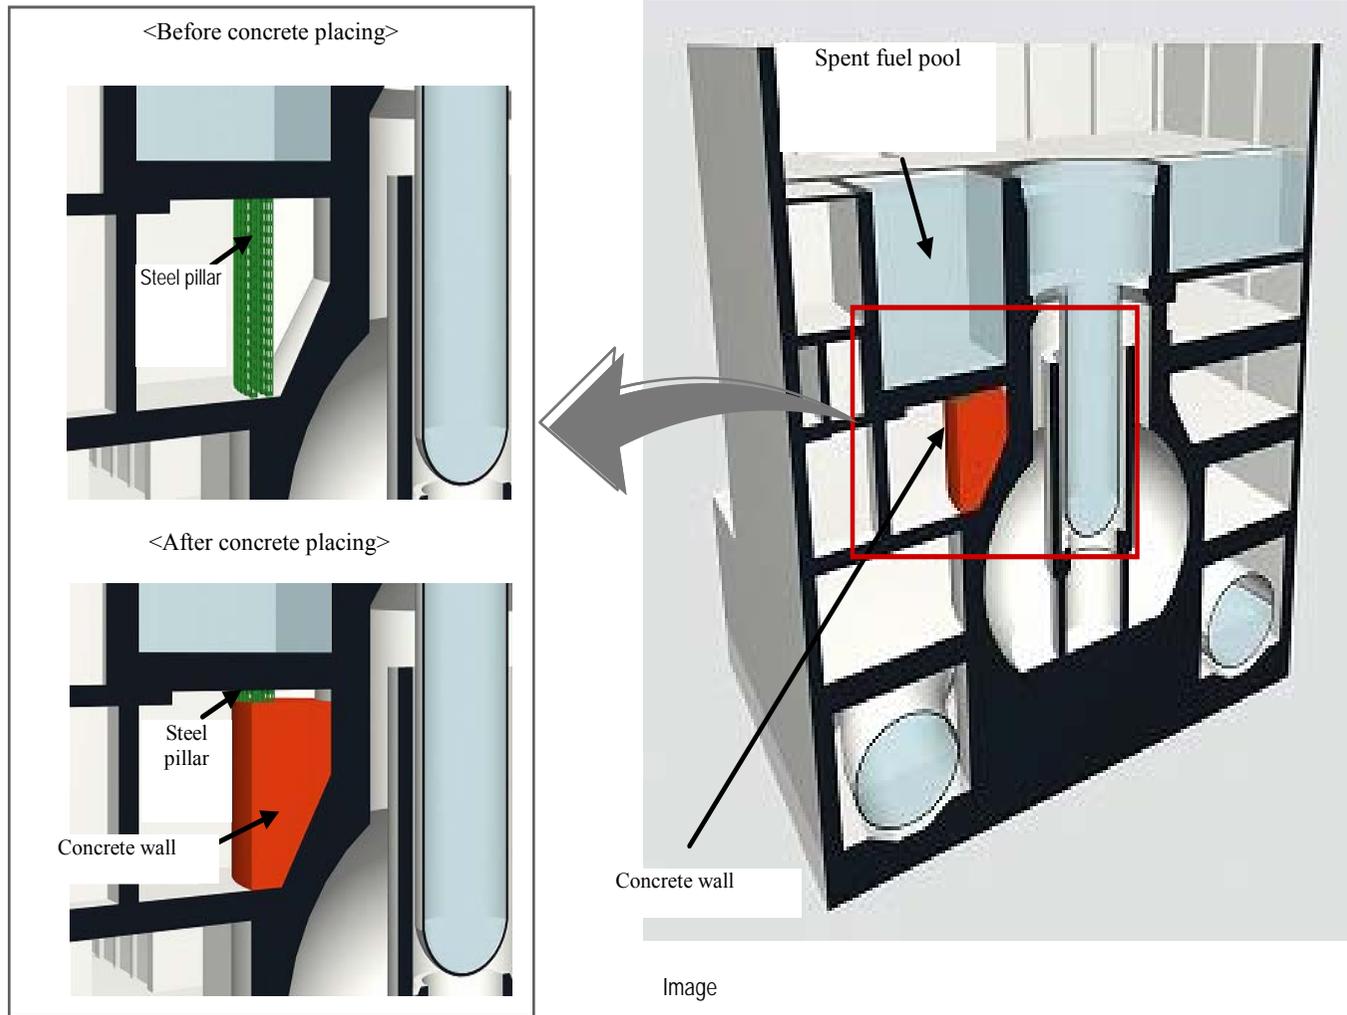
Figure II-2-50 Installation of Support Structure at Bottom of Spent Fuel Pool of Reactor Building of Fukushima Dai-ichi Unit 4

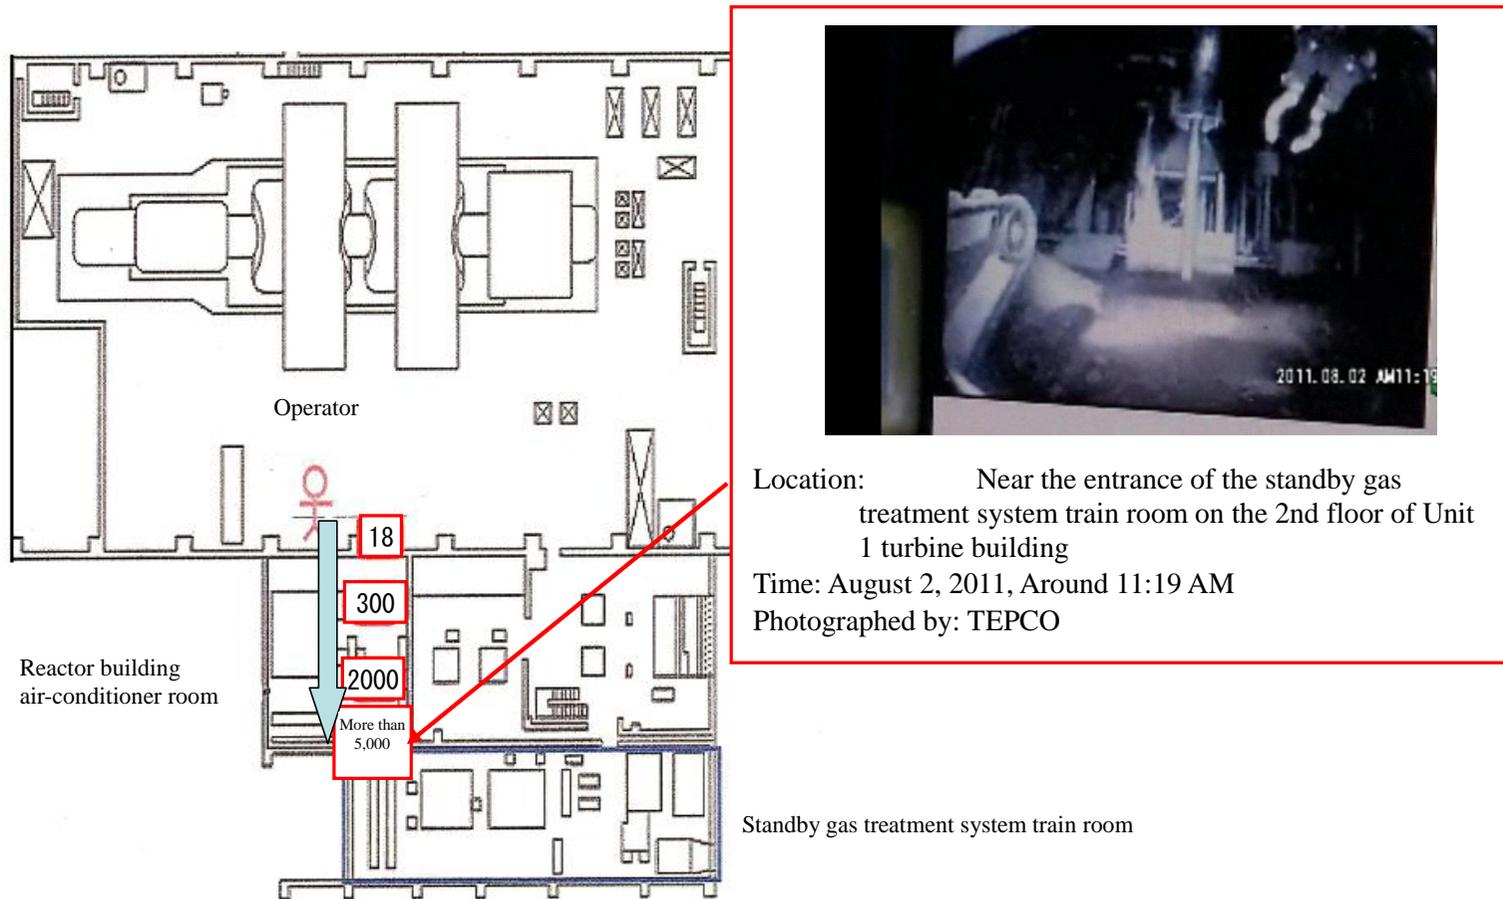
Figure II-2-61 High-dose Detected Area on the 2nd Floor of Unit 1 Turbine Building in Fukushima Dai-ichi NPS

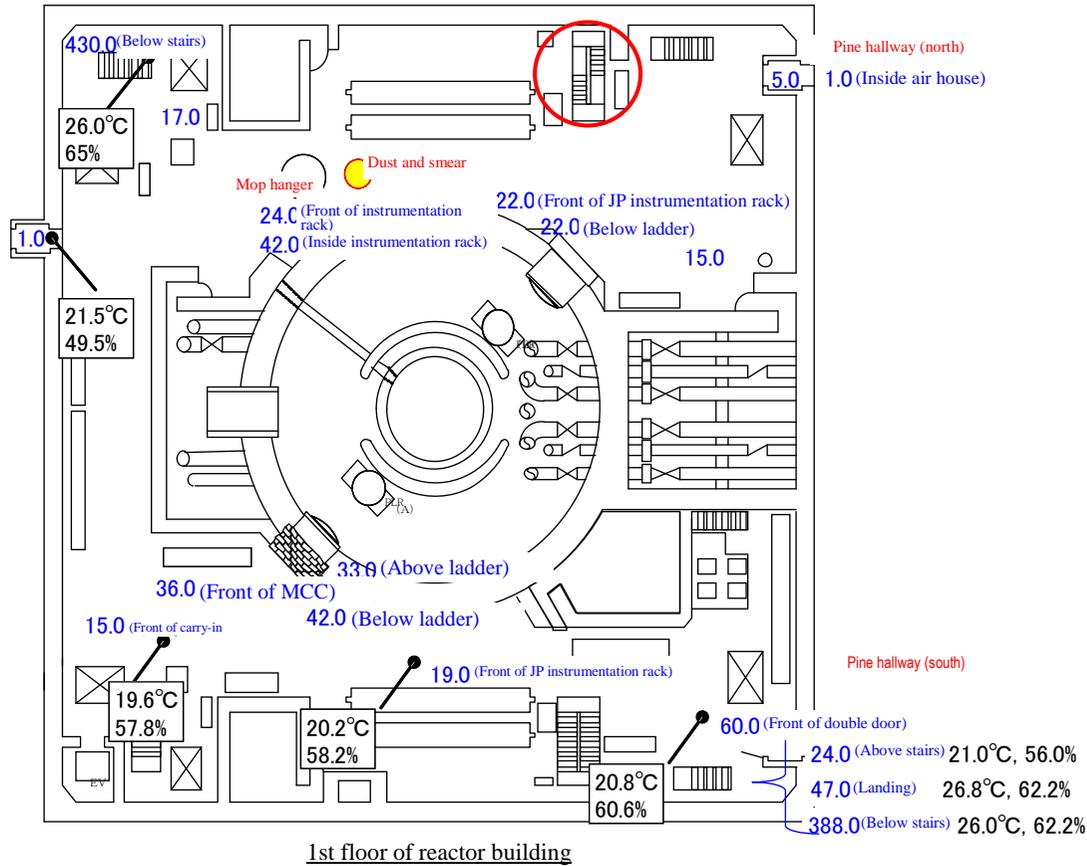
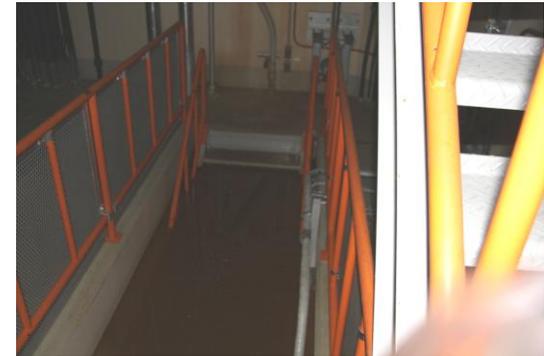
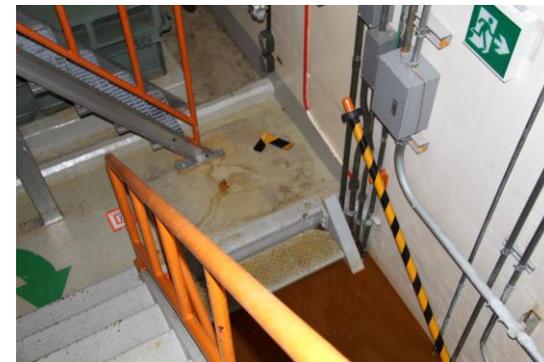
Northwest stairs (half basement)

Southeast stairs (half basement)

Figure II-2-63 Result of Investigation inside Unit 2 Reactor Building in Fukushima Dai-ichi NPS (No. 1)

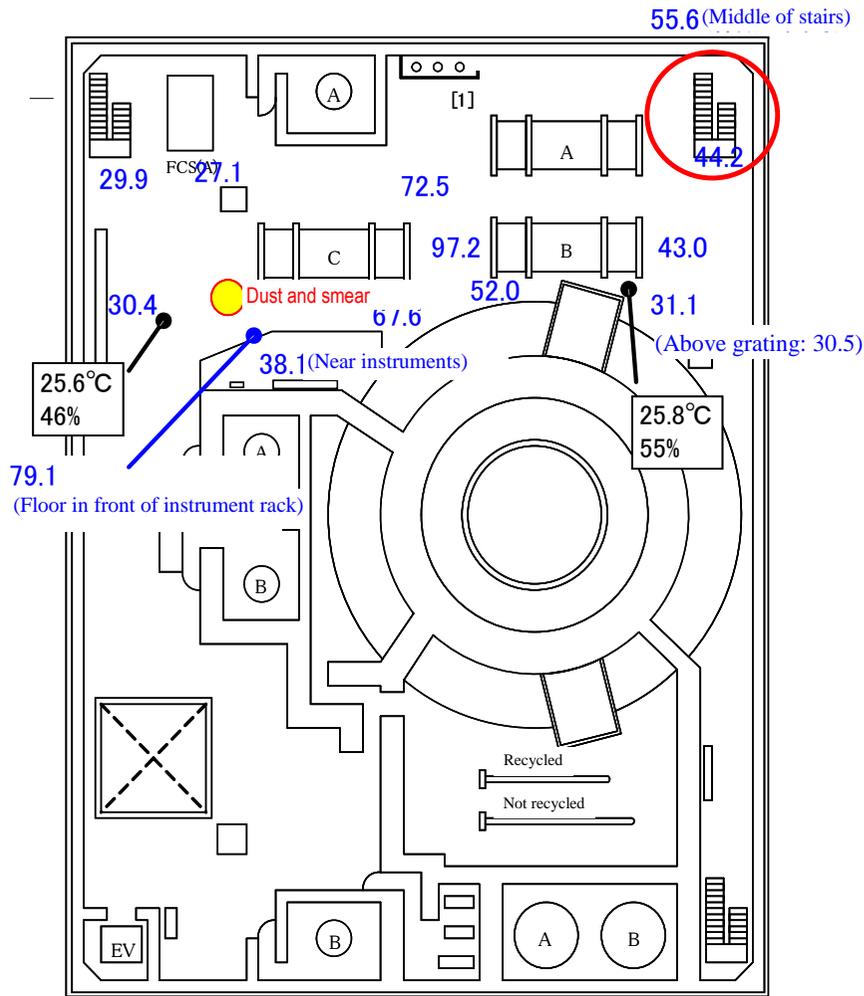
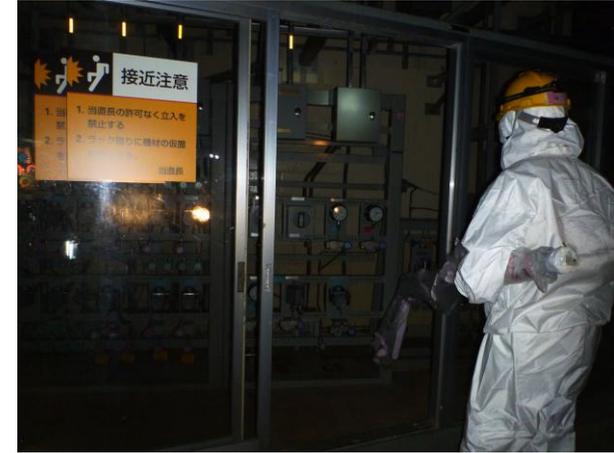
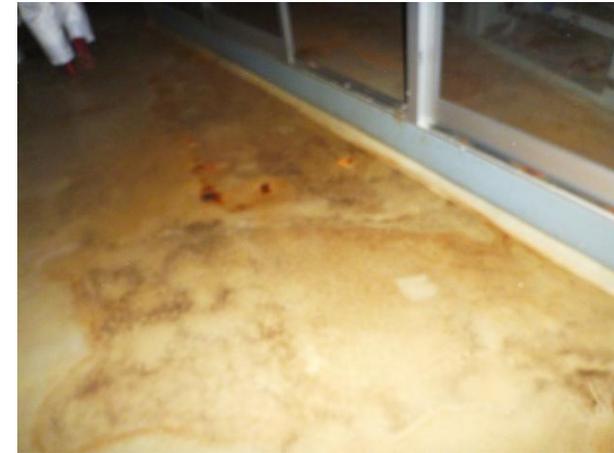
2nd floor of reactor building

Reactor instrumentation rack

Floor in front of reactor instrumentation rack

Figure II-2-64 Result of Investigation inside Unit 2 Reactor Building in Fukushima Dai-ichi NPS (No. 2)

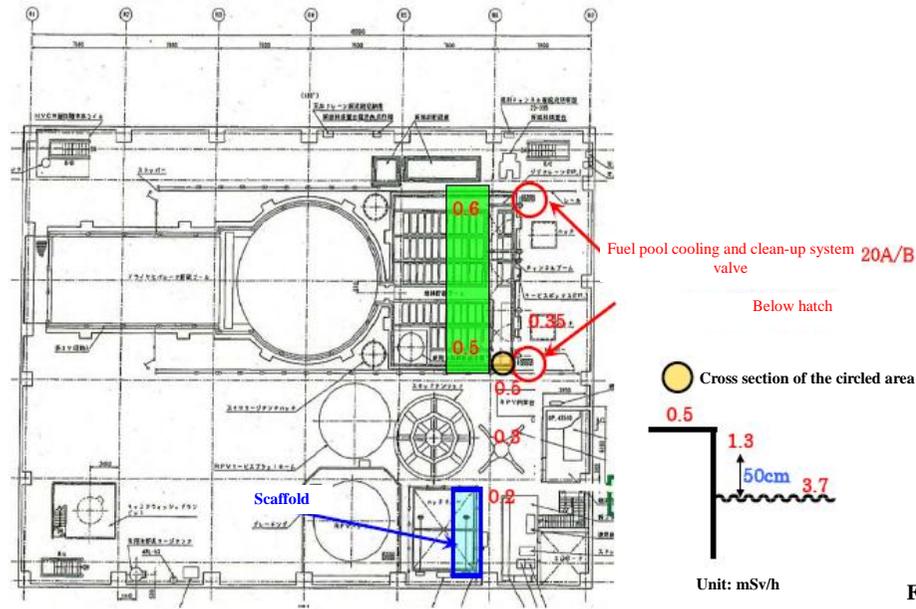
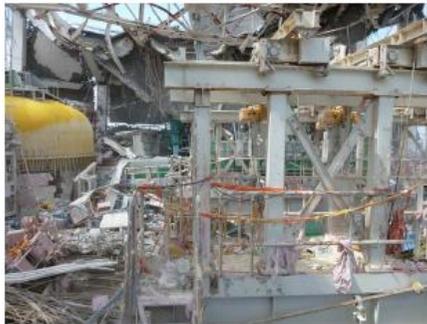
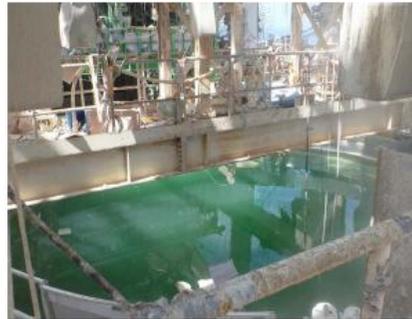
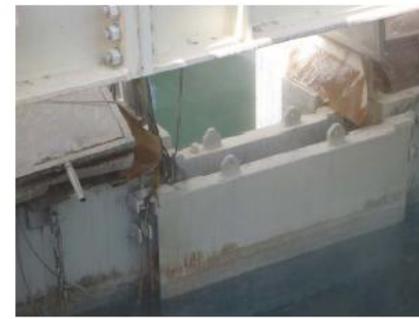
Fuel pool cooling and clean-up system valve

Equipment storage pool viewed from refueling carriage

Reactor well

Spent fuel pool gate

Figure II-2-69 Result of On-the-spot Investigation of the 5th Floor of Unit 4 Reactor Building in Fukushima Dai-ichi NPS

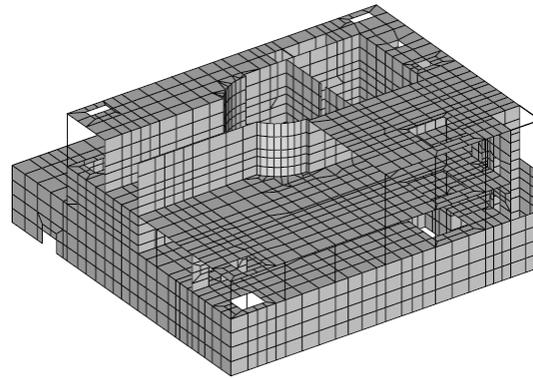
Fig. II-2-75 Finite Element Model for Unit 3 (TEPCO Report, July 13)

As for the Unit 3 reactor building, the structures above the operating floor (the fifth floor level) were damaged by an incident which is believed to be a hydrogen explosion on March 14. According to available sources such as photographs and video films, a majority of the structures above the fifth floor level are in the state of a stack of iron frame and concrete structures which collapsed after the explosion. The floor at the fifth level at the northwestern corner has been damaged, causing some of the collapsed iron frame and concrete structures to pile up on the fourth floor, and many parts of the walls on the fourth level are damaged.

In consideration of the above information, modifications were made to a model (II2-6) that had been prepared for the seismic design back-check; the frame structures that remained above the operating floor and the damaged seismic walls below the operating floor were no more counted as structural components. In other words, the structures above the operating floor were removed from the model for the back-check, and modifications were made to the assumed structural performance of the structures below the operating floor by decreasing the shearing cross-sectional area and the cross-sectional secondary moment from their integrity states. In addition, the model was modified to properly represent how the weight of the structures above the operating floor is distributed on the operating floor. The model was further modified to properly represent how the weight of the collapsed northwestern corner of the operating floor, and the weights of the collapsed walls and frame structures on the fourth level, are distributed on the fourth floor.

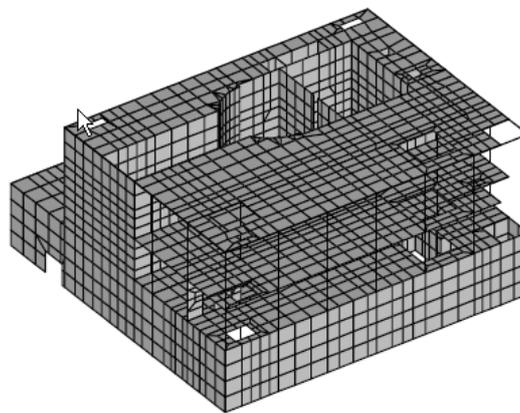
Fig.II-2-76 Finite Element Model for Unit 4 (TEPCO Report, May 28)

As for the Unit 4 reactor building, the building lost a majority of its roof slabs and walls above the fifth floor level due to unidentified cause on March 15, leaving only the frame structures of columns and beams, and furthermore, the available sources such as photographs and video films indicate that a majority of walls on the fourth level and some walls on the third level have also been damaged.

In consideration of the above information and also of the fact that Unit 4 was not loaded with fuel because of a scheduled outage underway on the day of the earthquake, modifications were made to a model (II2-7) for the seismic design back-check, referring to data concerning the load conditions during scheduled outages. The frame structures that remained above the operating floor and the damaged seismic walls below the operating floor were no more counted as structural components. In other words, the structures above the operating floor were removed from the model for the back-check, and modifications were made to the assumed structural performance of the structures below the operating floor. In addition, the model for the back-check was modified to properly represent how the weight of the structures above the operating floor is distributed on the operating floor.

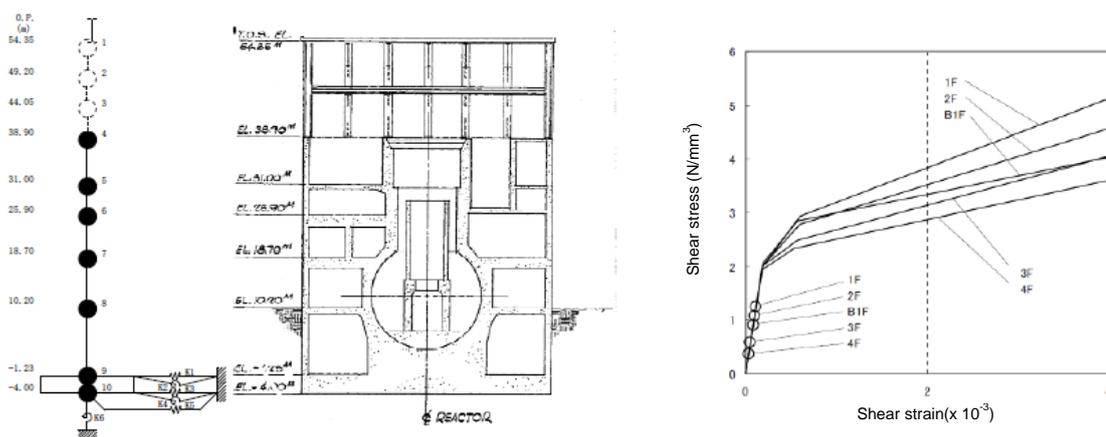
Fig.II-2-77 Lumped Mass Model and Maximum Shear Strain in the Seismic Wall for Unit 1 (TEPCO Report, May 28)

At the Unit 1 reactor building, the structures above the operating floor (the fifth floor level) were damaged by an event, which is believed to be a hydrogen explosion, occurring on March 12, the day after the Tohoku District - off the Pacific Ocean Earthquake.

Studying damages from the available sources of information such as photographs and video films, modifications were made to a model (II2-6) that had been prepared for the reassessment of seismic safety using the updated guide for seismic design (hereinafter referred to as “seismic design back-check”); the steel frame structures that remained above the operating floor were no more counted as structural components. In other words, the structures above the operating floor were removed from the model that had been prepared for the seismic design back-check. In addition, the model that had been prepared for the back-check was modified to properly represent how the weight of the structures above the operating floor is distributed on the operating floor. Components such as seismic walls and floors below the operating floor were assumed as unaffected by the explosion, thus the structural performance of the back-check model was assumed to remain unchanged.

Since no part of the building was identified to have any danger of failure in ensuring the seismic safety, TEPCO, at this moment, does not plan any urgent implementation of seismic reinforcement works, etc.

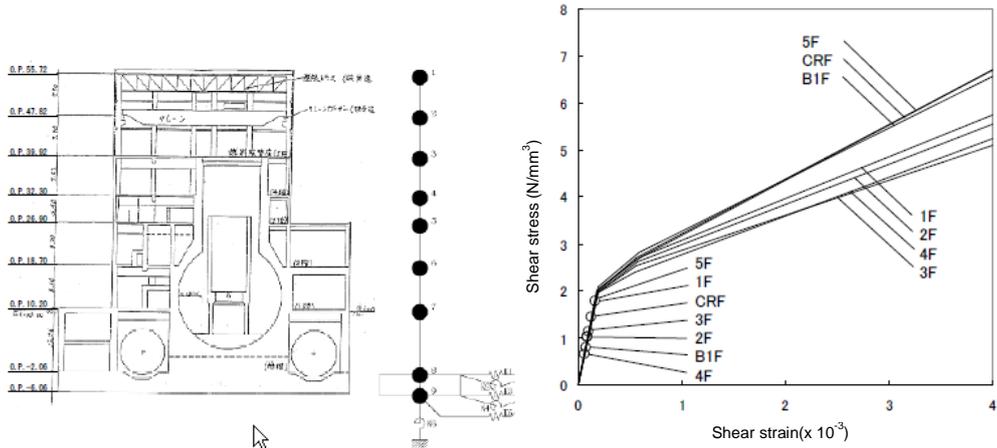
Fig. II-2-78 Lumped Mass Model and Maximum Shear Strain in the Seismic Wall for Unit 2 (TEPCO Report, August 26)

The Unit 2 reactor building shows no apparent damage even though the blow out panel on the east end external wall is exposed. Access is restricted due to high dose level, hindering the inspection of building interior, but at this moment, it is believed that there is no damage.

For more assurance, parameter studies were conducted considering the possibility of the shell wall stiffness having been reduced by a temporary rise of temperature inside the PCV and the identified noise on March 15 near the S/C at the underground level. The modifications to parameters caused some changes to the numerical outputs but did not significantly impact the analysis results.

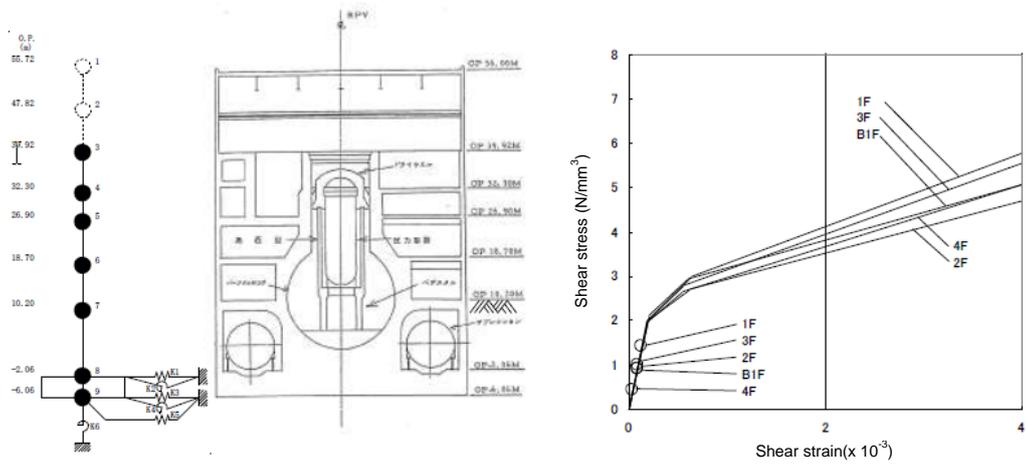
Fig. II-2-79 Lumped Mass Model and Maximum Shear Strain in the Seismic Wall for Unit 3 (TEPCO Report, July 13)

Since no part of the building was identified to have any danger of failure in ensuring the seismic safety, TEPCO, at this moment, does not plan any urgent implementation of seismic reinforcement works, etc.
