Discovery of a crack in a connection valve between tanks for concentrated water* treated by Reverse Osmosis at Fukushima Daiichi NPS

On 17 September 2014, the Nuclear Regulation Authority (NRA) of Japan received a report from TEPCO regarding a recent incident at Fukushima Daiichi NPS, pursuant to the Act on Regulation of Nuclear Source Material, Nuclear Fuel Material and Nuclear Reactors. The report delineates as follows:

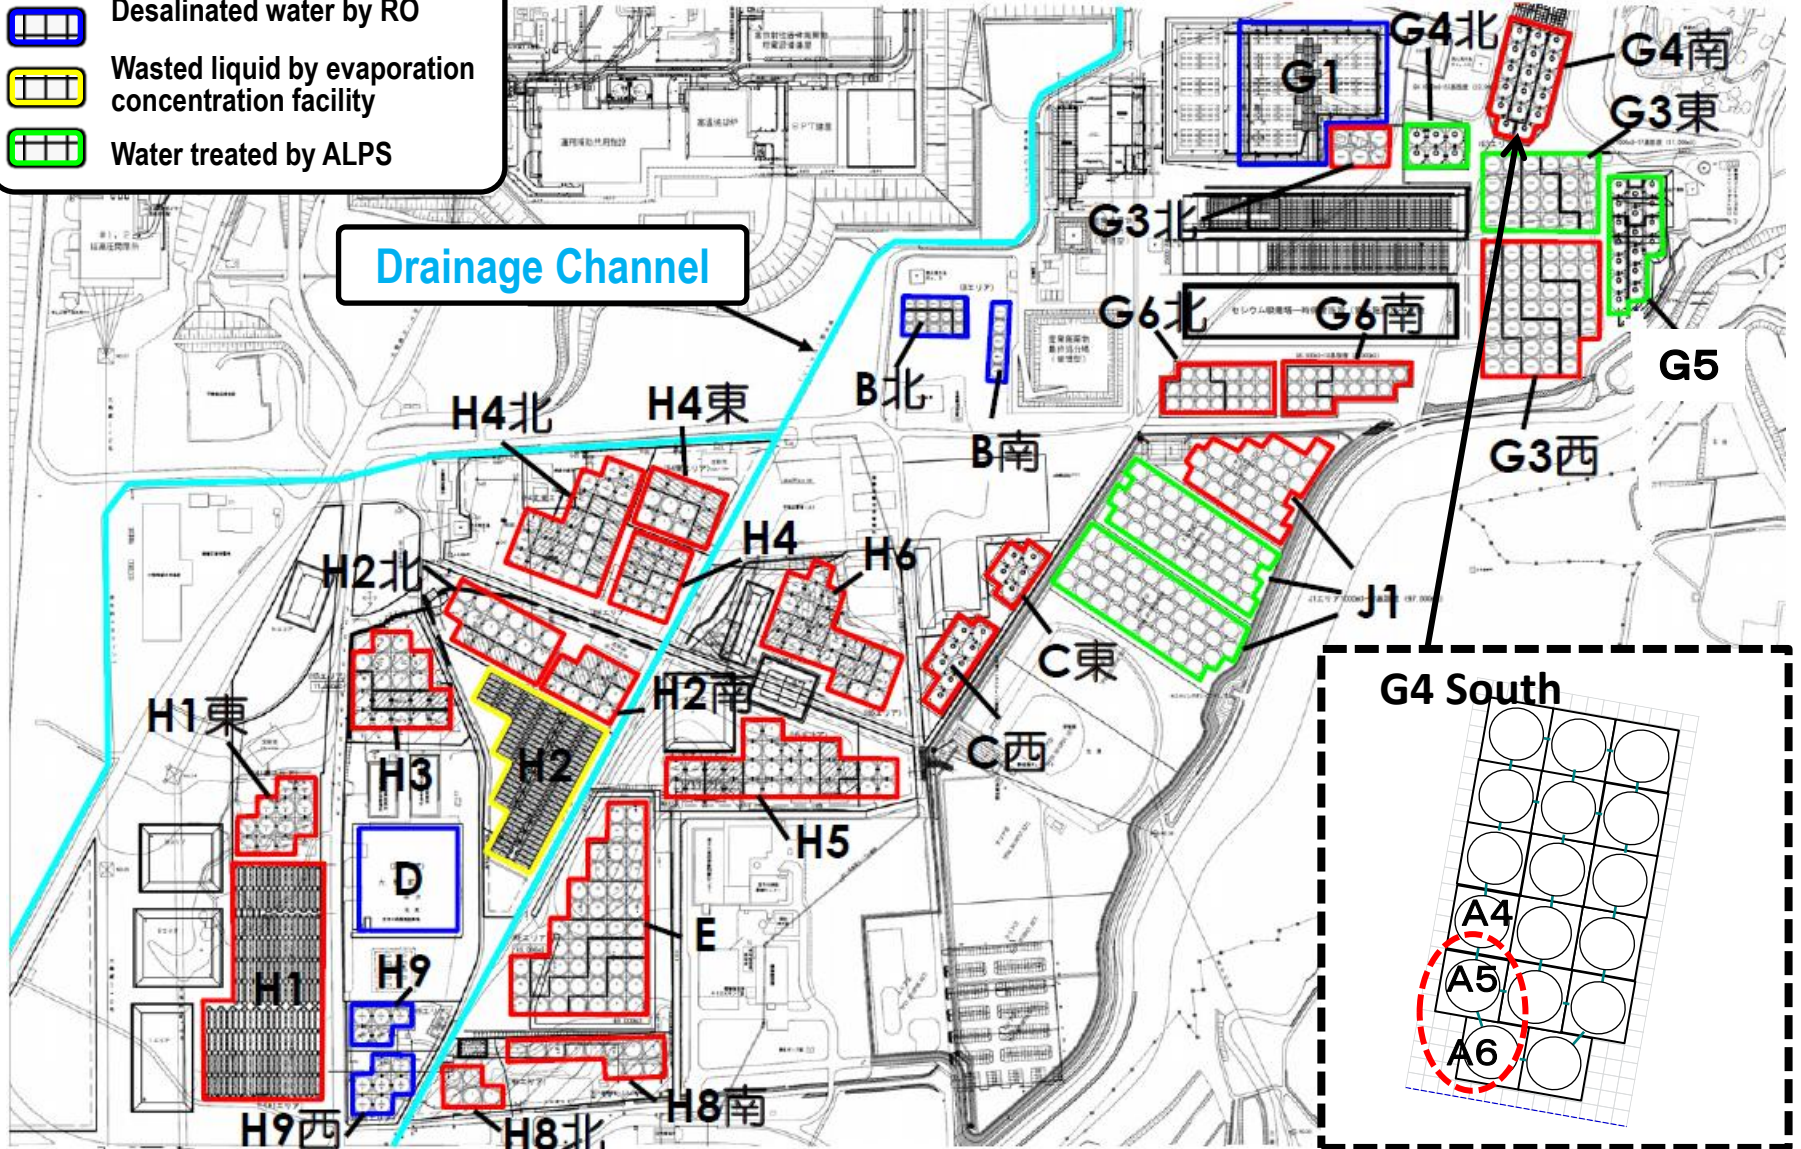
Location of the valve with the crack and leakage

- TEPCO found on 4 September that the concentrated water treated by Reverse Osmosis (RO) was leaking from a connection valve between A5 tank and A6 tank in the G4 South Tank Area. The leaked water was remaining within the dike surrounding the area.
- As a result of inspection by TEPCO, it was found on 17 September that the connection valve had a crack which penetrated the valve.
- Therefore, this crack constitutes a lack of functionality in ensuring safety in the nuclear reactor facility under TEPCO's Implementation Plan.

- To swiftly inspect similar valves connecting storage tanks which are not surrounded by dikes, to ensure there are no cracks.
- To take prevention measures including review of inspections of equipment (i.e. tanks, valves and connection pipes) in light of the result of cause-finding measure.
