IAEA EC- FAC Activities

Recent material and related managerial issues on nuclear power plants

15 - 18 February. 2005 at VIC

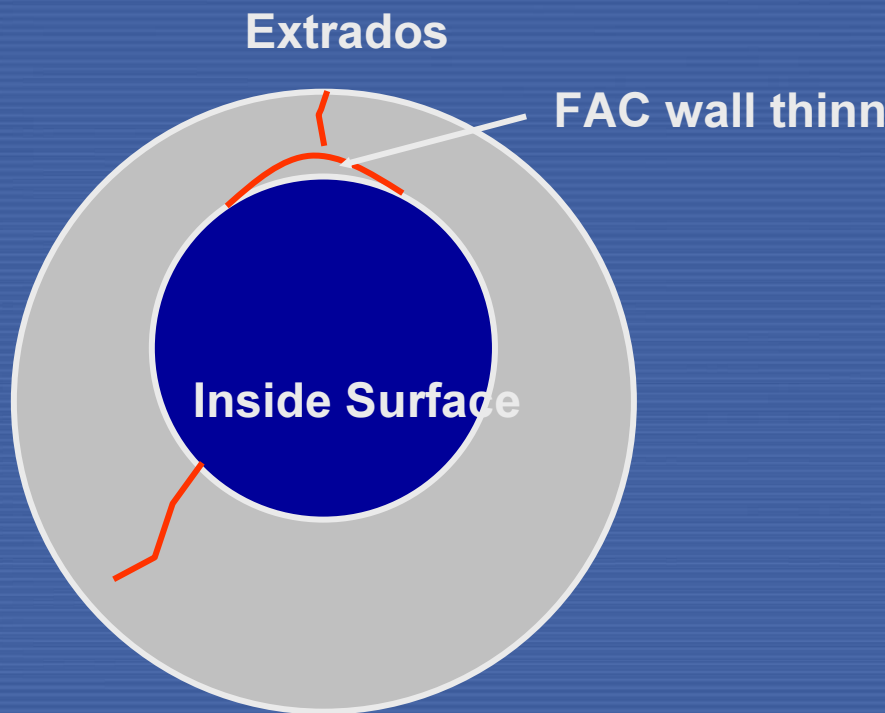
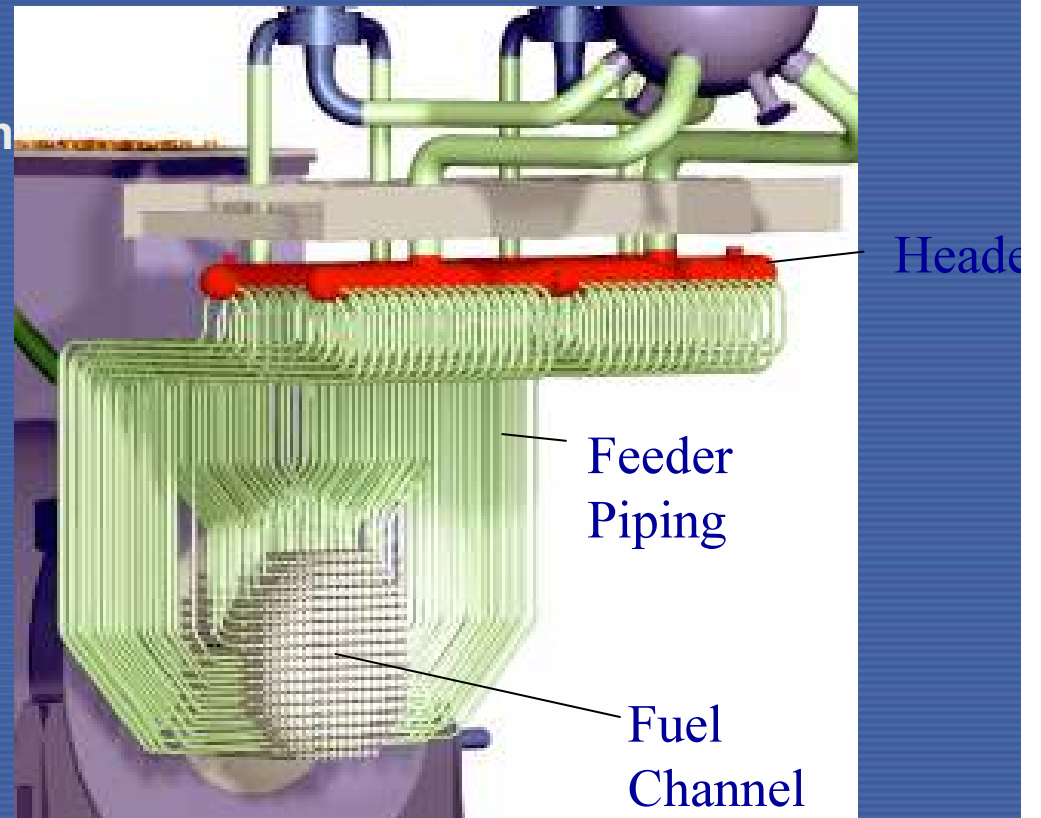
Feeder Bend

Service Induced Degradations of CANDU feeder piping - FAC wall thinning and cracking

Intrados
IAEA

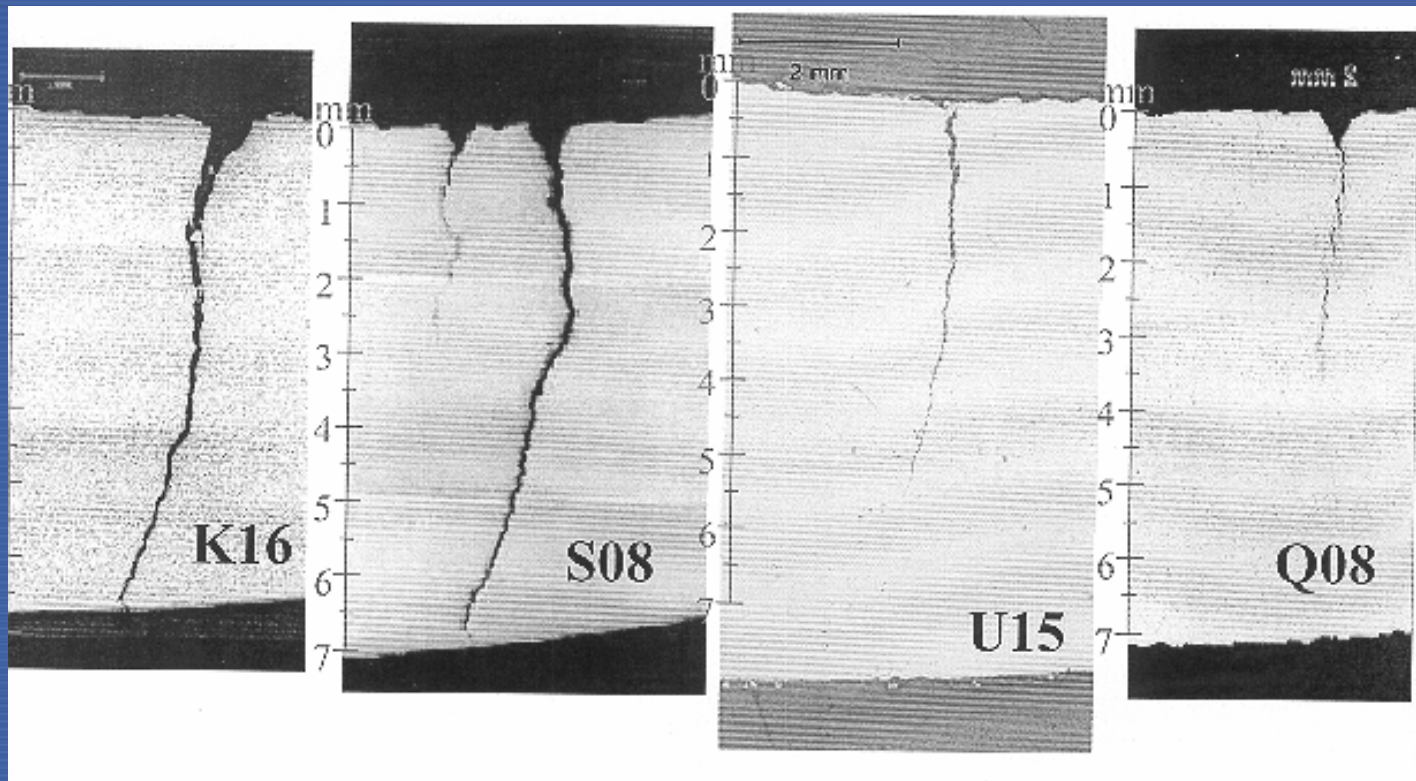
Metallographic Images Cross-Sections of the Cracks - Canada

Intergranular

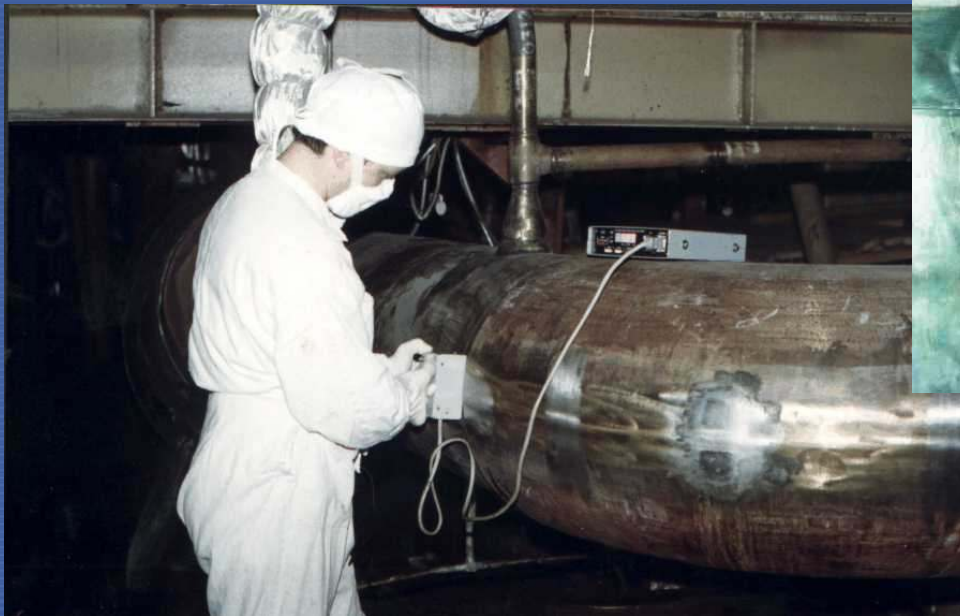
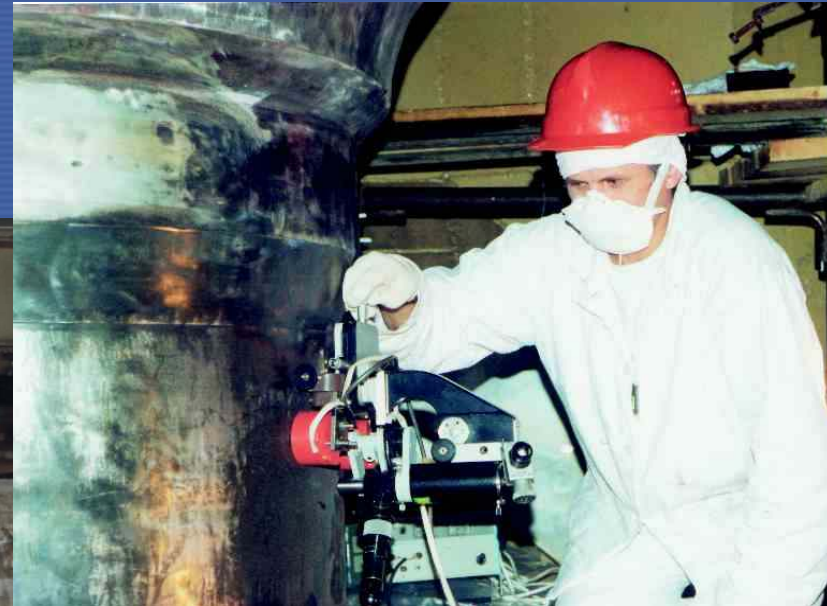
Inspection of the microstructure and of the magnetic properties - Russia

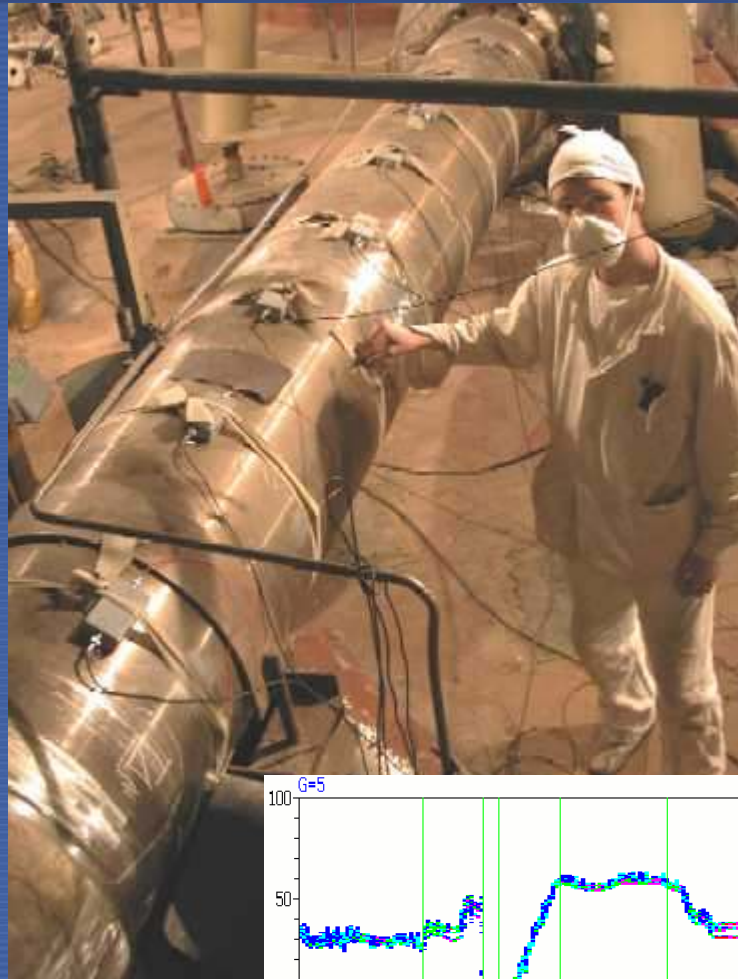
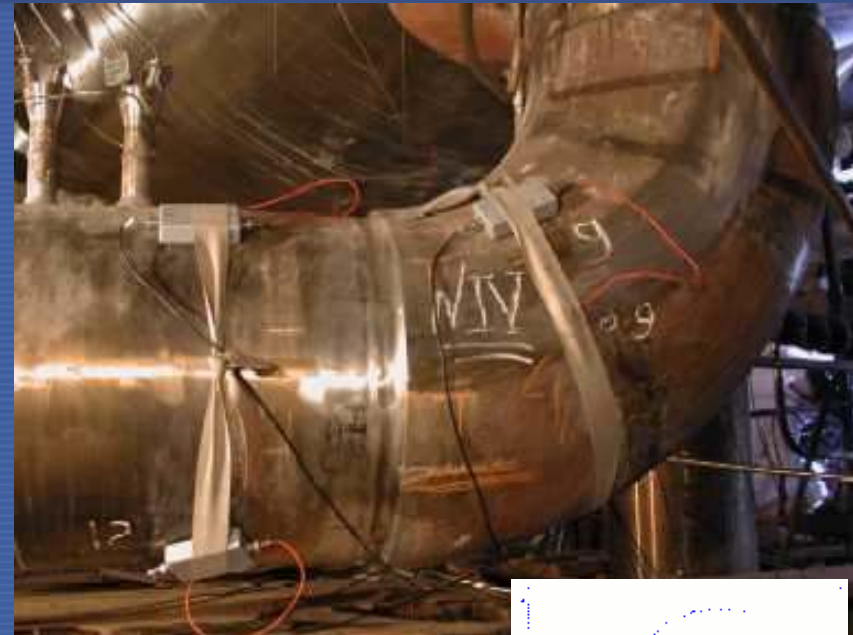
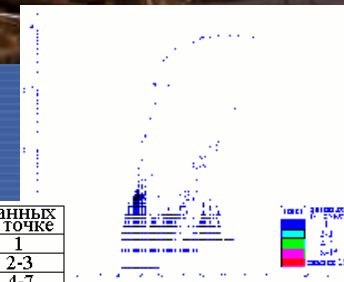
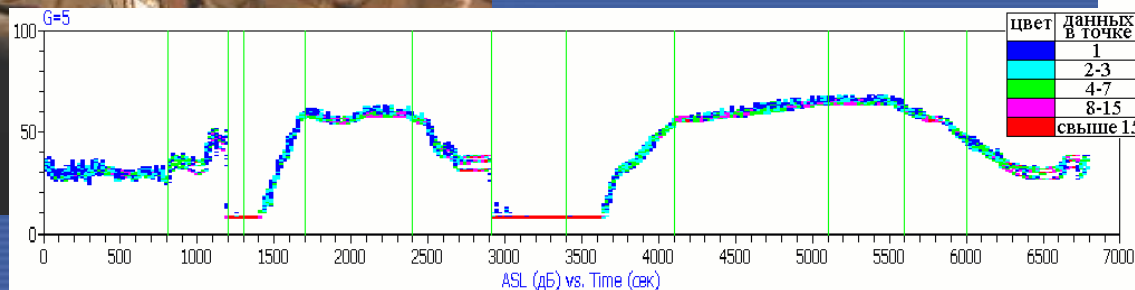
Examination of the potential defect growth by use acoustic-emission method - Russia

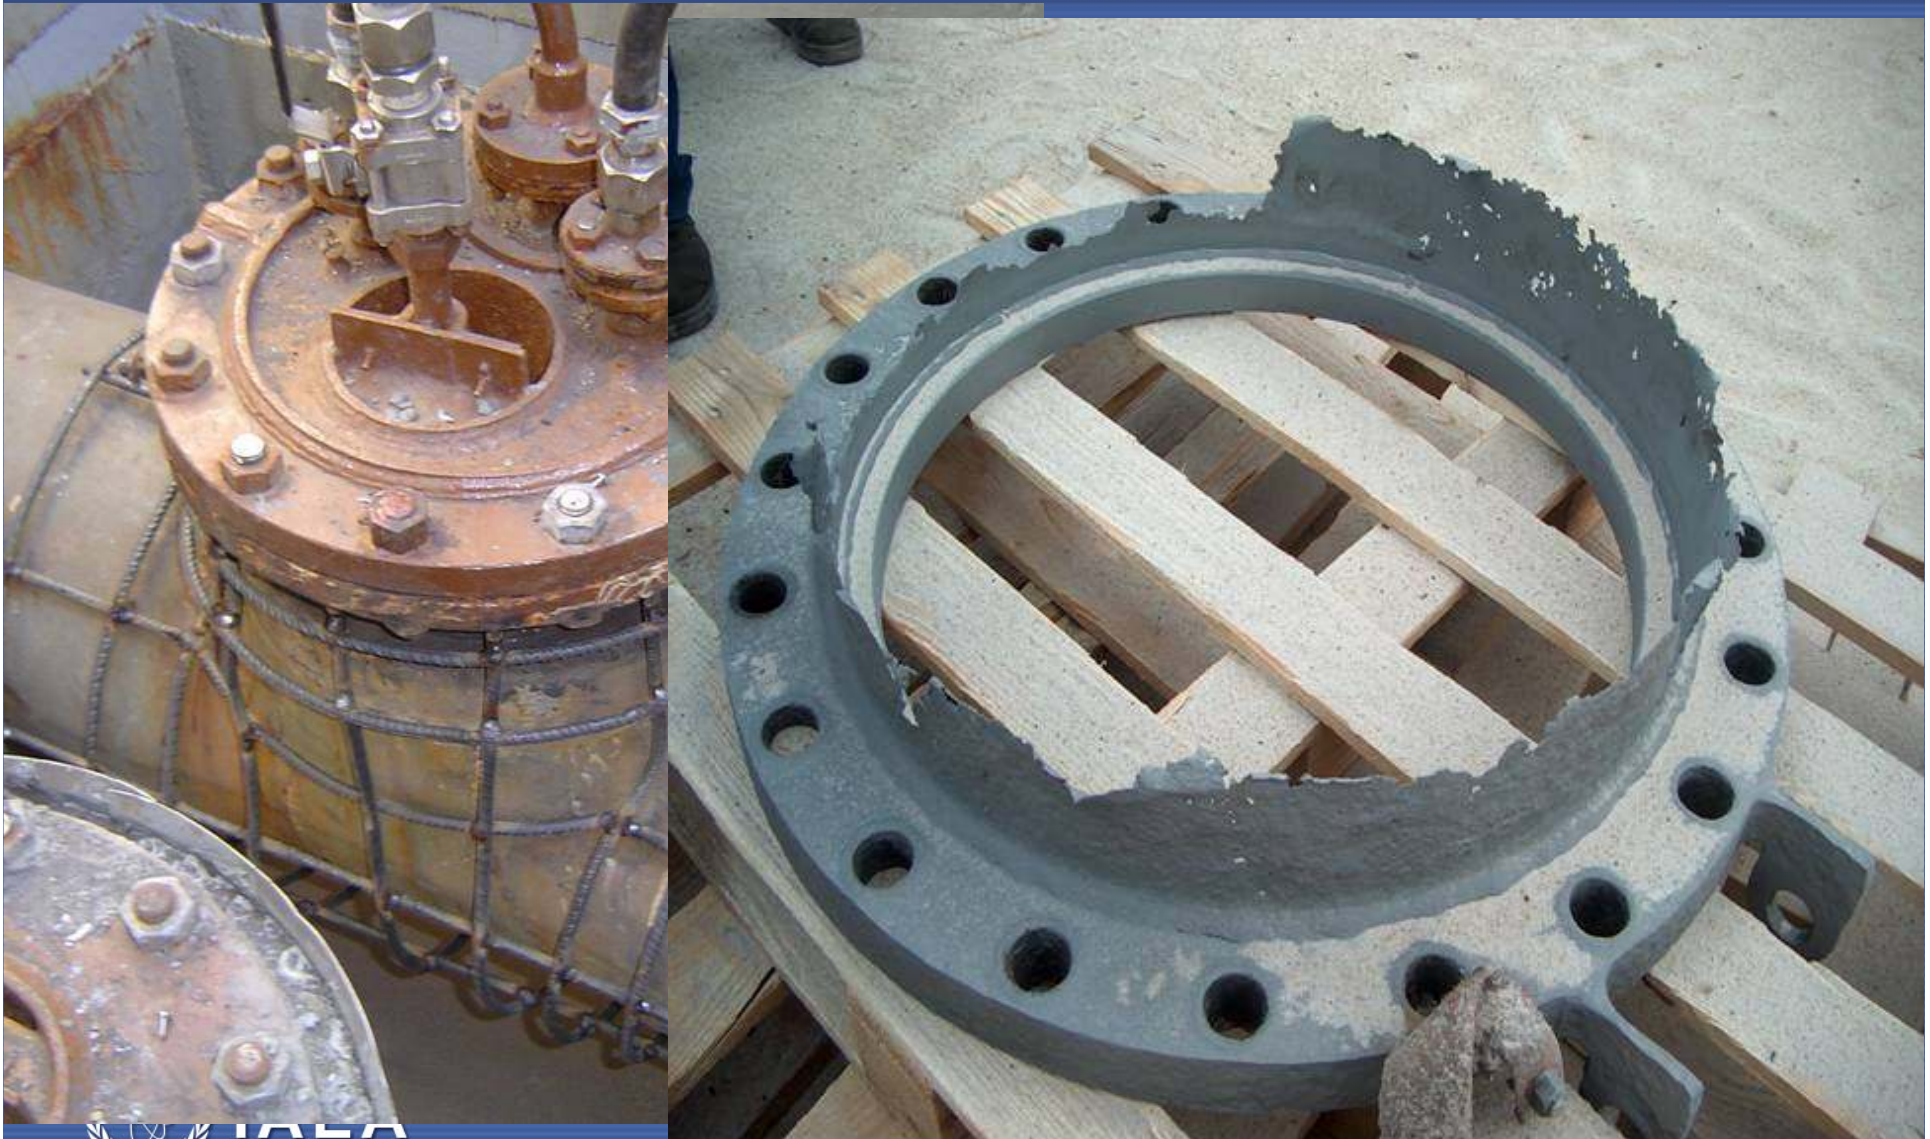
Vandellós II - Essential Service Water System Pipe Degradation - Spain

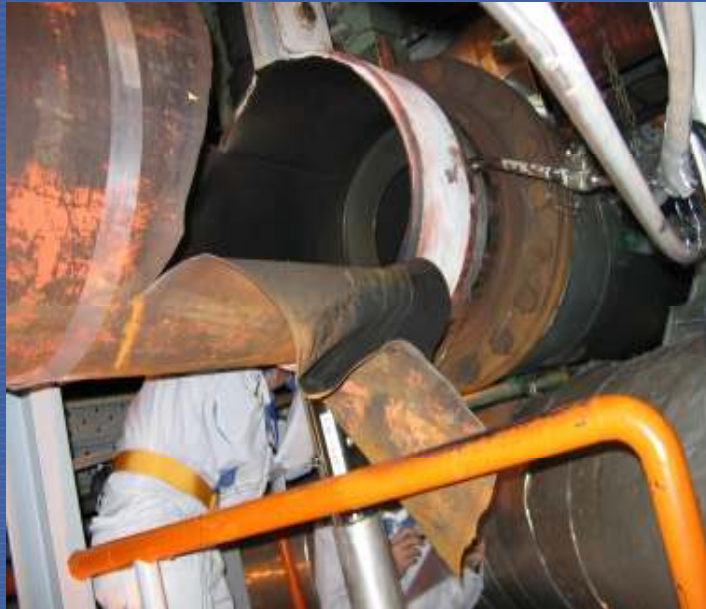
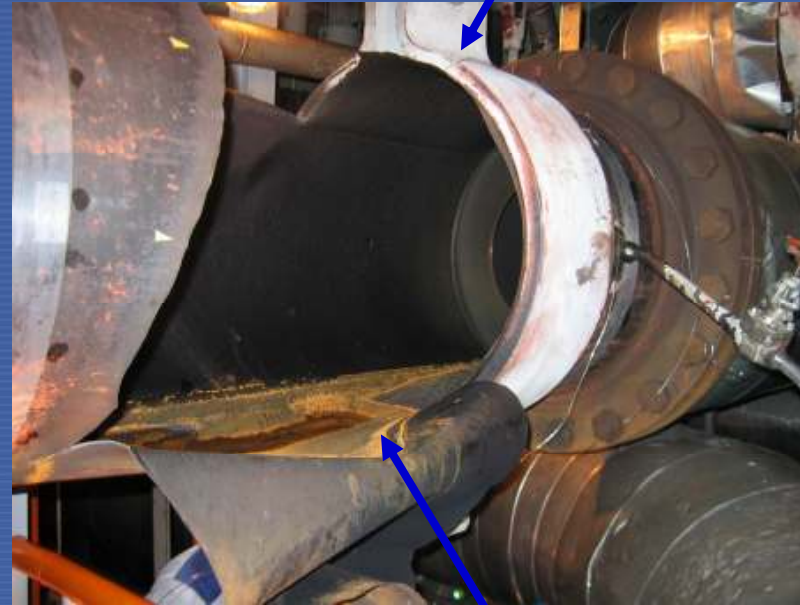
Pipe Rupture Accident at Mihama-3 NPP - Japan

Ruptured Opening

Spring hanger

Rust in stagnant water

- The pipe is of carbon steel and the rupture occurred downstream of the orifice where unsteady boundary layer flow occurs
- Water chemistry conditions(pH, dissolved oxygen, etc.) have been maintained within control values
- Normal operating temperature is 140°C that is favorable for erosion/corrosion
- Pipe inner surface shows considerable thinning with overall fish-scale like pattern, which is specific to erosion/corrosion
- At the corresponding portion of B-line, pipe inner surface shows the same aspects as A-line

- Pipe wall thickness had been reduced gradually by erosion/corrosion during long operating time.
- Thinning rate: 0.47×10^{-4} mm/hr)
- The pipe rupture occurred finally by operating loads because of insufficient pipe strength

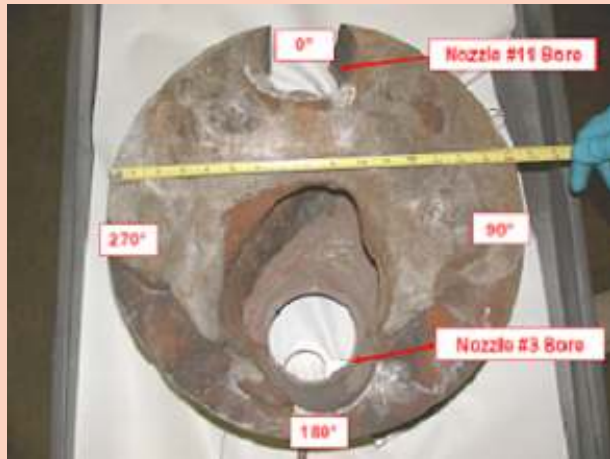
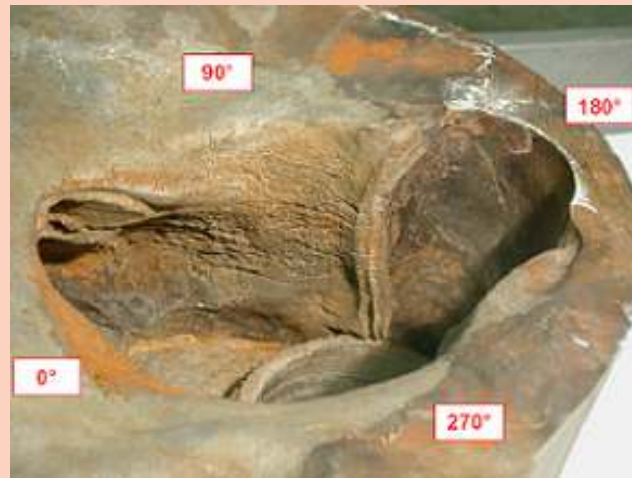
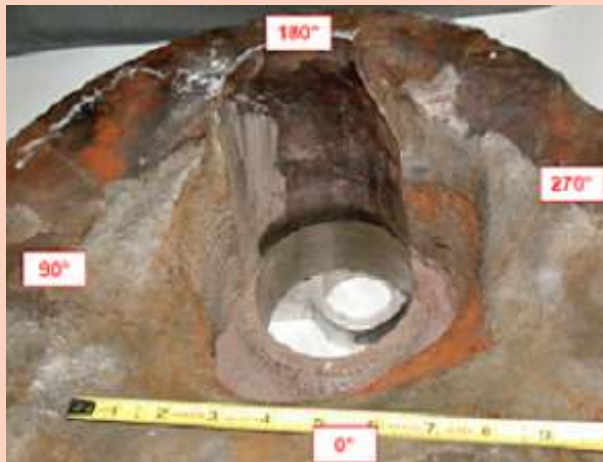
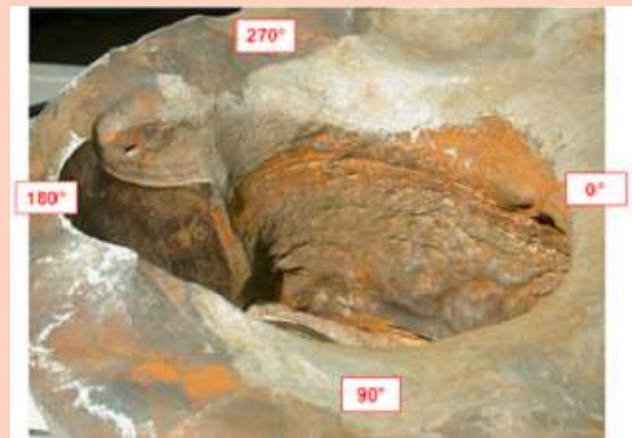
Davis Besse NPP – Reactor Vessel Head

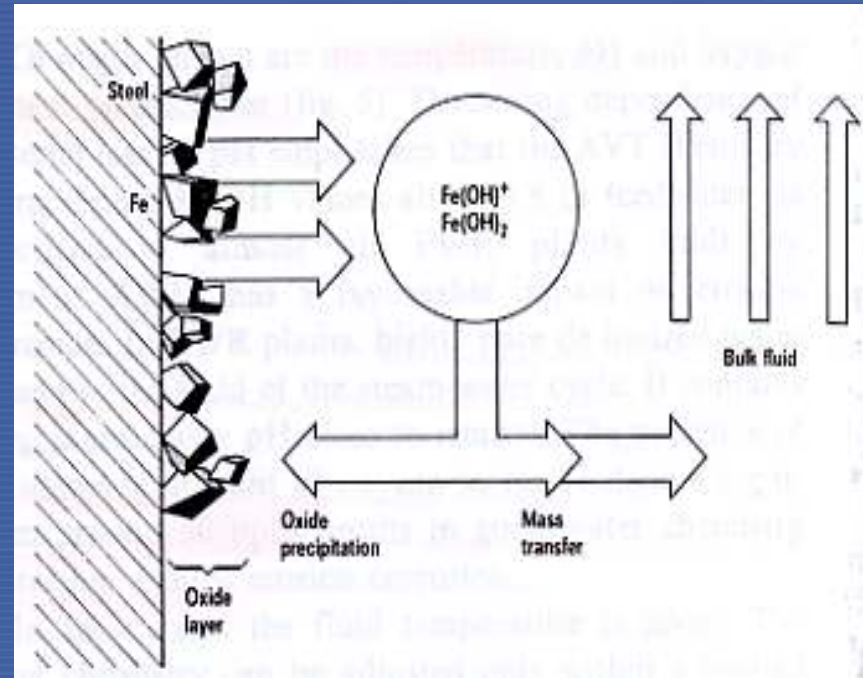
- Erosion-corrosion is a flow-induced degradation. This phenomenon can affect metallic materials which owe their corrosion resistance to the formation of oxide process of material films.
- Wearing away of the oxide films by turbulent water or wet steam flow is followed by dissolution corrosion of the unprotected metal.

Oxide precipitation process

Mass Transport process in flow

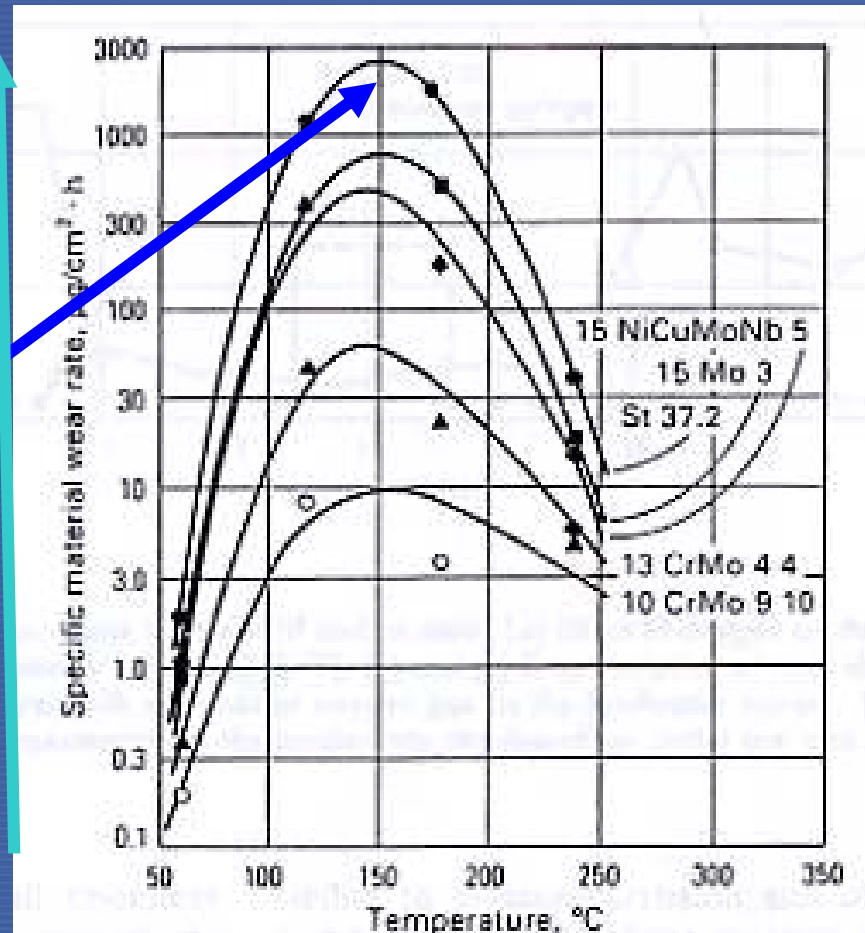
Temperature is a very important factor. There is peak point at around 150°C and temperature between 100°C and 250°C to be paid attention to.

Fig. 73 Temperature effect on material wear due to erosion-corrosion. P : 40 bar, v : 35 m/s, pH: 7, O_2 content: <40 ppb, period of exposure: 200 h. See Fig. 71 for material composition. Source: Ref 137

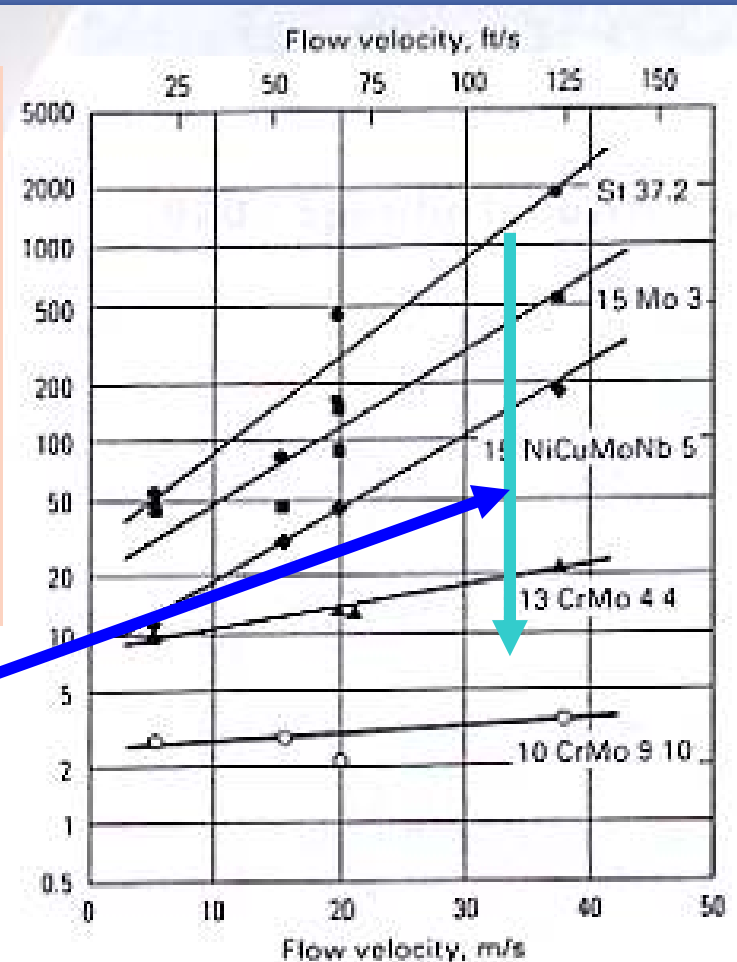
Flow velocity is also a very important factor. As Flow velocity increases, reduction rate in pipe wall thickness by FAC increases.

However as amount of Cr and Mo in pipe material increases, the rate decreases.

ig. 78 Effect of flow velocity on material wear due to single-phase erosion-corrosion. P : 1 bar (4000 kPa, or 580 psi), T : 180 °C (355 °F), pH: oxygen content: <5 ppb, period of exposure: 200 h. See Fig. 71 for material composition. Source: Ref 137

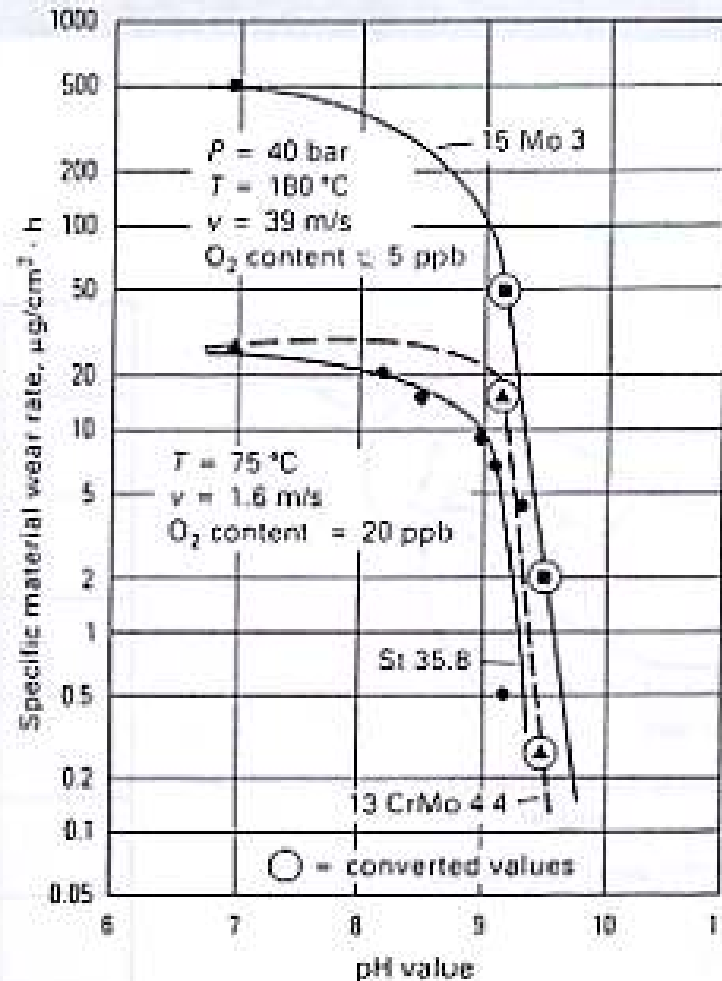
pH is also a very important factor. Reduction rate in pipe thickness by FAC decreases over pH 9.5.

This reduction rate is depending upon content of Cr and Mo in pipe materials.

Fig. 72 Effect of pH value on material wear due to erosion-corrosion. *P*, pressure; *T*, temperature; *v*, velocity. For material composition, see Fig. 71. Source: Ref 137

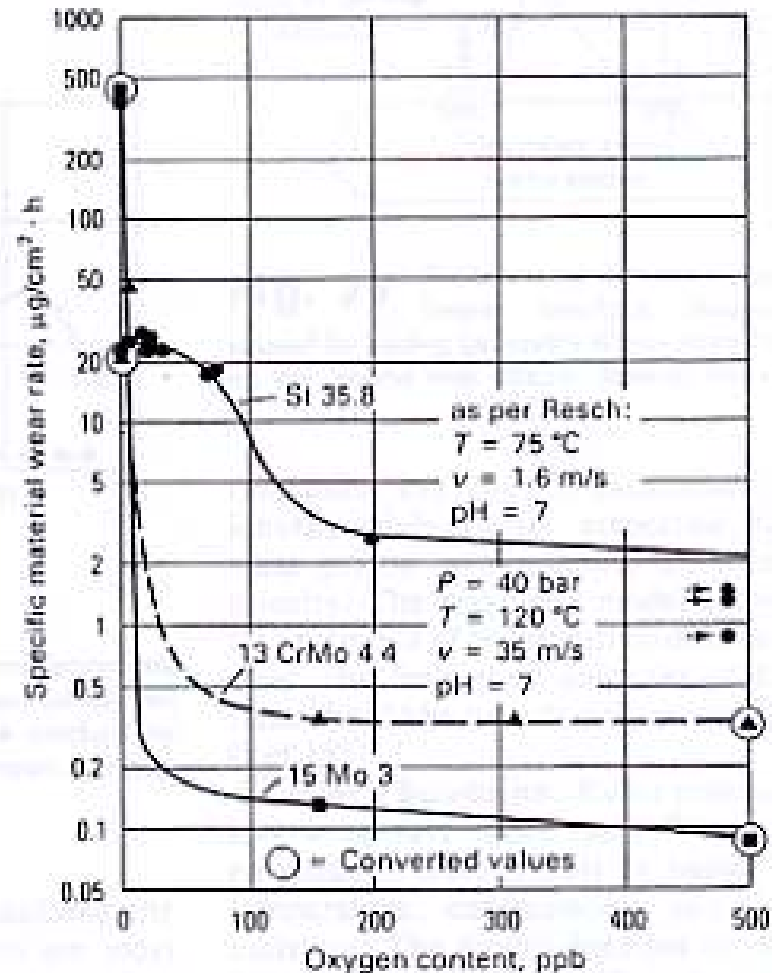
Reduction rate in pipe thickness by FAC increases below 200ppb and especially increases suddenly below 15ppb.

Fig. 74 Effect of oxygen content on material wear due to erosion-corrosion. See Fig. 71 for material composition. Source: Ref 137

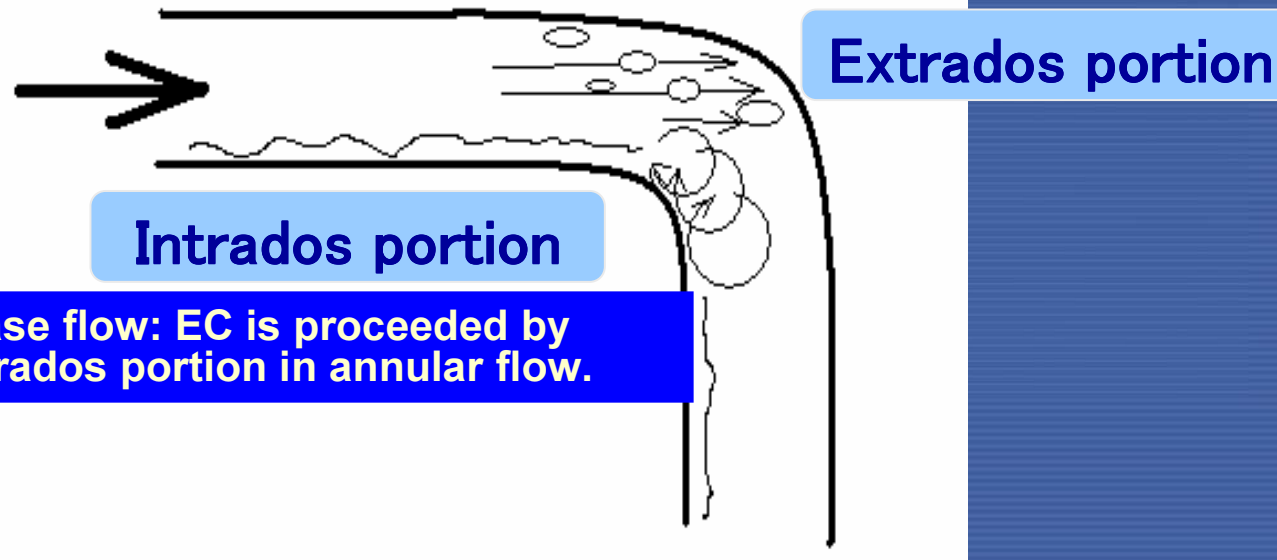
There are completely different corrosion process between single phase flow and two phase flow.

In case of two phase flow: Erosion is proceeded by collision of water masses to the corner of bent wall surface at extrados portion in vapor or mist flow.

In case of single phase flow: EC is proceeded by turbulent flow at intrados portion in annular flow.

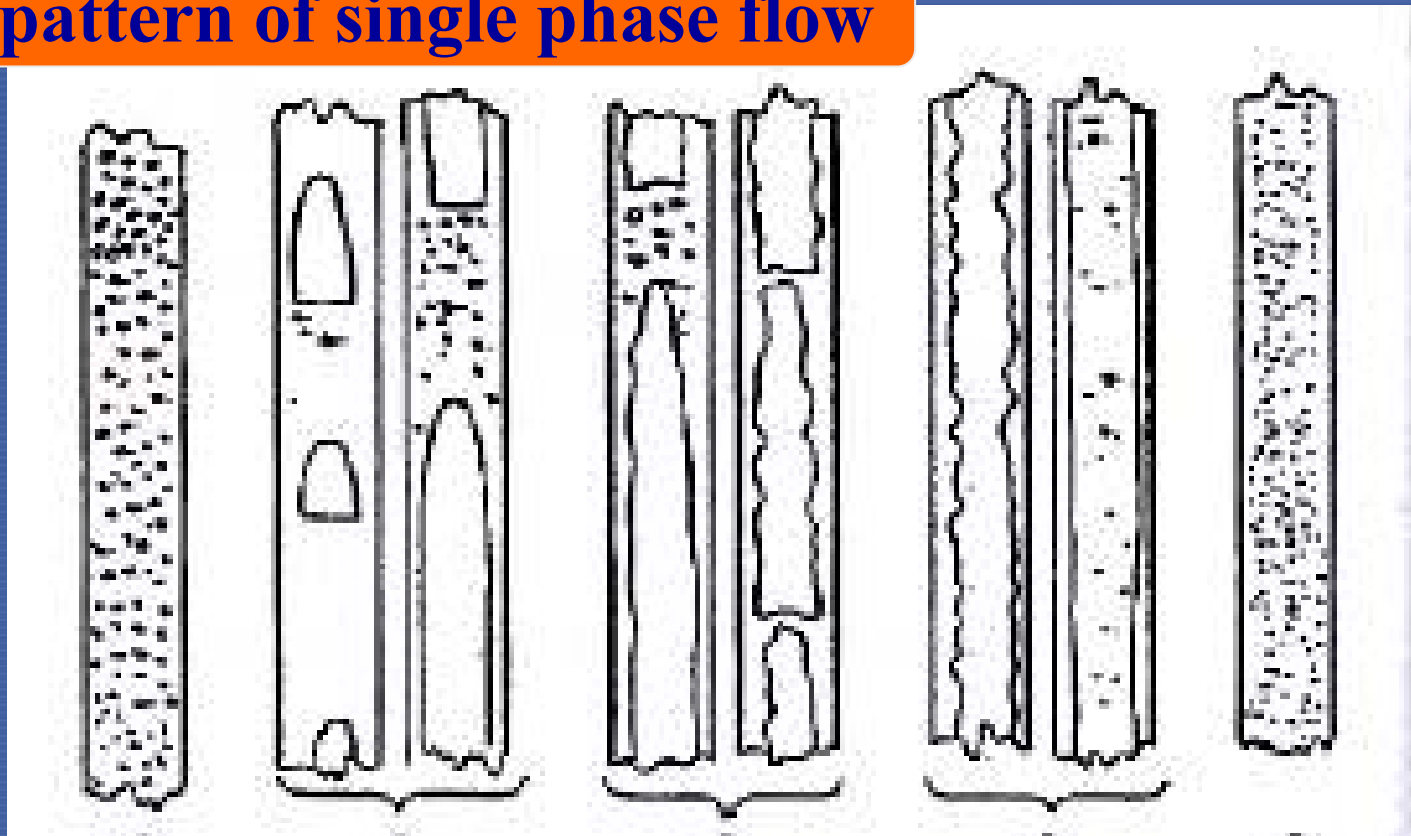
Flow pattern of single phase flow

water flow -> air bubble flow -> slug flow -> annular flow -> single phase - increase flow velocity → steam flow.

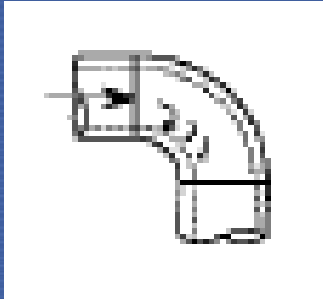
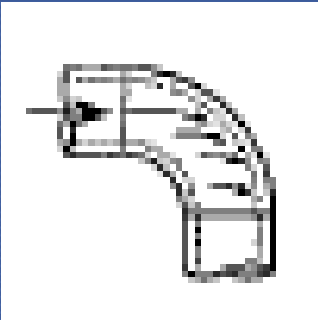
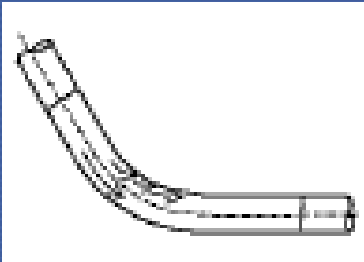
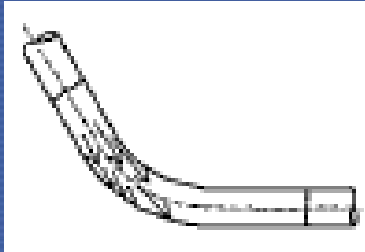
Corrosion feature on Elbow and Pipe Bend

Elbow		Pipe bend	
Flow	Single phase water flow	Water and steam two-phase flow	Single phase water flow	Water and steam two-phase flow
Sketch of flow state

Mechanism generating flow accelerated corrosion	Generated when an eddy occurs on the inside (anterior side) of the flow.	Generated when mist or water mass in wet steam impinges on the rear side of the pipe wall.	Thickness reduction advances when eddy is formed on the inside (anterior side) of flow.	Generated when mist or water mass in wet steam impinges on the rear side of the pipe wall.

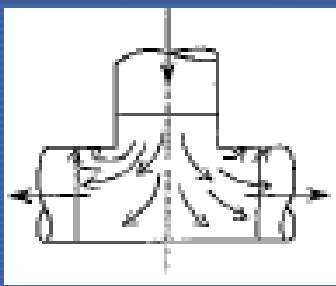
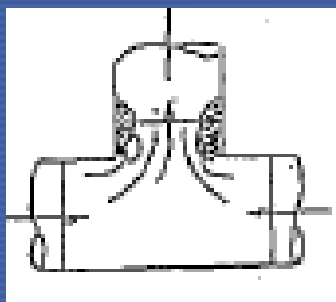
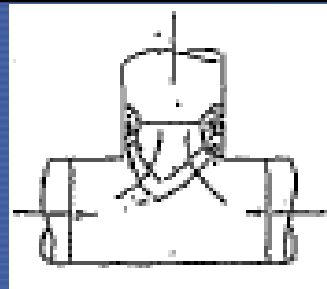
Corrosion Feature on T- Junction

T-joint (branch)		T-joint (merge)	
Flow	Single phase water flow	Water and steam two-phase flow	Single phase water flow	Water and steam two-phase flow
Sketch of flow state

Mechanism generating flow accelerated corrosion	Generated when an eddy occurs due to the flow.	Generated when mist or water mass in wet steam impinges on the surface of the pipe wall.	Generated when an eddy occurs internally due to the flow.	Generated when mist or water mass in wet steam impinges on the surface of the pipe wall.

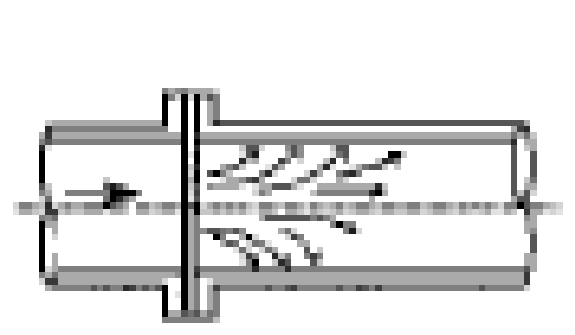
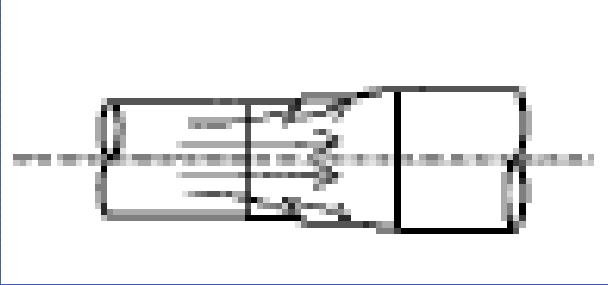
Corrosion feature on Orifice & Reducer

Downstream of orifice	Reducer
Flow	Single phase water flow	Water and steam two-phase flow
Sketch of flow state

Mechanism generating flow accelerated corrosion	Generated when an eddy occurs in downstream parts in the flow constricting elements.	Generated when mist or water mass in wet steam impinges on the surface of the pipe wall.

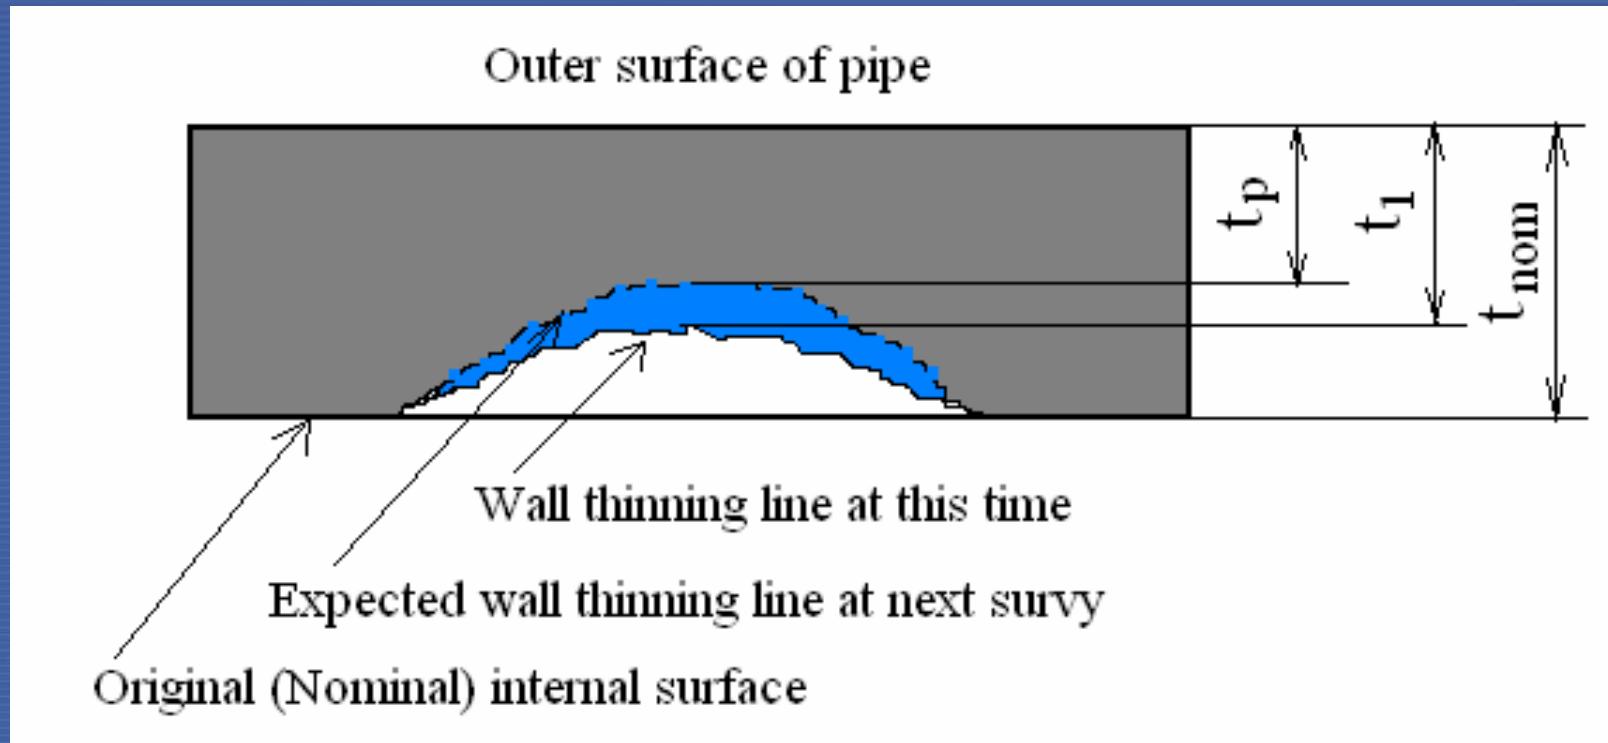
How to decide repairing work for wall thinned pipe

$t_p > 0.9t_{min}$: Pipes may be used.

$t_p < 0.9t_{min}$: Pipes to be repaired or replaced,

T_{min} : Required minimum thickness excluded by corrosion allowance

C : Corrosion allowance (mm)
