STATE SCIENTIFIC CENTER  
SPA «TsNIITMASH» Co.

**Methodical aspects of studies of a multifactor E/C process with assessment of the external factors influencing on the corrosion phase of the process and the uncertainties related to the nature and degree of damage while performing diagnostics by ultrasonic methods**

**A. V. Doub, I.L.Kharina, A.Ye.Korneyev, N.P.Razygraev, A.N. Razygraev**

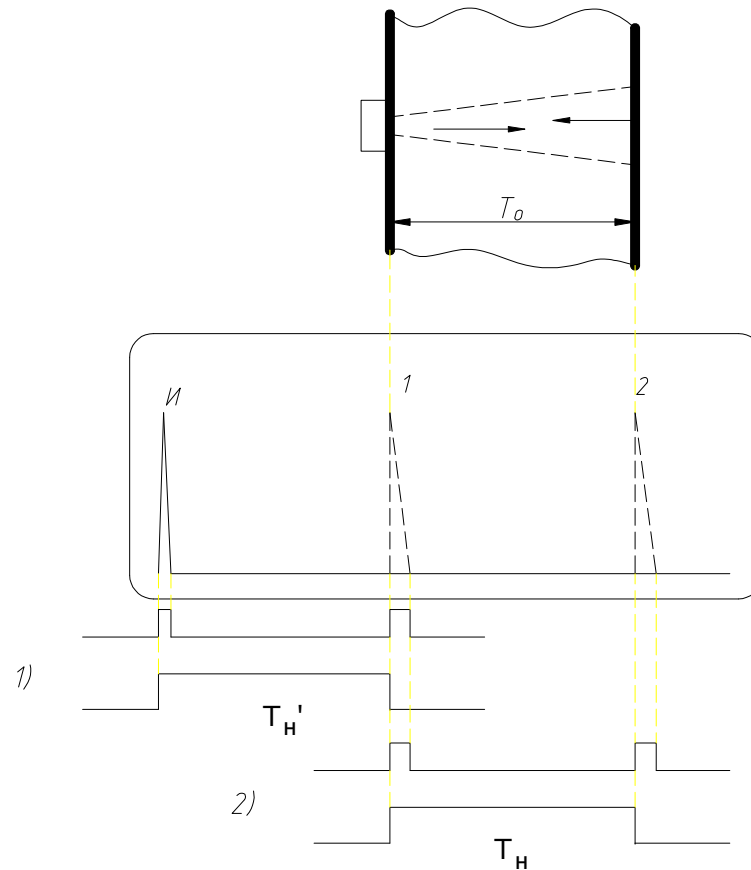
## 1. Thickness inspection of metal without EC deposits

Here: Ultrasound reflection from free surface in homogenous metal with known density and ultrasonic speed.

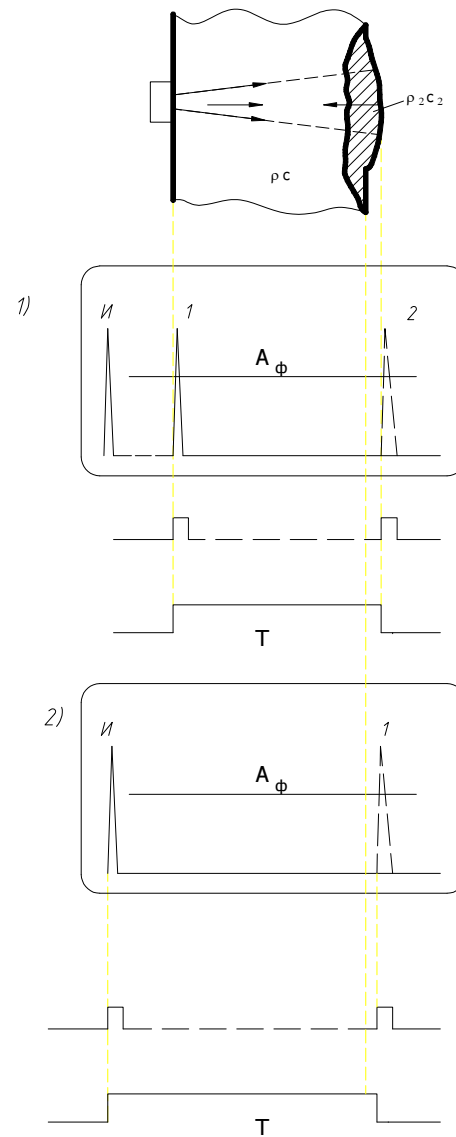
## 2. Thickness inspection of metal with EC deposits

**Here: Ultrasound reflection from a surface with unknown acoustic parameters:  
substance density and ultrasonic speed inside it.**

Ultrasound speed in EC deposits = ? (unknown)

**We cannot establish the thickness of residual metal in damaged area with EC deposits!!!**

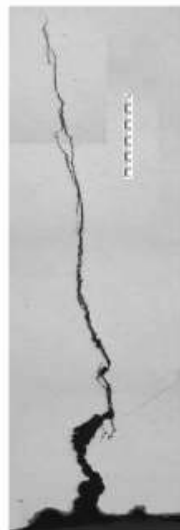
Discontinuities similar cracking from hot  
(Bal NPP) and cold (KlnNPP) headers

Balakovo NPP

Kalinin NPP

ЗДКР  
SSSCC

Pitting corrosion

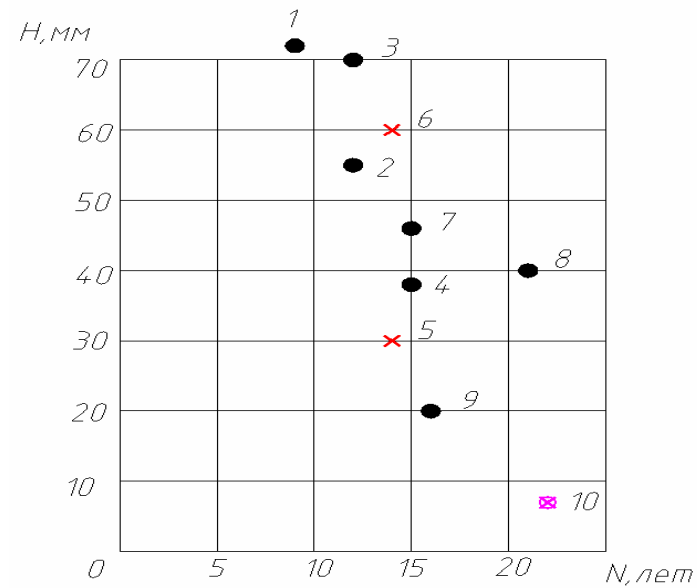
## Relation between the damage size and SG operation period

**H,mm – cracking size at the moment of detection**

**N,years – term of SG operation from the beginning to the moment of cracking detection**

- -longitudinal and longitudinal-transverse cracks
- × -transverse cracking
- ⊗ -pitting corrosion

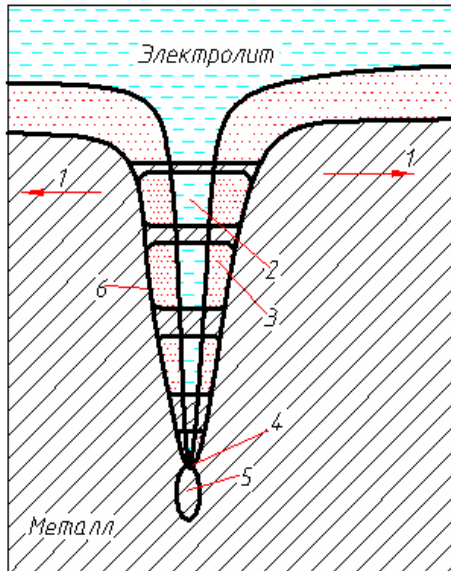
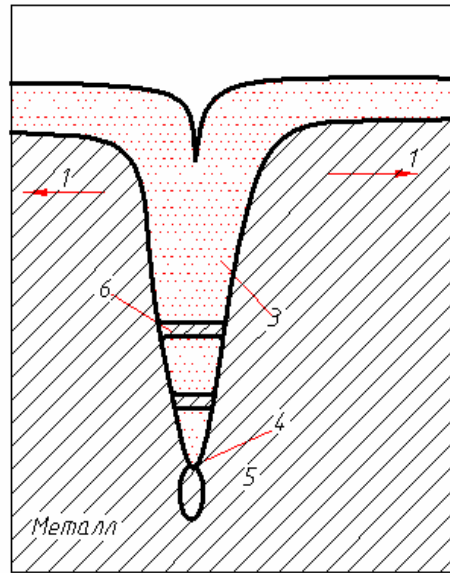
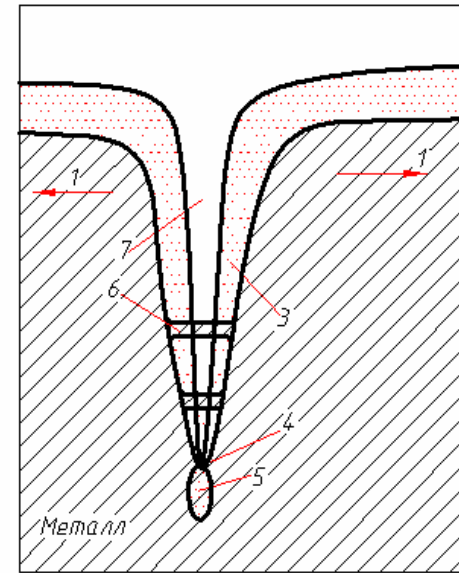
## Possible state of damage in header-steamgenerator connecting joint

- 1 – direction of tension stress;
- 2 – metal damage filled with electrolyte;
- 3 – protection film;
- 4 – active metal at the top of cracking;
- 5 – sector of maximum stress concentration;
- 6 – metal bridge remained between damage sides

1. It is assumed that corrosion deposits interaction mechanism in pipelines subjected to EC and damages of slow strain-rate stress corrosion cracking (SSSCC) interact with ultrasonic waves in the same way.
