Steam Generator Ageing Management in Canada - current practices and related issues

J. Riznic

Operational Engineering Assessment Division
IAEA Consultancy Meeting on Ageing Management of Steam
Generators, IAEA, June 15-18, 2009, Vienna

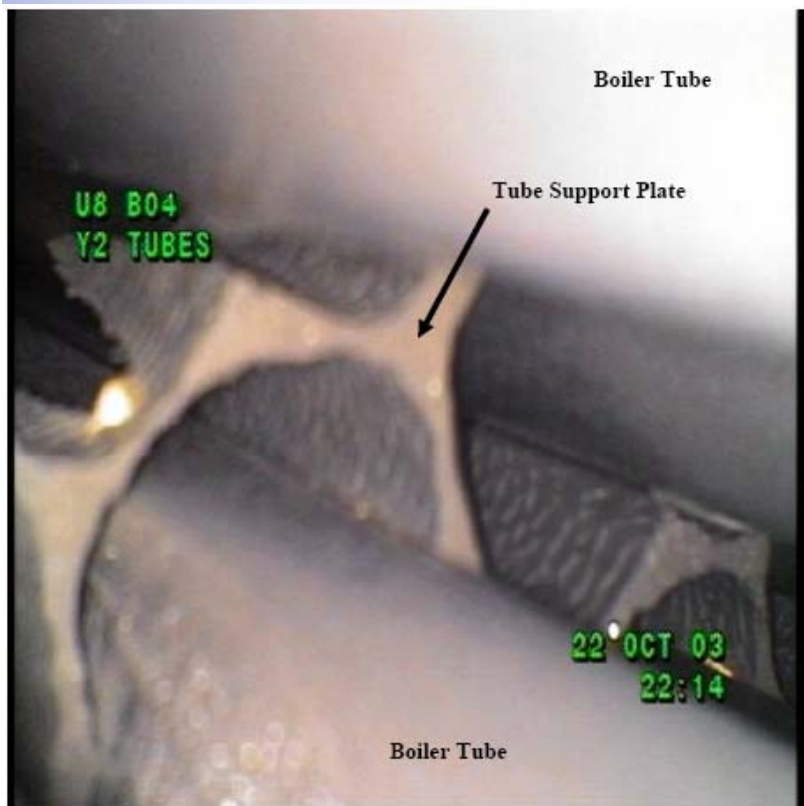
FAC of Support Plates

- FAC observed in carbon steel supports

- May contribute to tube fretting
- Concerns regarding additional loading applied to tubes and pinching if support plates bend

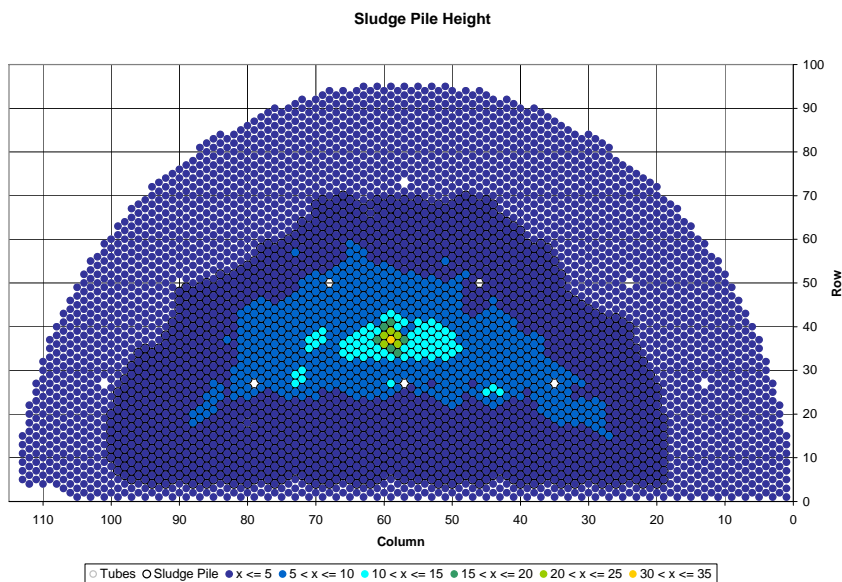
Sludge Pile

- Pitting and ODSCC have been attributed to the top of tubesheet sludge pile region
- Sludge piles can be extensive

- Mitigation strategies include
 - Waterlancing (hard sludge may be difficult to remove)
 - Monitoring sludge pile growth and expansion of area-at-risk as required
 - 100% HL and partial CL TTS inspection during outages as required

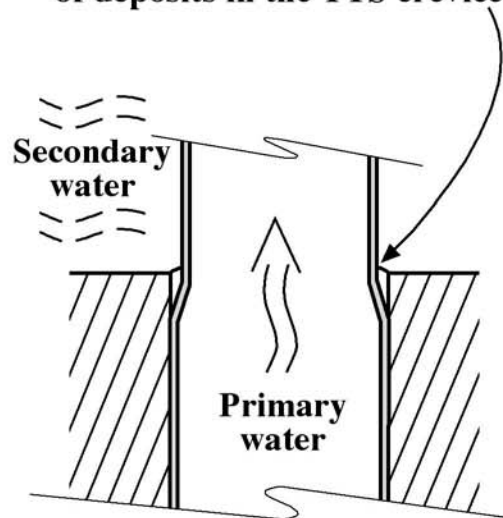
Top of Tubesheet (TTS)

Concentration of chemicals increases with accumulation of deposits in the TTS crevice

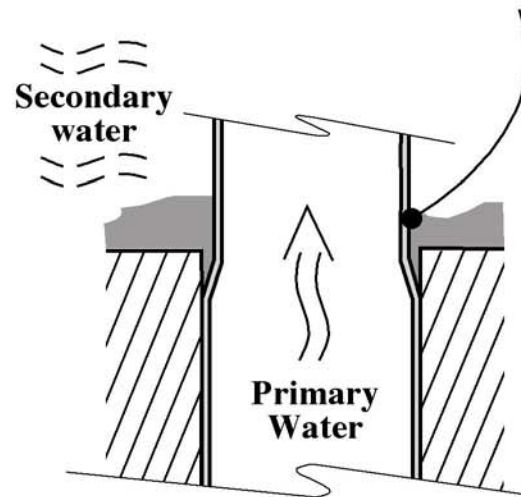
Sludge

Concentration of chemicals at sludge/metal interface increases with accumulation of sludge on TTS surface

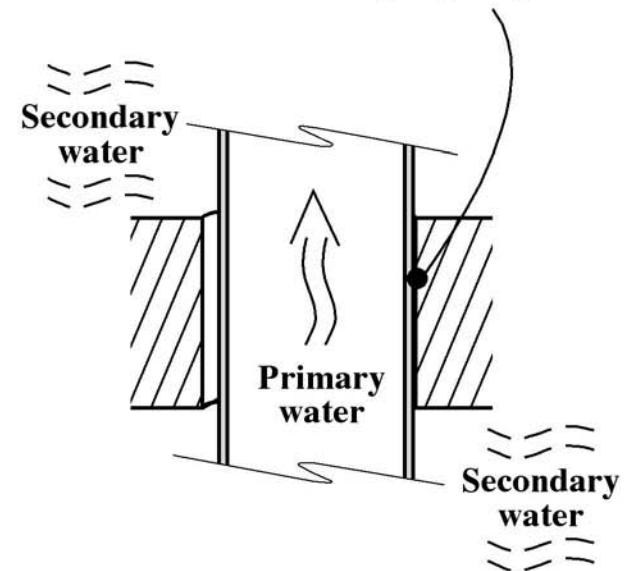
Tube Support (TSP)

Initial concentration of chemicals on contacting side. Concentration of chemicals increases as deposits accumulate around periphery.

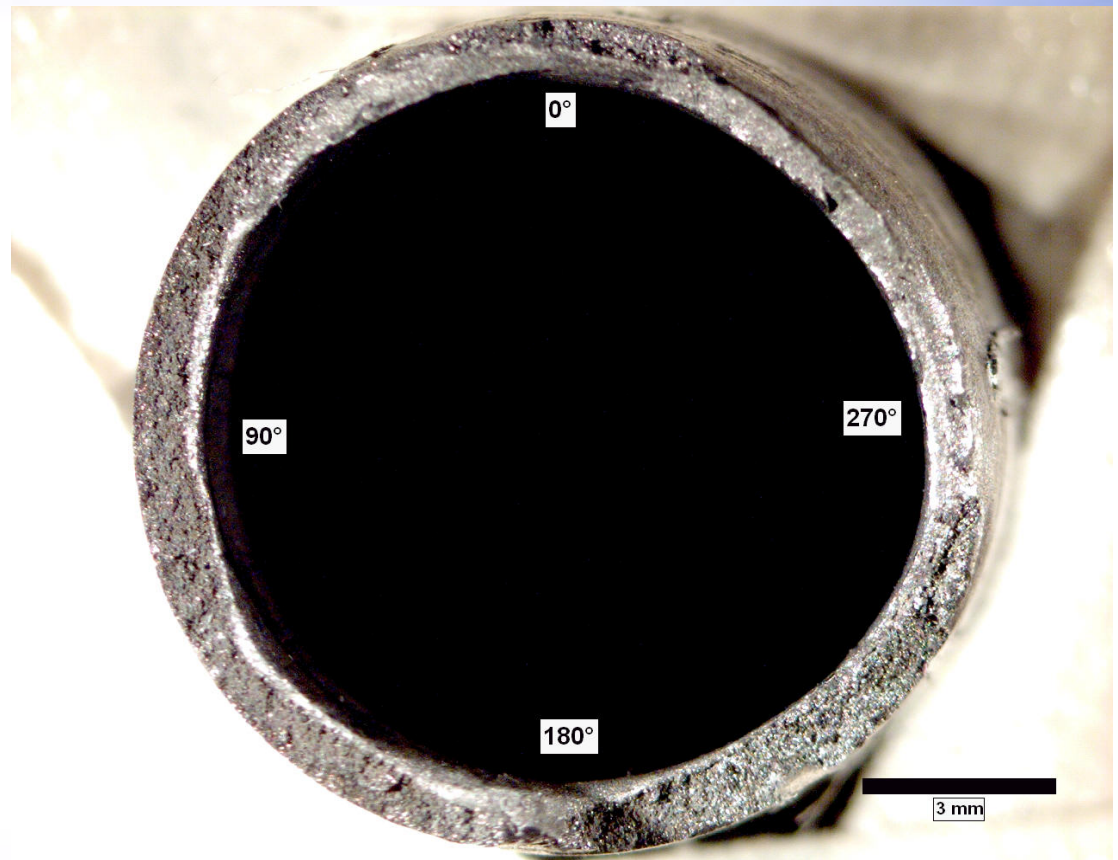
TTS SCC / IGA (I-600)

- Rough surfaces in-service degradation
- Smooth surfaces remaining ligament of tube wall

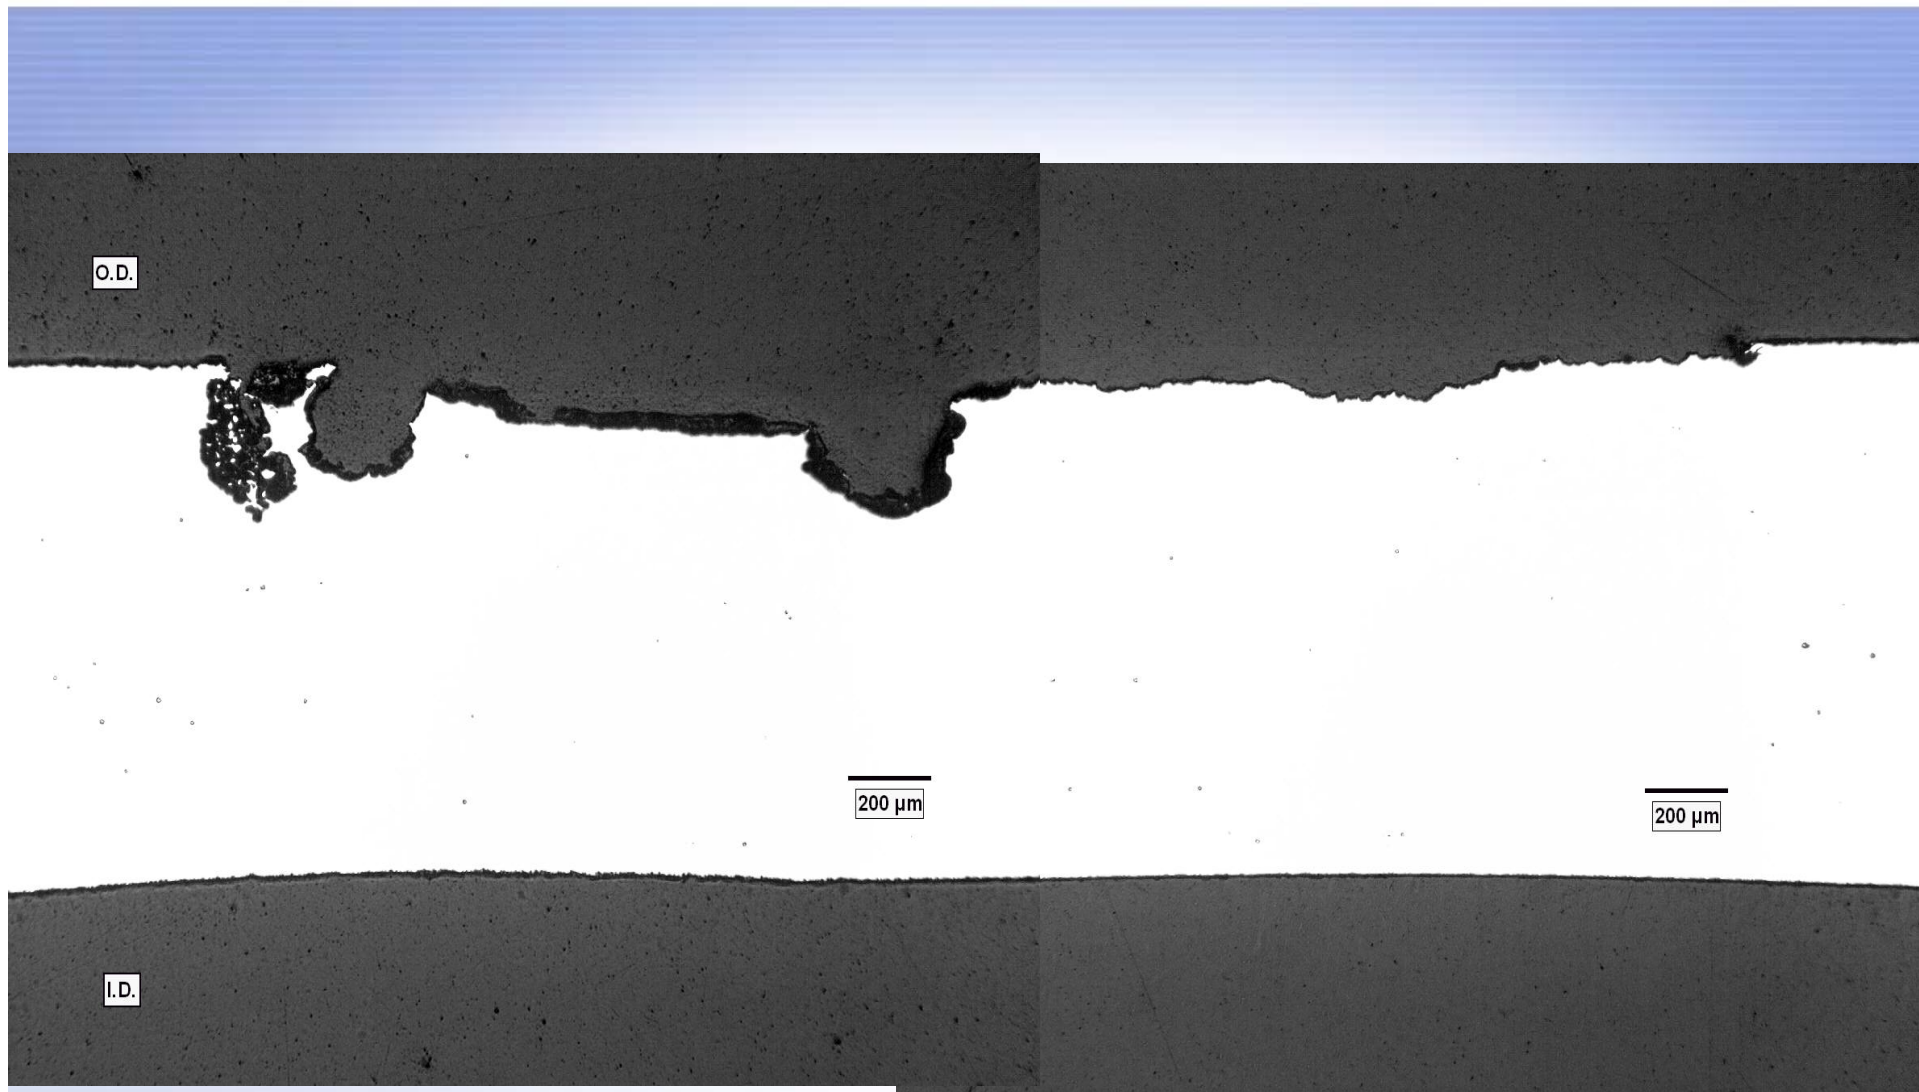
Pitting (I-600)

- Following lay-up of some SGs with I-600 tubes, pitting was detected at the HL TTS between the top of the upper expansion and top of sludge pile
- Appears to be primarily associated with chemistry during lay-up
- Limited number of new pits and limited growth detected during in-service inspection following return to service

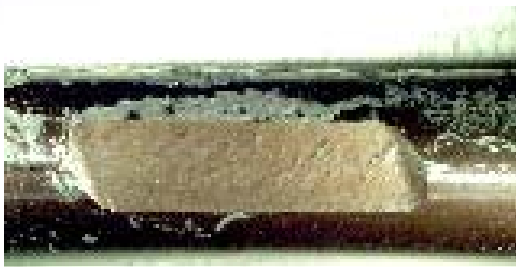
Fretting (I-800)

- High fret growth rates associated with U-bend region flat bar and fan bar supports have been observed in some SGs

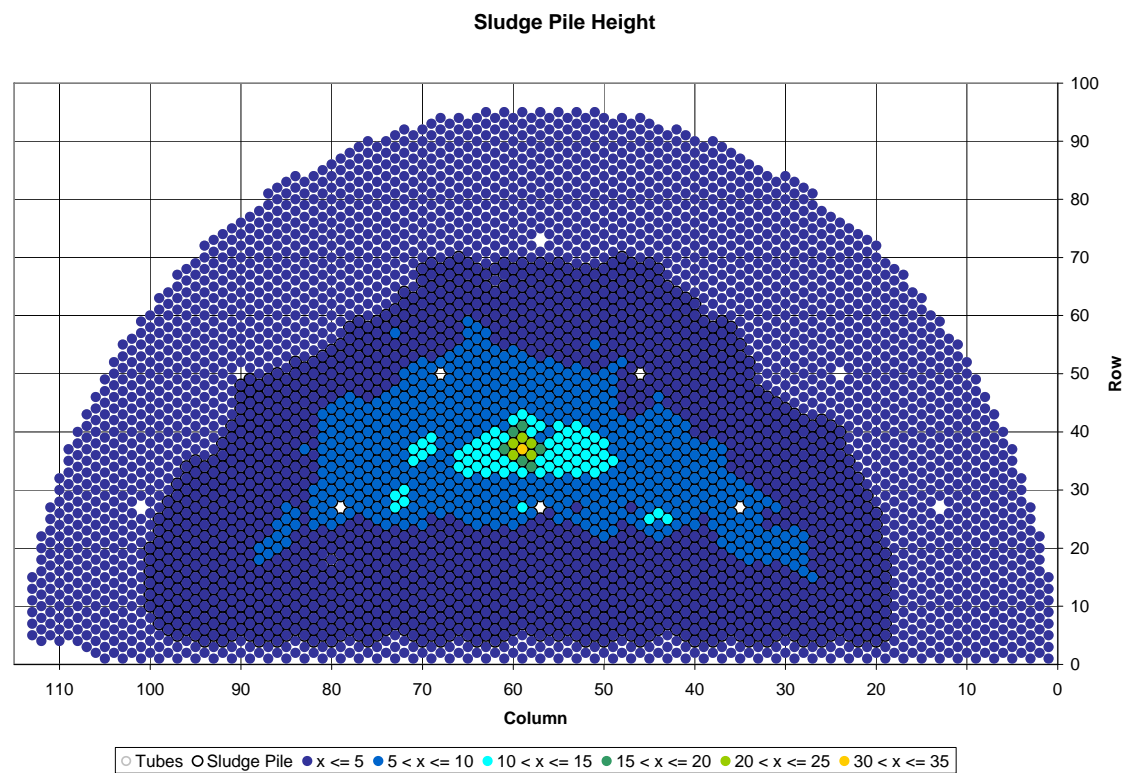
Area-At-Risk (AAR)

- Example: AAR defined as HL sludge pile region for TTS degradation
