Accident nuclear submarines Problems of dismantlement and provision of safe isolation

V.A. Mazokin, N.A. Dollezhal NIKIET, Moscow, Russia

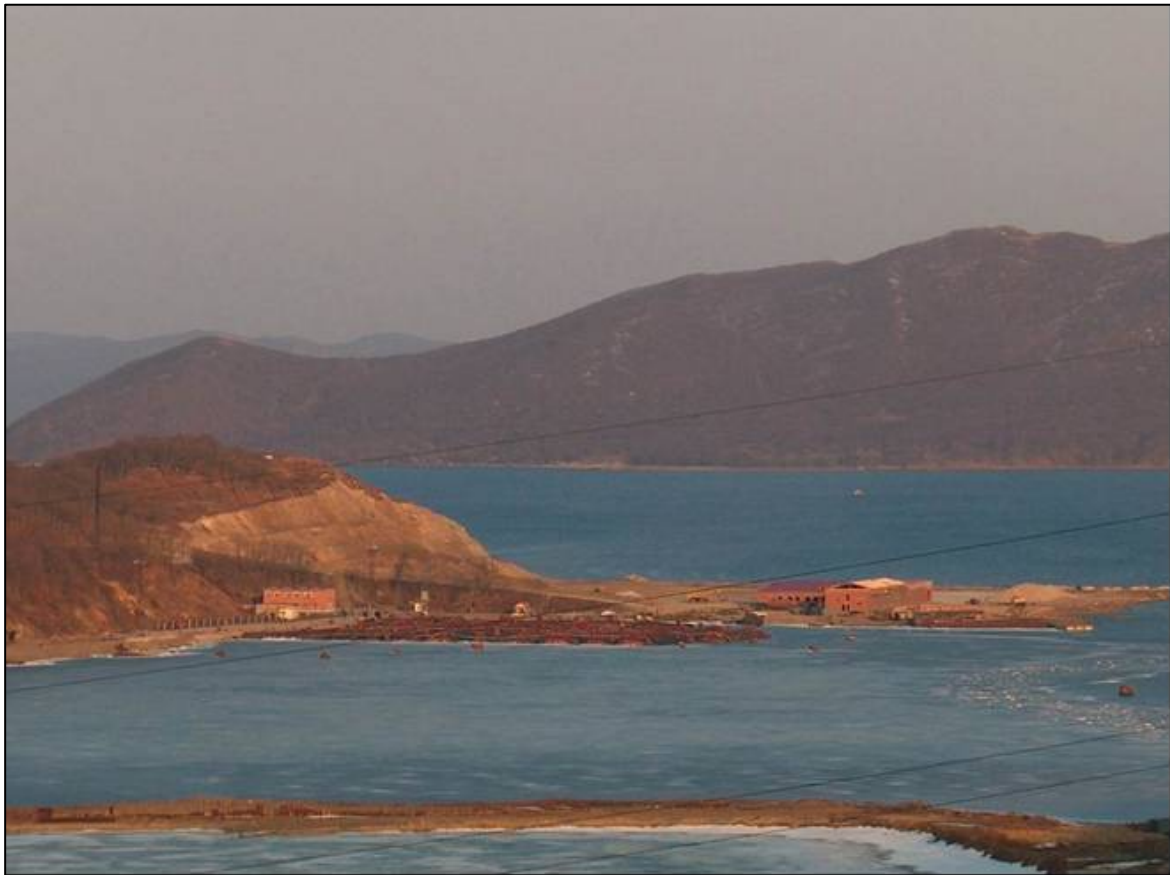
Fig. 1. Layout of the coastal facility for damaged nuclear submarines

- 1 – storage of three-compartment reactor blocks afloat;
- 2 – Ustrichny long-term storage point;
- 3 – shelter for the damaged nuclear submarines, factory Nos. 175 and 610;
- 4 – FSUE «30 SRZ VMF».

An area near the long-term storage point for the reactor compartments of utilized nuclear submarines under construction on the Ustrichny Cape in the Razboynika Bay (see Fig. 1) was selected for deployment of the site (nuclear submarine storage site) as the result of the surveying work undertaken by FSUE «VNIPIPromtekhologii».

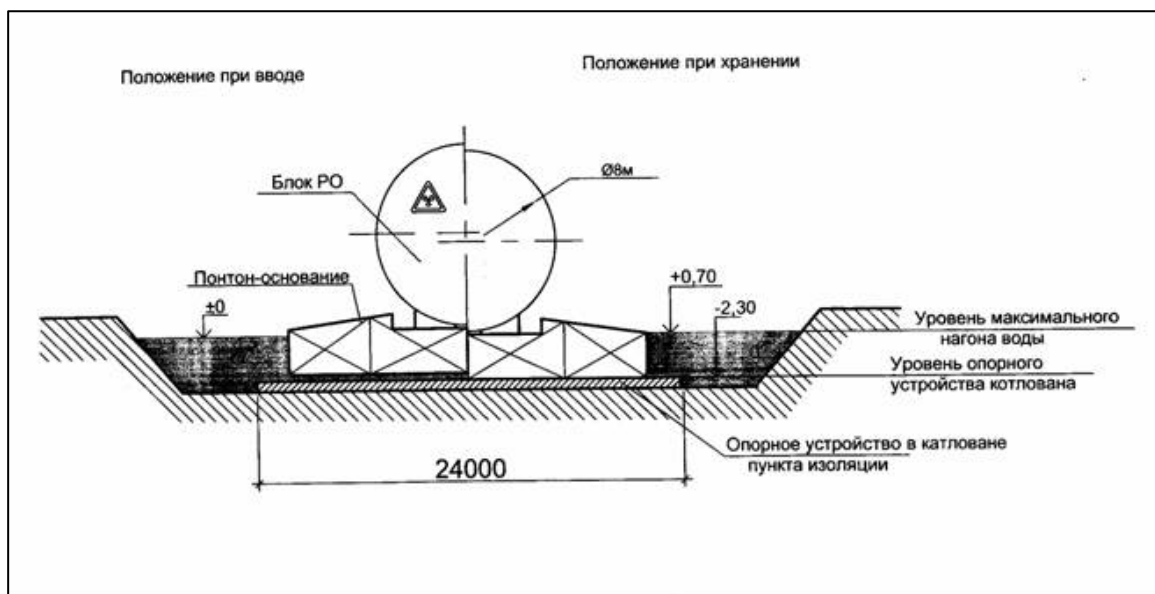
Fig. 2. Pontoon foundation with the reactor unit

A diagram showing the reactor block installed onto the pontoon foundation is presented in Fig. 2.

The option using a pontoon foundation was selected by proposal of FSUE «TsKBMT «Rubin». Its implementation requires to:

- create the pontoon foundation to fit the nuclear submarine parameters;
- transfer the nuclear submarine to the floating dock and install it onto the pontoon foundation;
- cut the nuclear submarines to form a three-compartment block on the pontoon foundation and prepare the block for long-term storage;
- float off the pontoon foundation with the reactor block after it is prepared and tow it to the coastal shelter's water area;
- excavate pit with a depth of about 25 m on the coastal site and build the shelter in it;
- build the channel to connect the water area with the reactor block storage (isolation) site;
- move the pontoon foundation through the channel and immobilize it in the shelter;
- close (backfill) the transfer channel.

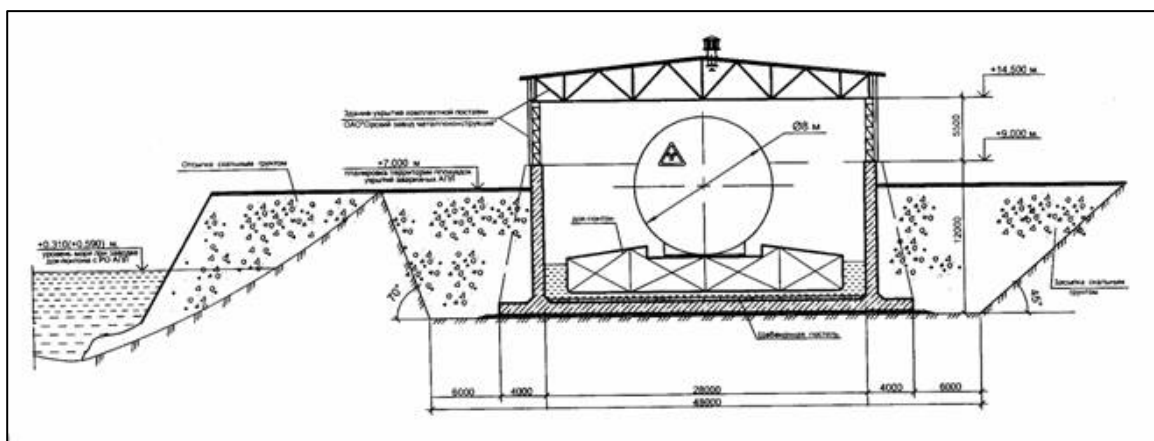
Fig. 3. Coastal shelter for the damaged nuclear submarines

The proposed design outline of the coastal shelter for the damaged nuclear submarines is presented in Figures 3,4 and 5.

The shelter is a structure embedded in 3 meters (with respect to the sea level) with reinforced-concrete walls (with a height of 3 m from the elevation of - 3 m) and a bottom onto which the pontoon foundation with the damaged reactor block is installed. A metal structure is installed atop of the walls to form a closed space together with the walls. The free space between the reinforced-concrete walls and the pit walls and the coastal slope are filled with rock up to the elevation of +7 m to form a horizontal platform. The structure's end wall facing the channel is mounted after the pontoon foundation is brought into the shelter. After the pontoon foundation is brought into the shelter by water, it is installed within the structure based on the preset coordinates and submerged till it is placed onto the stone bed with the pontoon foundation in-

ternal structures filled with floated concrete through the holes made in-situ after the pontoon foundation is submerged. After the pontoon foundation is placed onto the hard surface, the transfer channel is dammed at the structure's open end, then the structure's end wall is mounted and the free space is filled with rock.
