## **Leakage of Water Treated by the Multi-Nuclide Removal Facility (ALPS) at Fukushima Daiichi NPS – Confirm No Leakage to Ocean**

Photos of the leakage

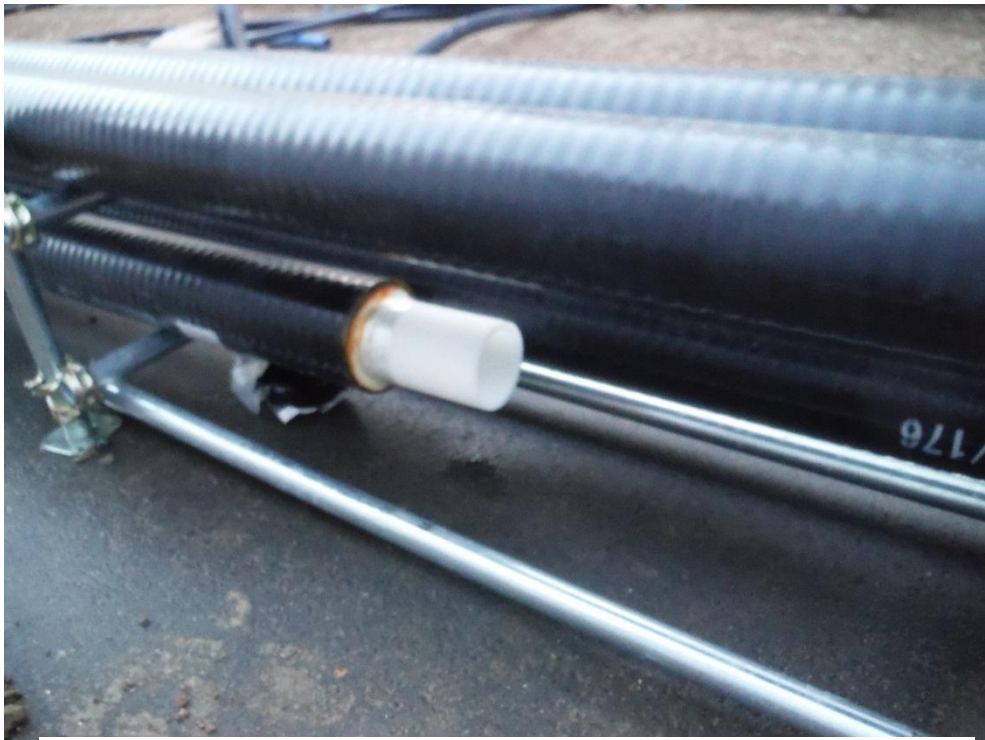
The report delineates the event in which water treated by the Multi-Nuclide Removal Facility (ALPS)\* leaked from an open end of a branch pipe branching off the main pipe.

- While having an open end, the valve on the branch pipe was open. Closing the valve on the branch pipe stopped the leakage. The estimated volume of the leaked treated water is approximately 6 tons, based on the flow rate and time.

Open end of the branch pipe which caused the leakage

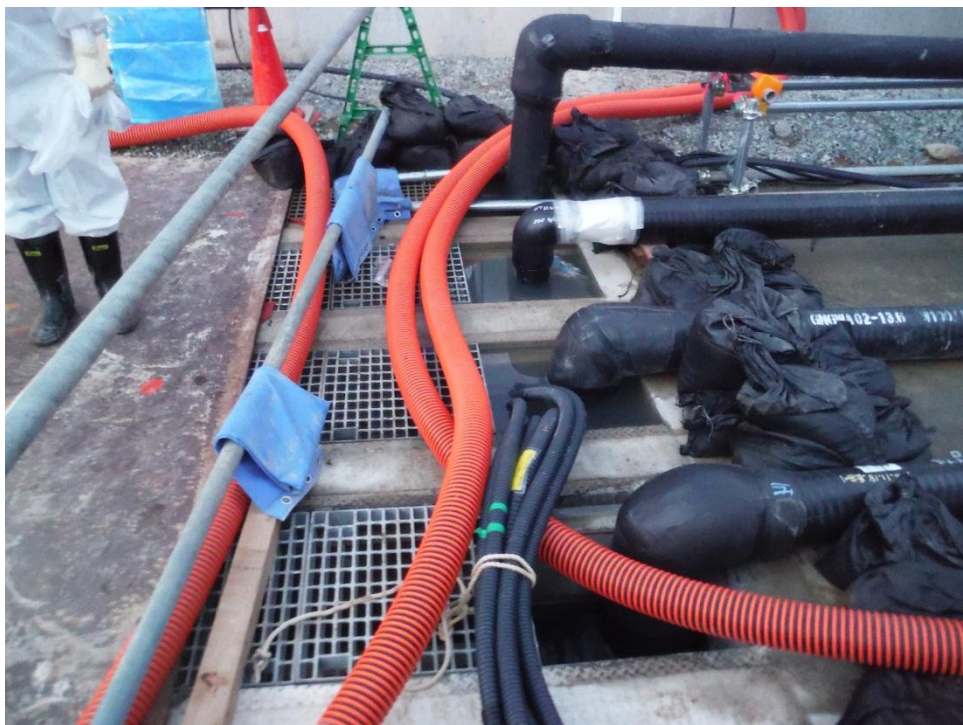
- The leaked treated water was also found accumulating in the closed pipe trench at a lower elevation from the point of leakage.

Accumulated water in the pipe trench

- Approximately 9 m<sup>3</sup> of water – rainwater included – was removed from the pipe trench by 7:35 pm on 17 December. Approximately 20m x 0.5m of soil soaked with water was removed by 5:30 pm the same day.
