# Events and highlights on the progress related to recovery operations at Fukushima Daiichi Nuclear Power Station

July 2019

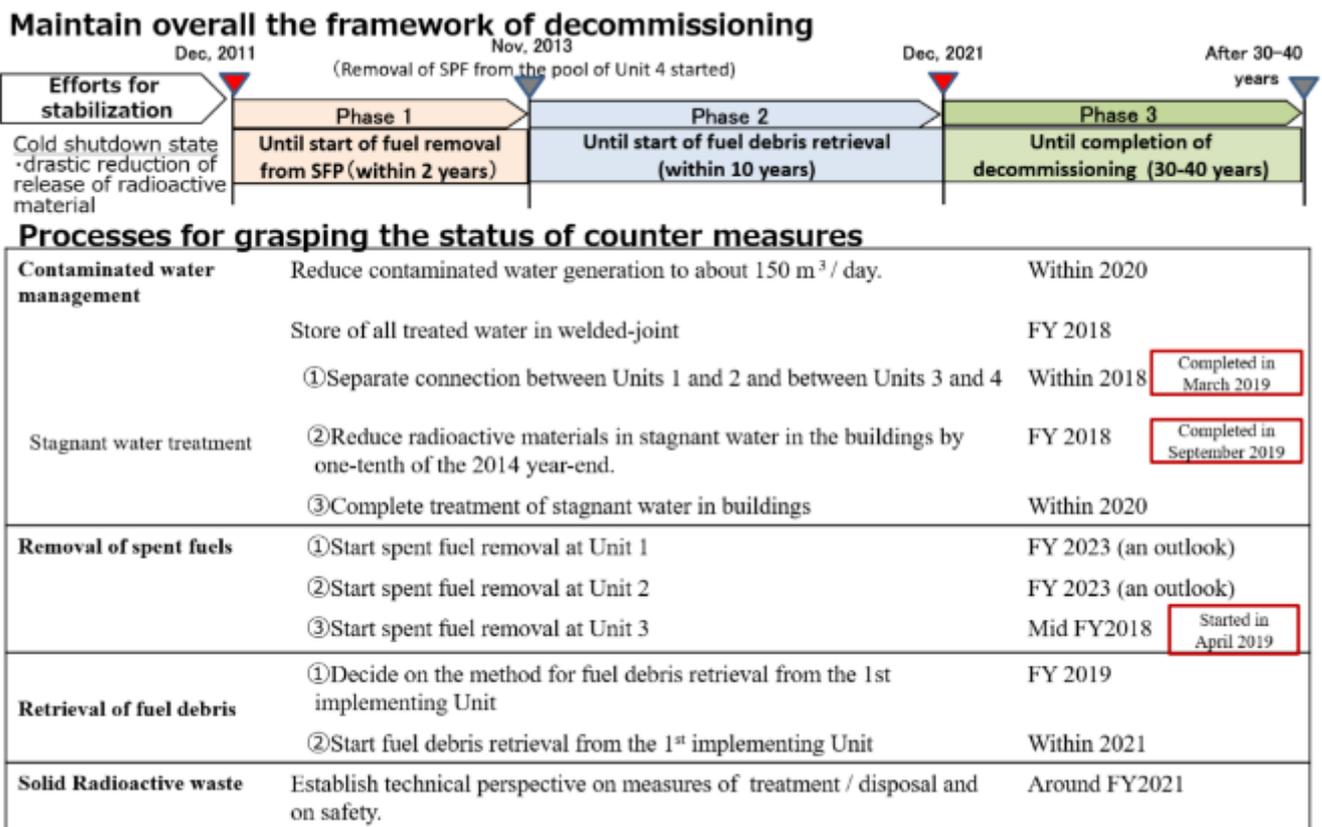
Figure. Milestones described in the “Mid-and-Long Term Roadmap”

Decommissioning work at Fukushima Daiichi NPS has been conducted by following the milestones described in the “Mid-and-Long Term Roadmap” with prioritising the safety.

The whole process of the decommissioning takes 30 to 40 years, and volume of tasks are gigantic. Therefore, the Government of Japan and TEPCO prioritized each tasks and set the goal to achieve.

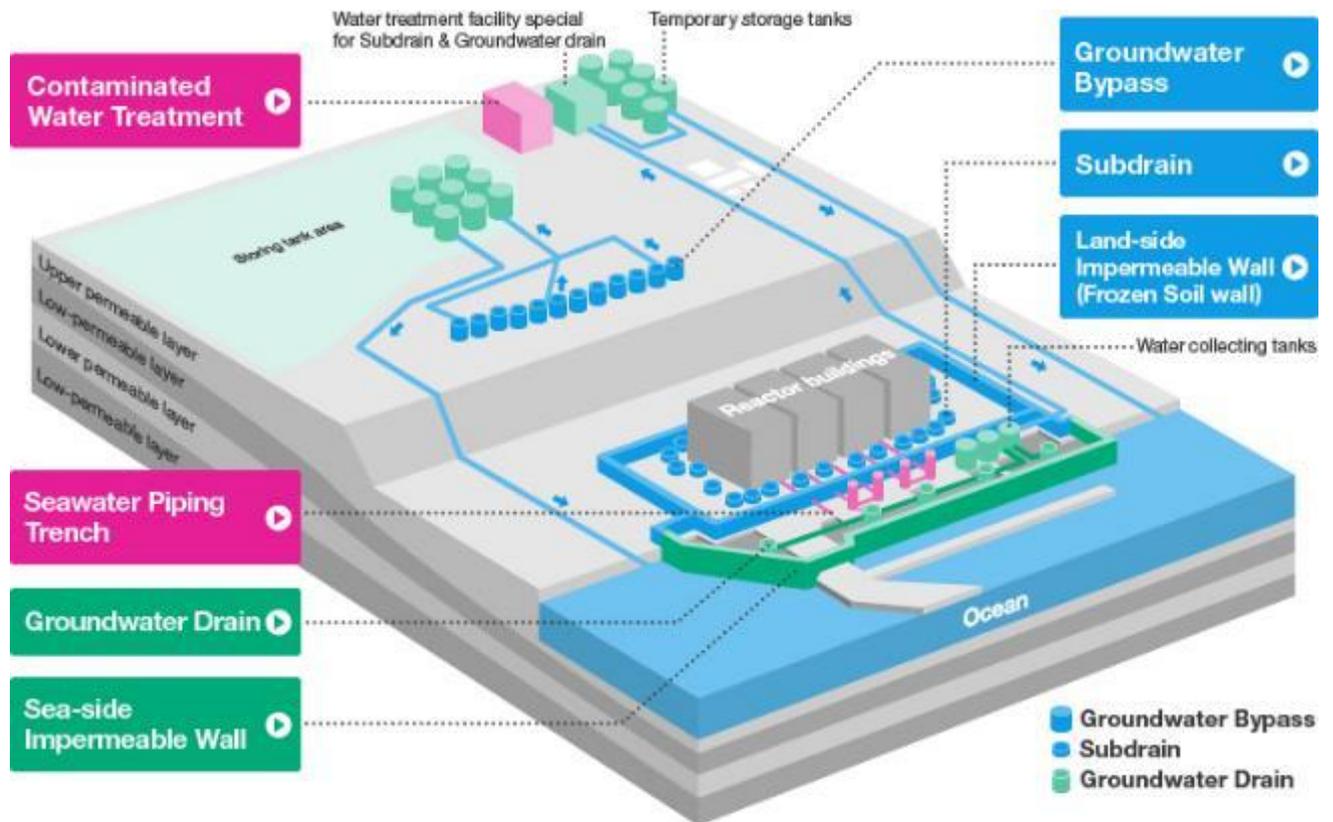
The preventive and multi-layered measures against contaminated water issue are implemented based on the three principles; “Removing contamination sources”, “redirecting ground water from contamination source” and “Preventing leakage of contaminated water”.

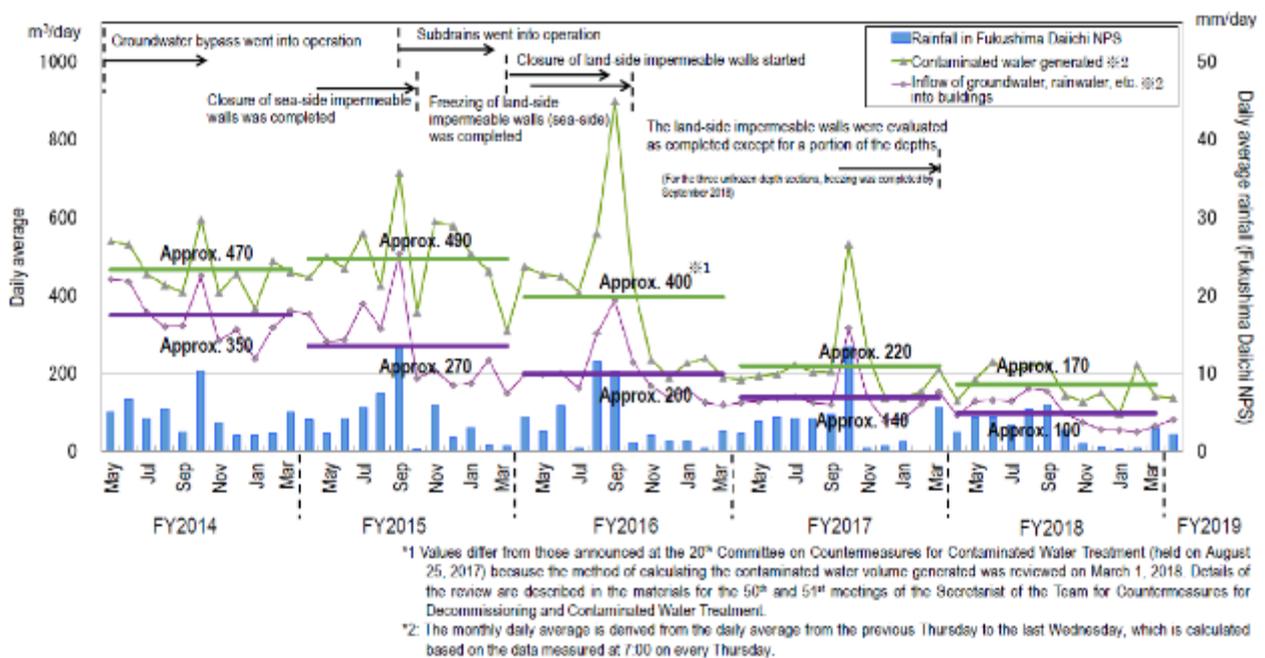
Subsequently, the generation of contaminated water was reduced from approx. 470 m<sup>3</sup>/day (in FY2014) to approx. 170 m<sup>3</sup>/day (in FY2018).

Through these measures, the generation of contaminated water was reduced from approx. 470 m<sup>3</sup>/day (in FY2014) to approx. 170 m<sup>3</sup>/day (in FY2018).

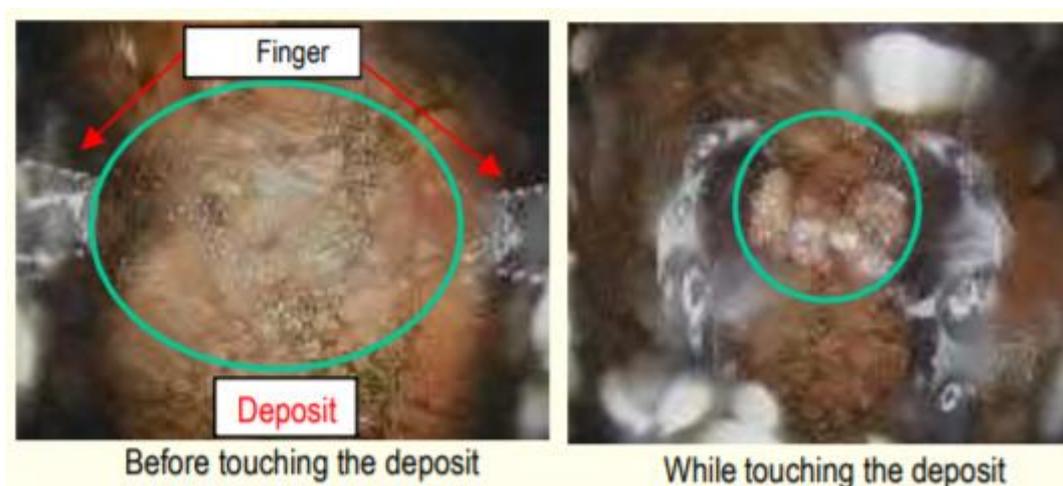
On February 13, 2019, an investigation touching the detected deposits inside the PCV was conducted to determine their characteristics (hardness, fragility, etc.). This contact investigation confirmed that the pebble-shaped deposits, etc. could be moved and that hard rock-like deposits that could not be gripped may exist. In addition, images, radiation dose and temperature data that would help determine the contour and size of the deposits could be collected by moving the investigative unit closer to the deposits. The result of this investigation will be utilized in the internal investigation in the second half of FY 2019, examination of the retrieval method.

Image: Before and while touching the deposit at the investigation of Unit 2

On February 13, an investigation touching the detected deposits inside the PCV was conducted to determine their characteristics (hardness, fragility, etc.).

This contact investigation confirmed that the pebble-shaped deposits, etc. could be moved and that hard rock-like deposits that could not be gripped may exist. In addition, images, radiation dose and temperature data that would help determine the contour and size of the deposits which could be collected by moving the investigative unit closer to the deposits.

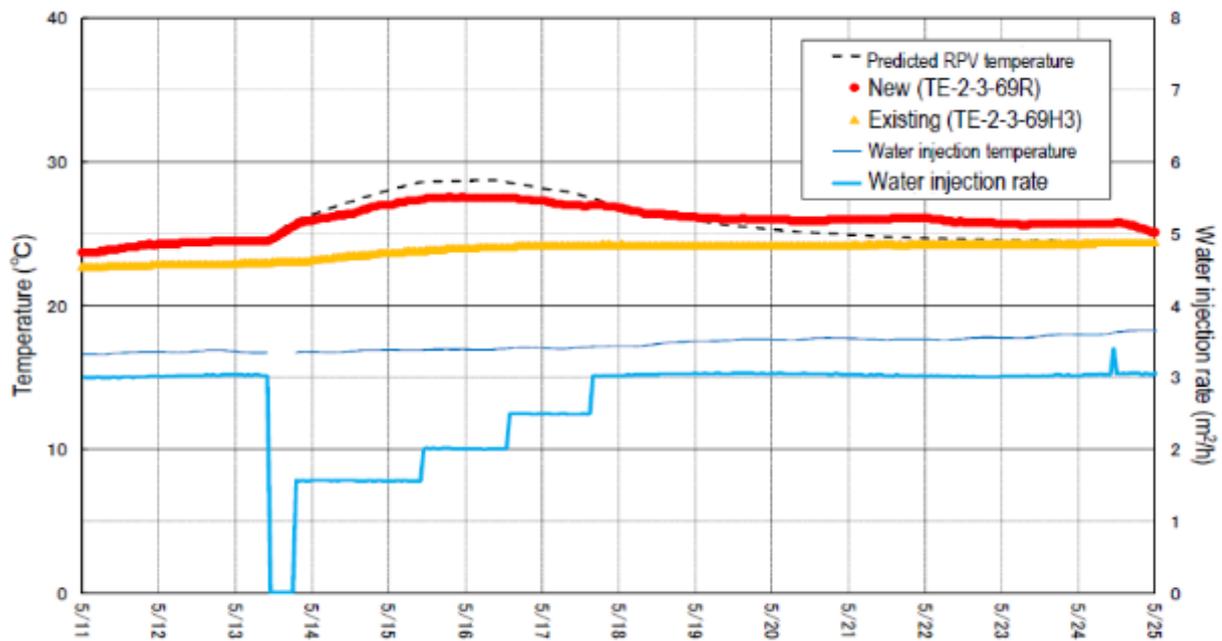
To optimize the emergency response procedures, a test (STEP 2) involving temporarily suspending water injection to the reactor (3.0 to 0.0 m<sup>3</sup>/h) was conducted on May 13 (and terminated on May 24). The graph below shows the changes in RPV bottom temperature during the test to suspend water injection to the reactor. The test confirmed that the temperature increase rate at the RPV bottom was at the same level of 0.2°C/h or less as predicted and that the temperatures at the RPV bottom and inside the PCV during the test also varied almost within expectations. No abnormality was detected in other parameters such as the dust density. The difference between the prediction data and the test data and the behavior variation depending on the location where the thermometer was installed will be evaluated to utilize the results in optimizing emergency response procedures.

Figure. Changes in PRV bottom temperature during the test to suspend water injection
