Events and highlights on the progress related to recovery operations at TEPCO's Fukushima Daiichi Nuclear Power Station

August 2020

The Government of Japan

Section 2: Decommissioning and contaminated water management at Fukushima Daiichi NPS

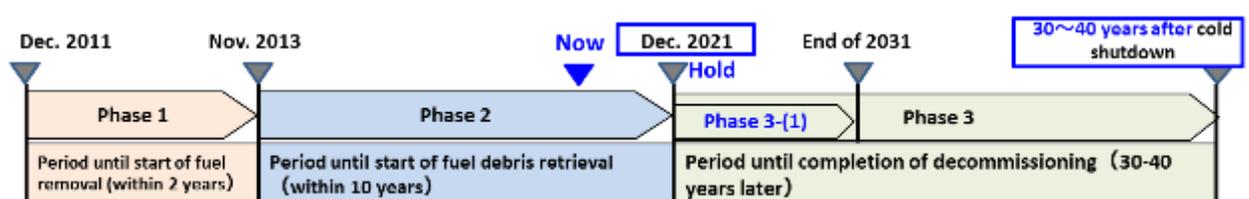
Major milestones		Roadmap (Sept. 2017)	Revised Roadmap	
Contaminated water management	Reduce to about 150 m ³ /day Reduce to about 100m³/day or less	Further reduction of generation	Within 2020 —	Within 2020 Within 2025 NEW
Stagnant water removal / treatment	Complete stagnant water removal / treatment in buildings* * Excluding the reactor buildings of Units 1-3, Process Main Buildings, and High Temperature Incineration building. Reduce the amount of stagnant water in reactor buildings to about a half of that in the end of 2020		Within 2020 —	Within 2020(*) FY2022 - 2024 NEW
Fuel removal	Complete of fuel removal from Unit 1-6 Complete of installation of the large cover at Unit 1 Start fuel removal from Unit 1 Start fuel removal from Unit 2	Methods have changed to ensure safety and prevent dust scattering	— — Around FY2023 Around FY2023	Within 2031 Around FY2023 FY2027 – 2028 FY2024 - 2026 NEW NEW REVISED REVISED

Fuel debris retrieval	Start fuel debris retrieval from the first Unit (Start from Unit 2, expanding the scale gradually)		Within 2021	Within 2021
Waste management	Technical prospects concerning the processing/disposal policies and their safety Eliminating temporary storage areas outside for rubble and other waste		Around FY2021 —	Around FY2021 Within FY2028 NEW

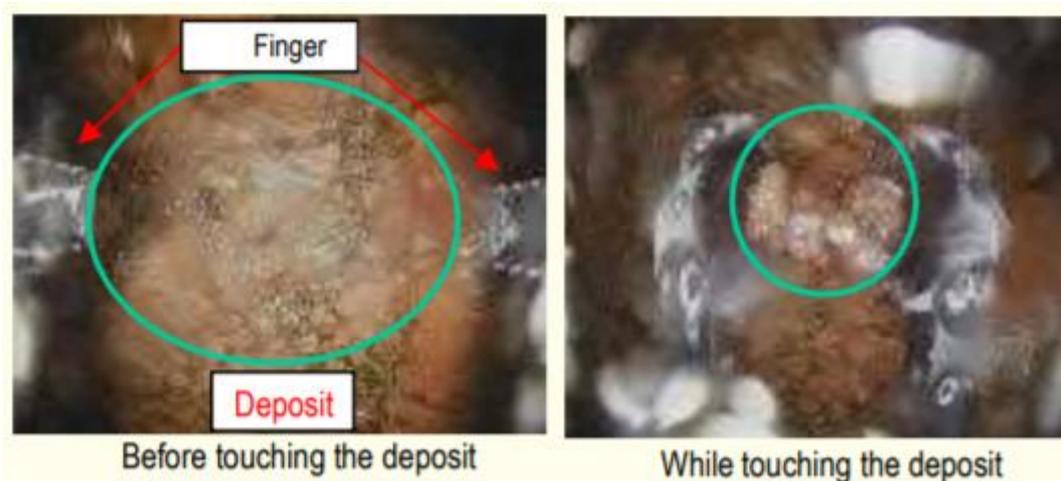
Image: Before and while touching the deposit at the investigation of Unit 2

On February 13, 2019, a contact investigation on the detected deposits inside the PCV was conducted to determine their characteristics (hardness, fragility, etc.). This contact investigation confirmed that the pebble-shaped deposits, etc. could be moved and that hard rock-like deposits that could not be gripped may exist. In addition, images of radiation dose and temperature data that would help determine the contour and size of the deposits could be collected by moving the investigative unit closer to the deposits. The result of this investigation will be utilized in the internal investigation in the second half of FY 2019, examination of the retrieval method.
