Events and highlights on the progress related to recovery operations at Fukushima Daiichi Nuclear Power Station

August, 2017

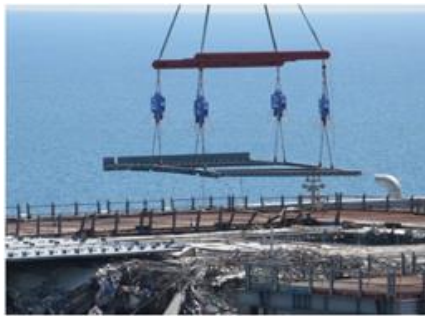
Installing shields on the operating floor

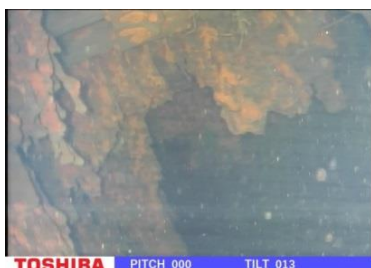
bottom of CRD housing

For Unit 3, It was succeeded for the first time after the accident to acquire image inside of pedestal using underwater ROV from 19 to 22 July 2017. As a result, in the pedestal, considered to be solidified molten materials and damage situation of some structure such as housing support and grating were confirmed.

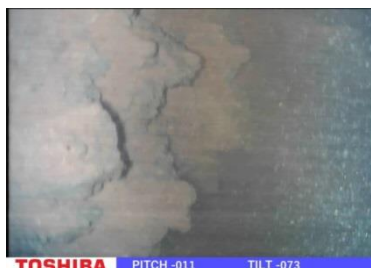
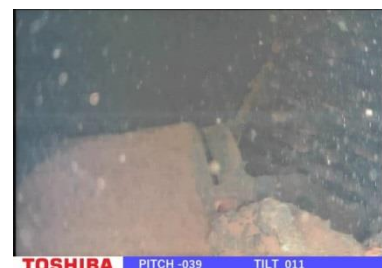
bottom of pedestal

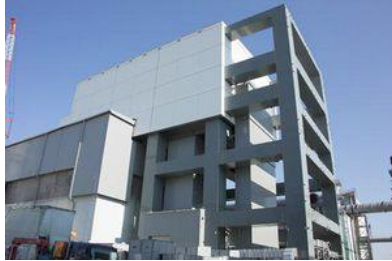
Equipment for fuel removal

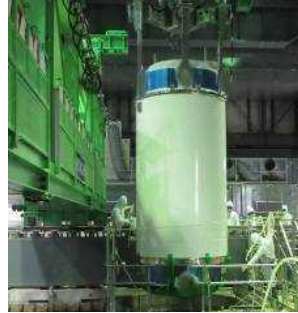
Storage of removed fuel
