INTERNATIONAL ATOMIC ENERGY AGENCY

ENGINEERING SAFETY REVIEW SERVICES SEISMIC SAFETY EXPERT MISSION

"PRELIMINARY FINDINGS AND LESSONS LEARNED FROM THE 16 JULY 2007 EARTHQUAKE AT KASHIWAZAKI-KARIWA NPP"

Kashiwazaki-Kariwa NPP and Tokyo, Japan 6 – 10 August 2007

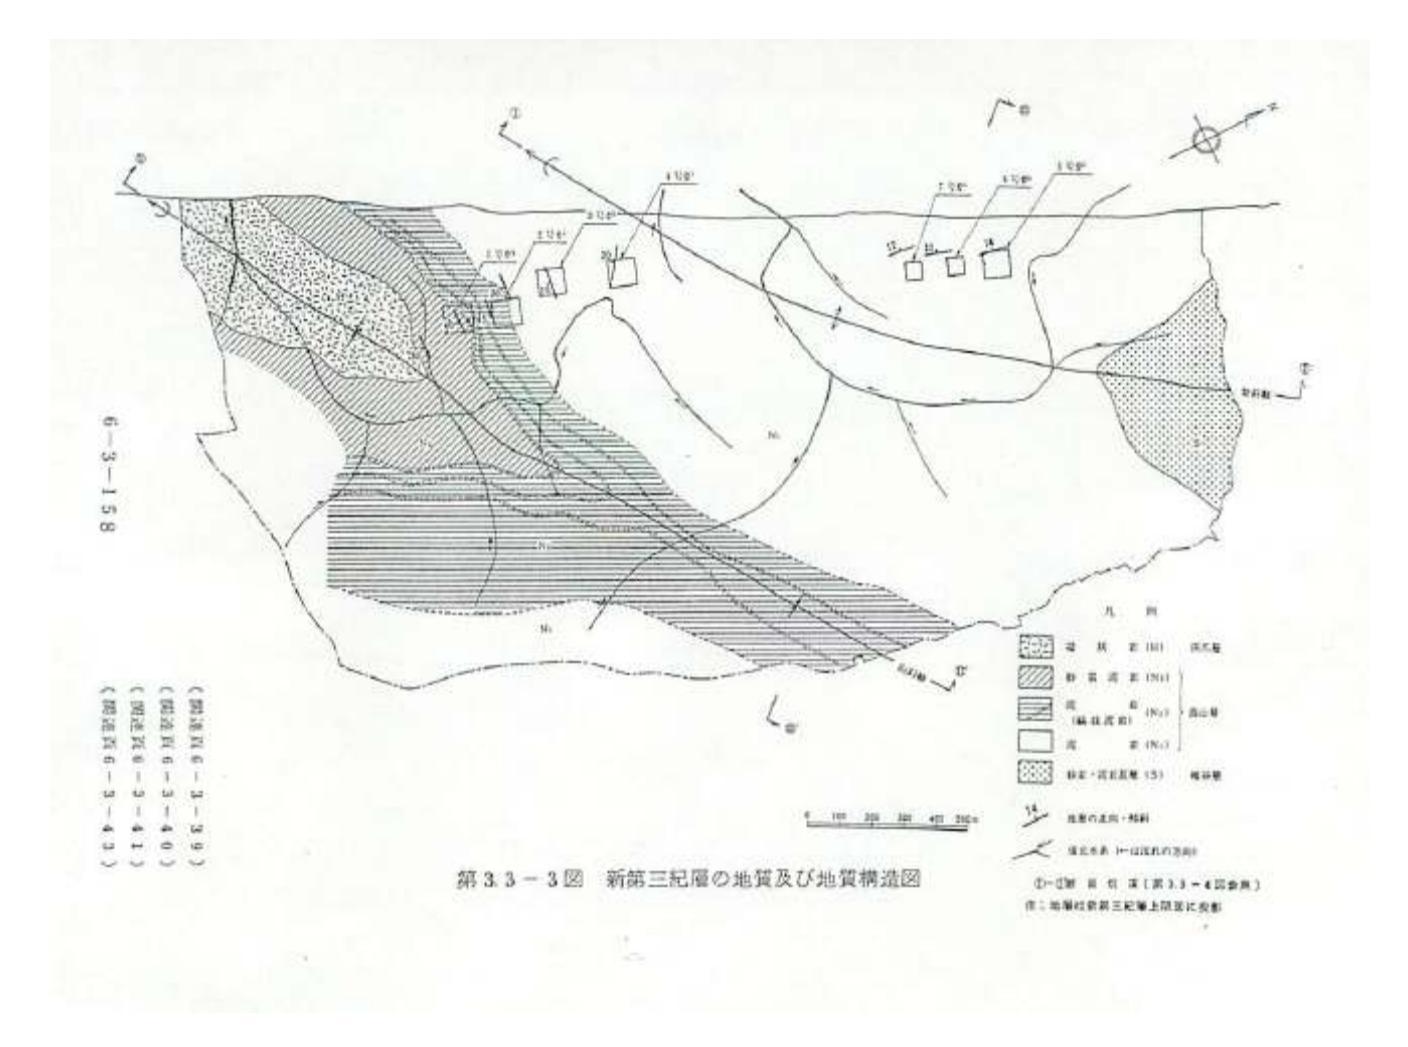
Fig. 3.3 – 3 : Geology and Geological Structure Map in Neogene layers (translated by IAEA Expert Team's support staff)

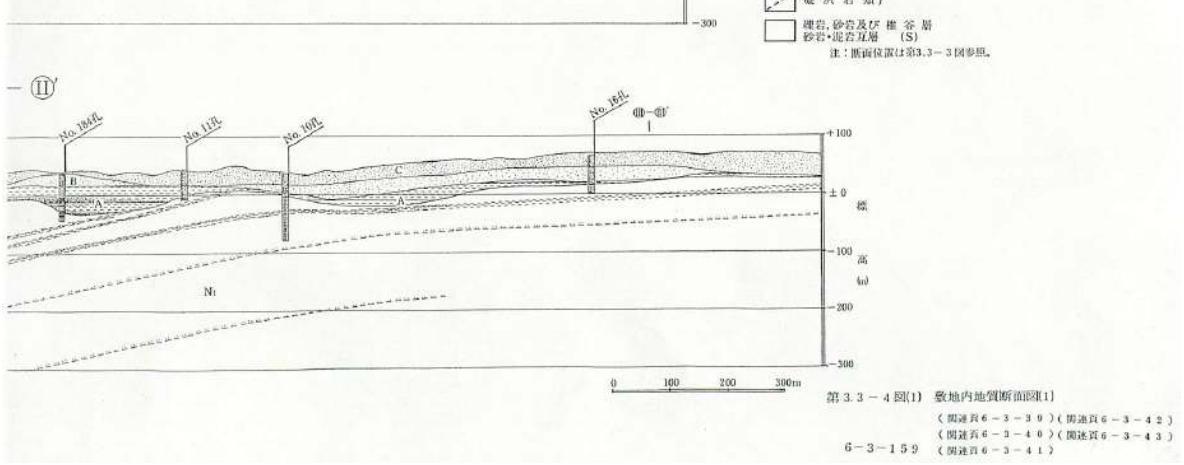
Fig. 3.3 -4 1: Geological profile in the site area. (translated by IAEA Expert Team's support staff)

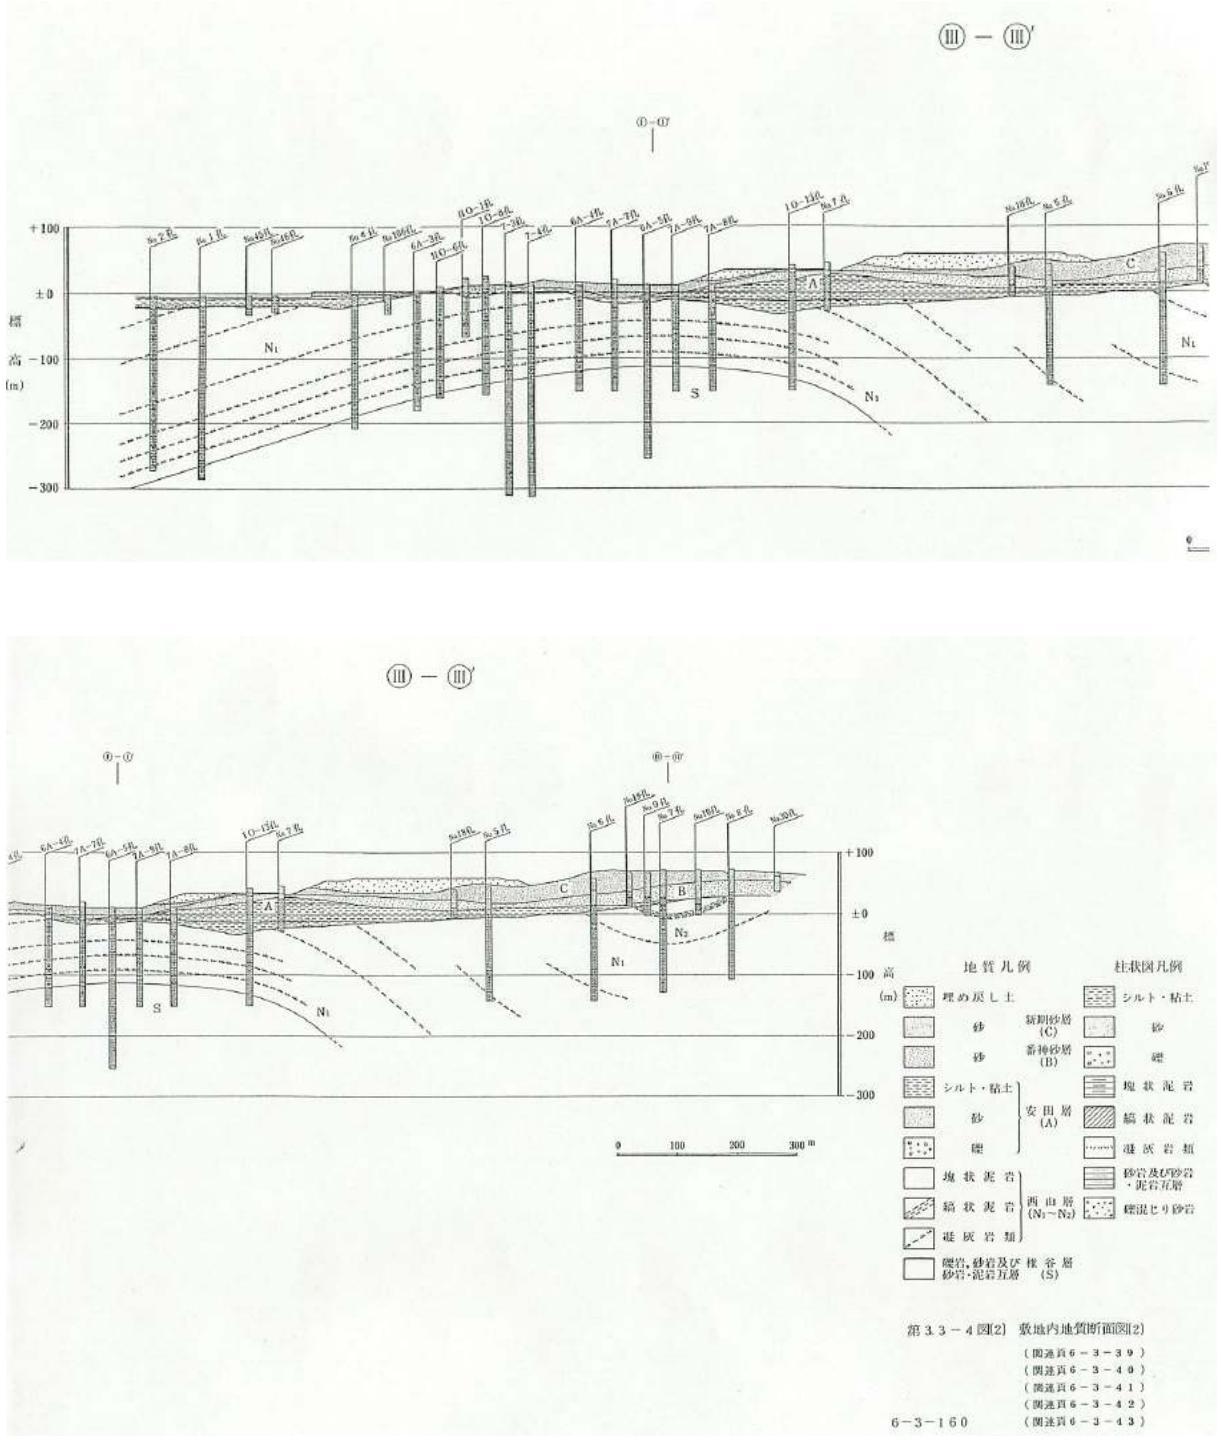
Fig. 3.3 -4 2: Geological profile in the site area. (translated by IAEA Expert Team's support staff)

The "dark" substratum pertains to Lower Pliocene to Miocene.

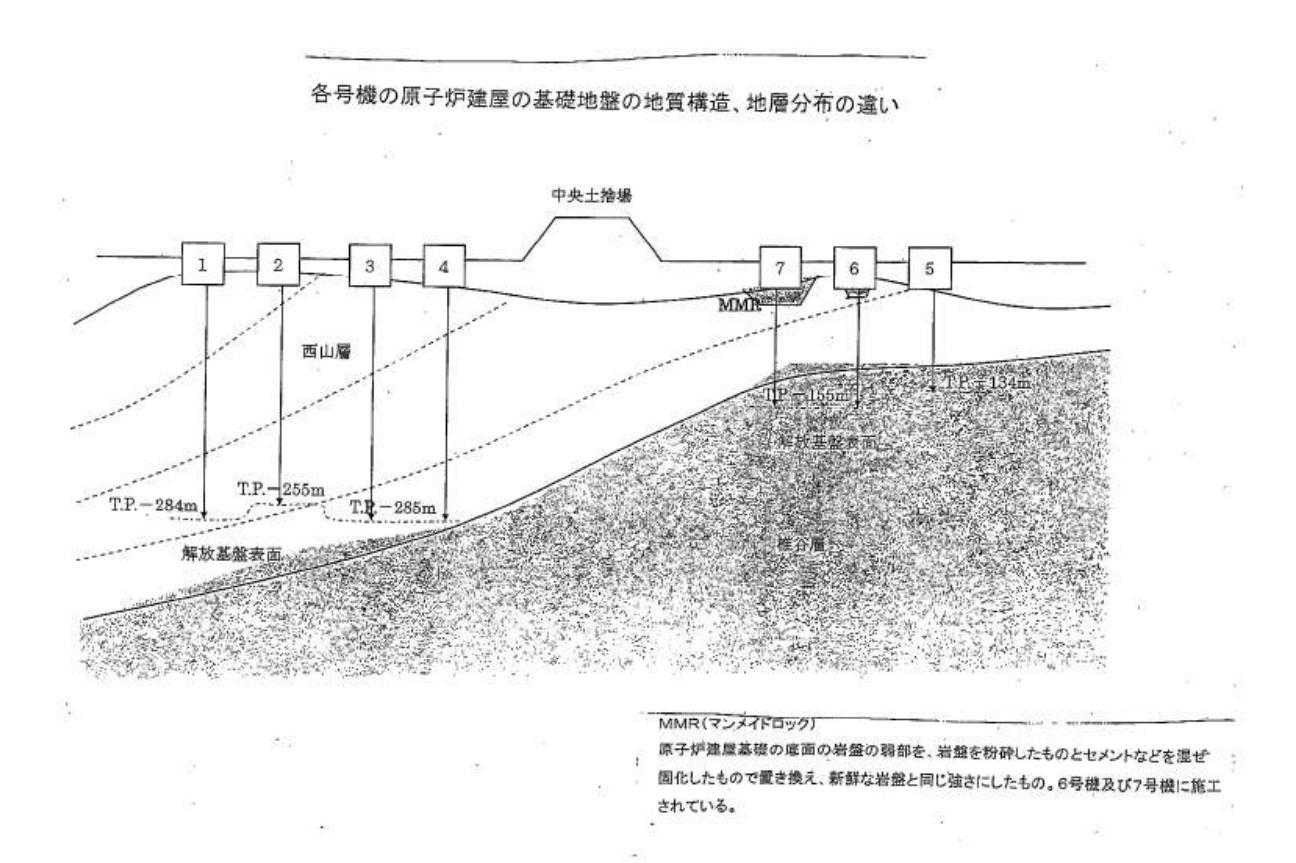
Distribution of geological structures and soil/rock layers underlying the reactor buildings (translated by IAEA Expert Team's support staff)

MMR (Man-Made Rock) is made of small rock mixed with cement replacing weak parts of the foundation material (Units 6 and 7), (translated by IAEA Expert Team's support staff)

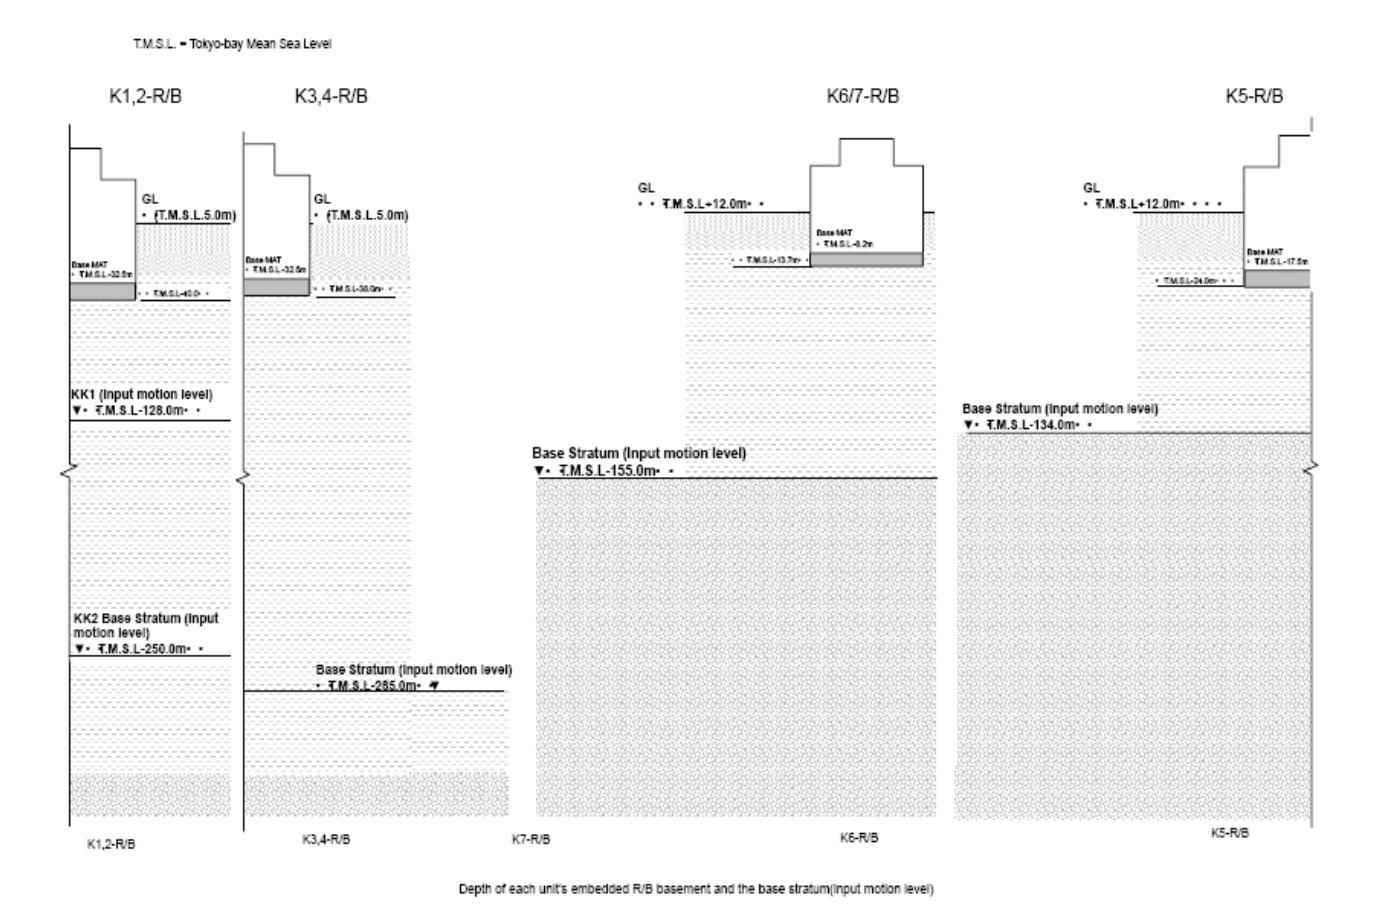
I.4.2. Input Motion and Base Stratum Levels for Units 1-7

Please, see also Background Document I.2 NISA presentation, slides #5 and #6. The "base stratum" (rock outcrop) is where the input position of the design basis ground motion is given. It is firm bedrock with a shear wave velocity higher than 700 m/sec as defined by the Japanese guidelines.

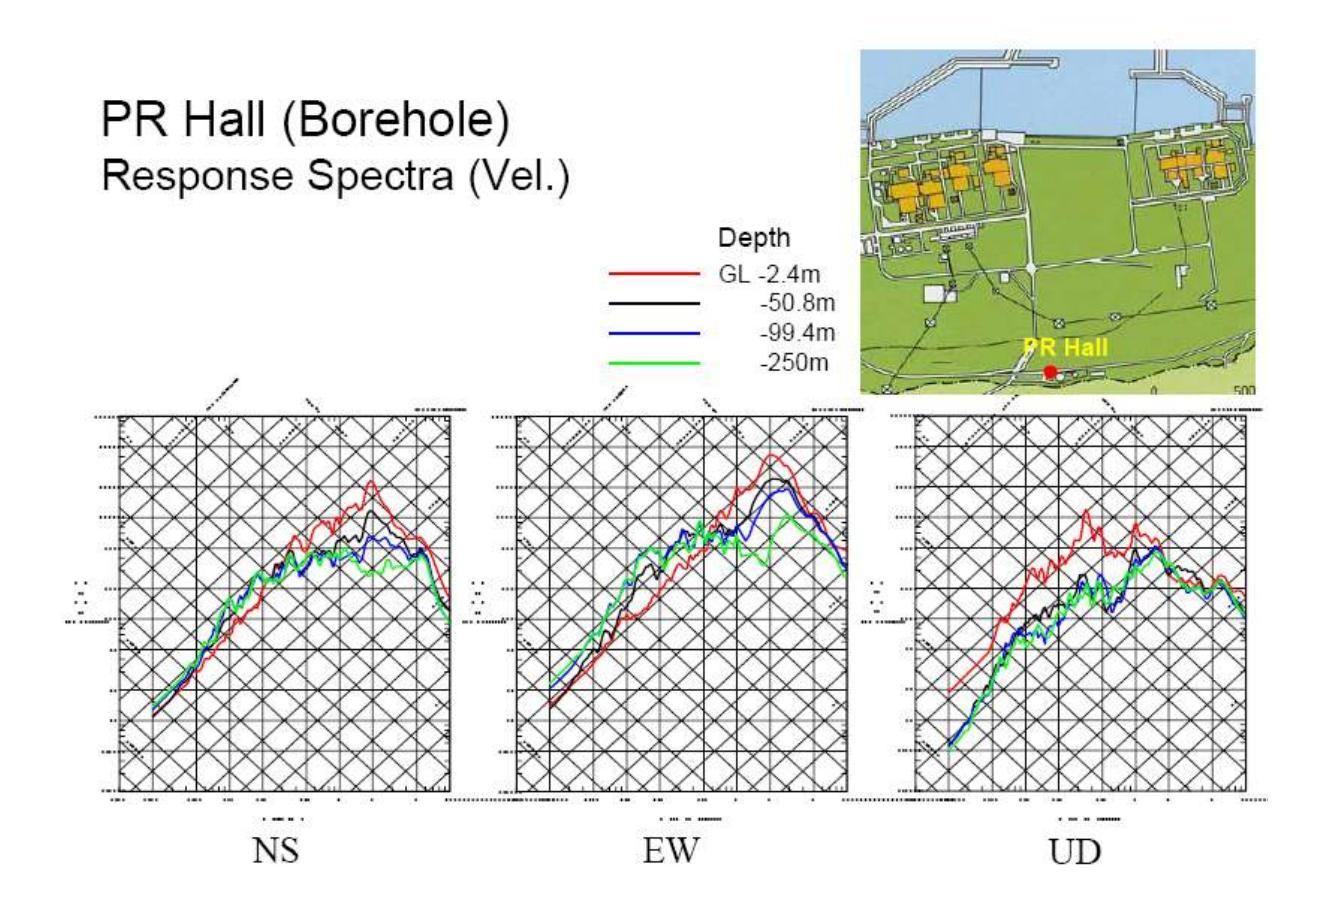
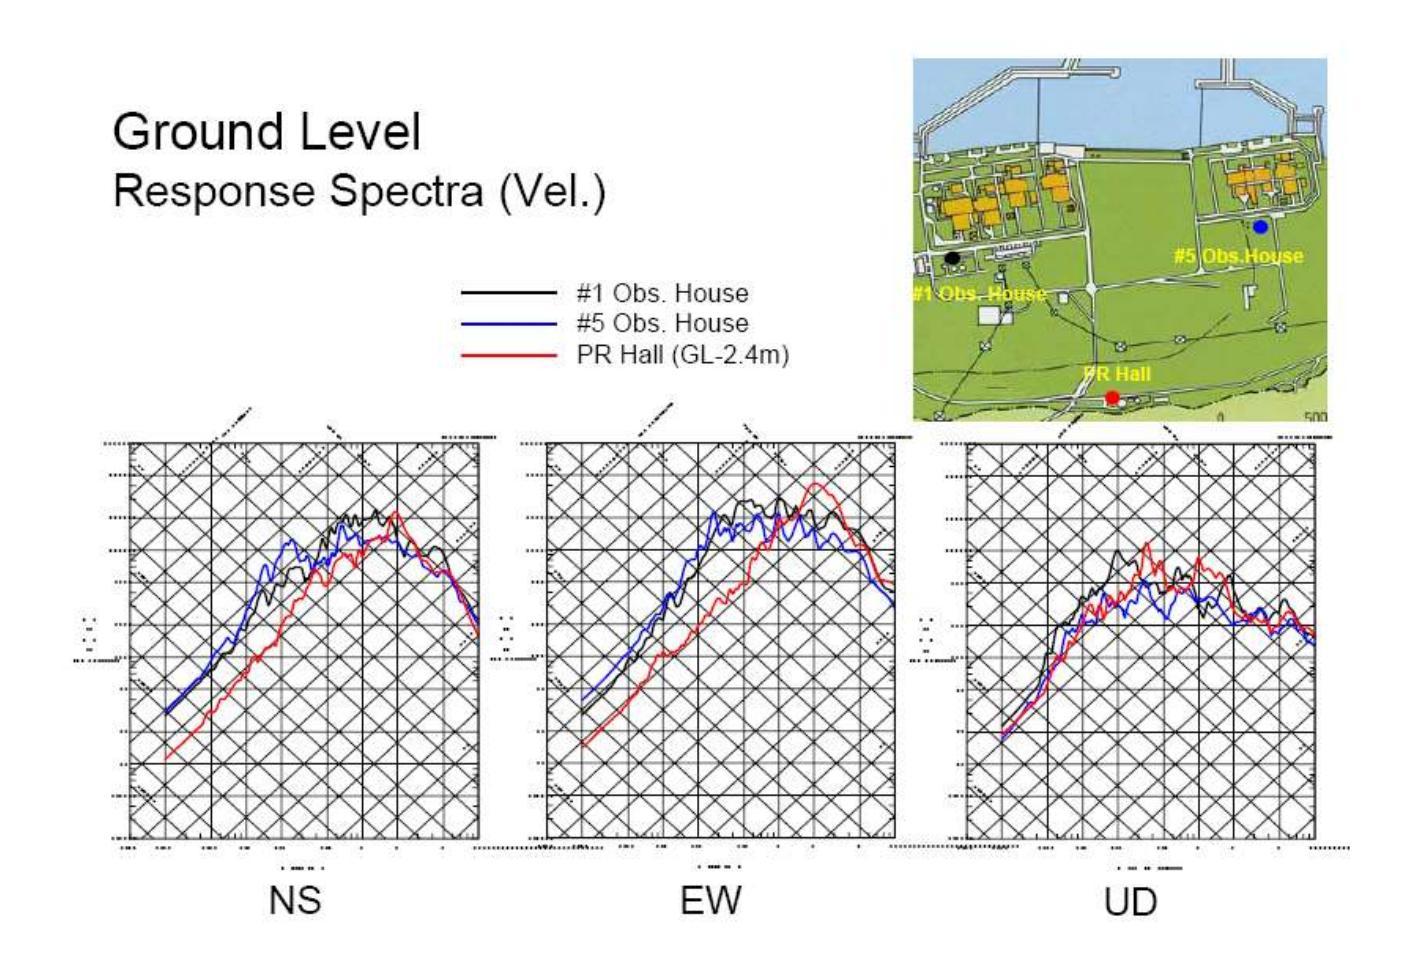
- II.A.1.4. Response spectra of the recorded motions (surface and down hole) at the PR Hall and Observation Houses #1 and #5
- a. Response spectra of the recorded motions at the borehole located at the PR Hall, at ground level and at 3 depths

b. Response spectra of the recorded motions at the PR Hall and at Observation Houses #1 and #5 at the ground level
II.A.1.5. Response spectra of the recorded vertical motions at foundation mat levels

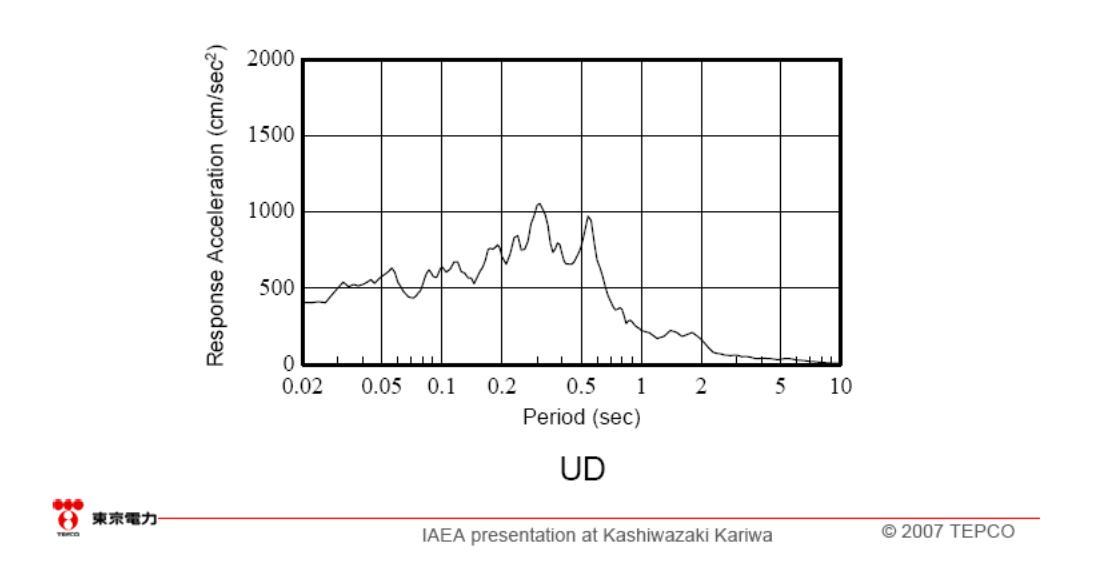
1. Unit 1:

Response Spectra (acc.) Base mat (B5F) R/B #1 1-R2

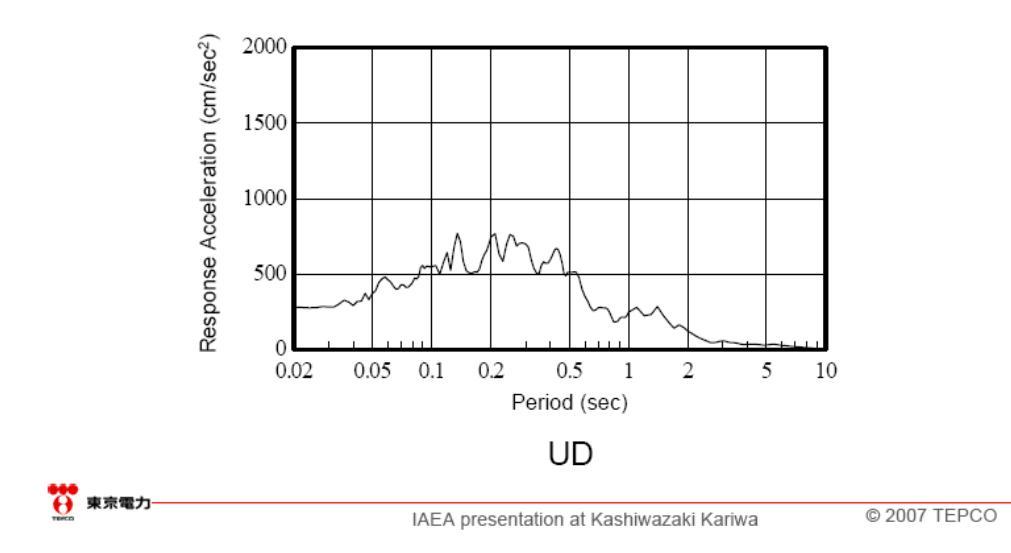
2. Unit 2:

Response Spectra (acc.) Base mat (B5F) R/B #2 2-R2

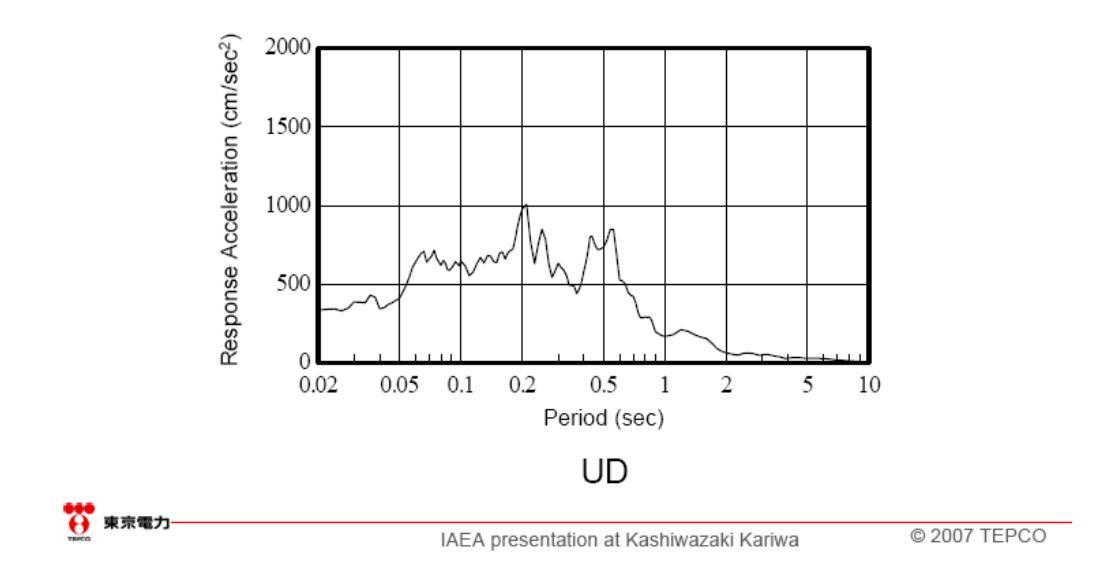
4. Unit 4:

Response Spectra (acc.) Base mat (B5F) R/B #4 4-R2

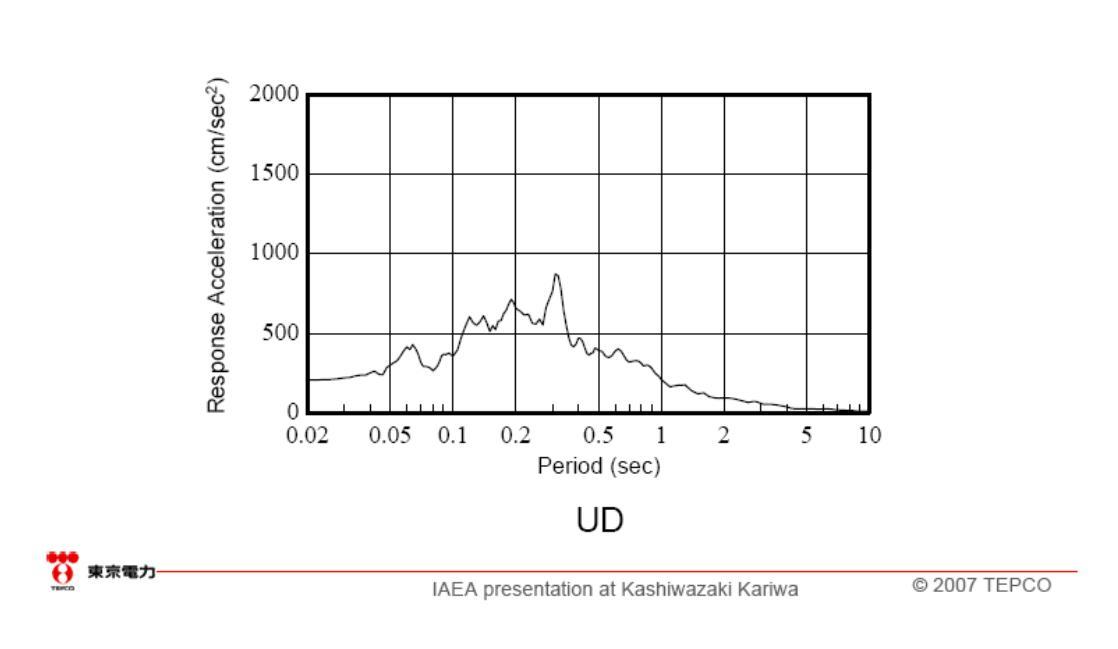
5. Unit 5:

Response Spectra (acc.) Base mat (B4F) R/B #5 5-R2

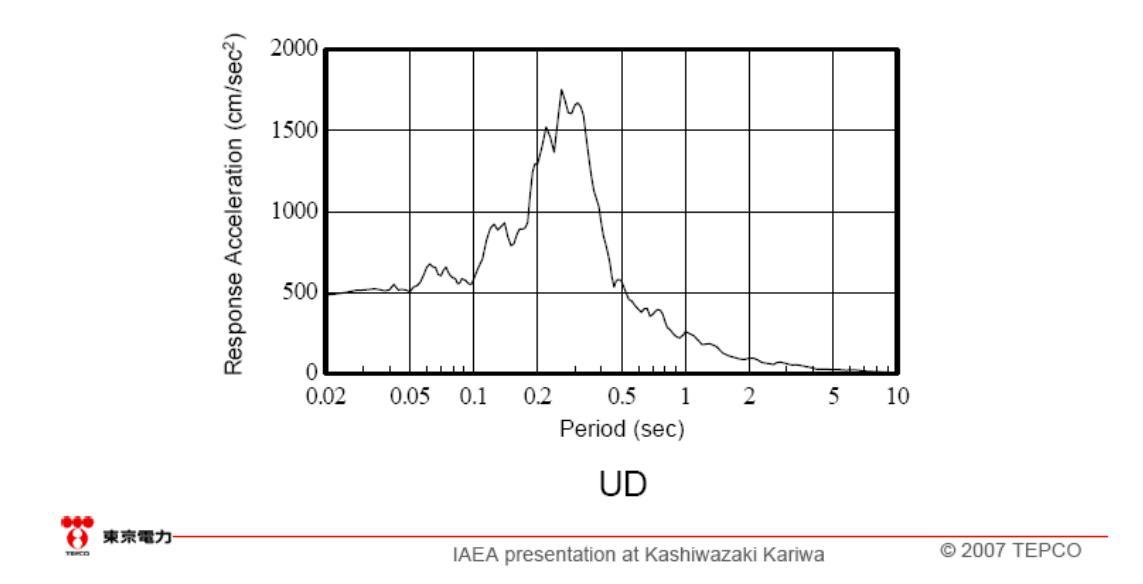
6. Unit 6:

Response Spectra (acc.) Base mat (B3F) R/B #6 6-R2

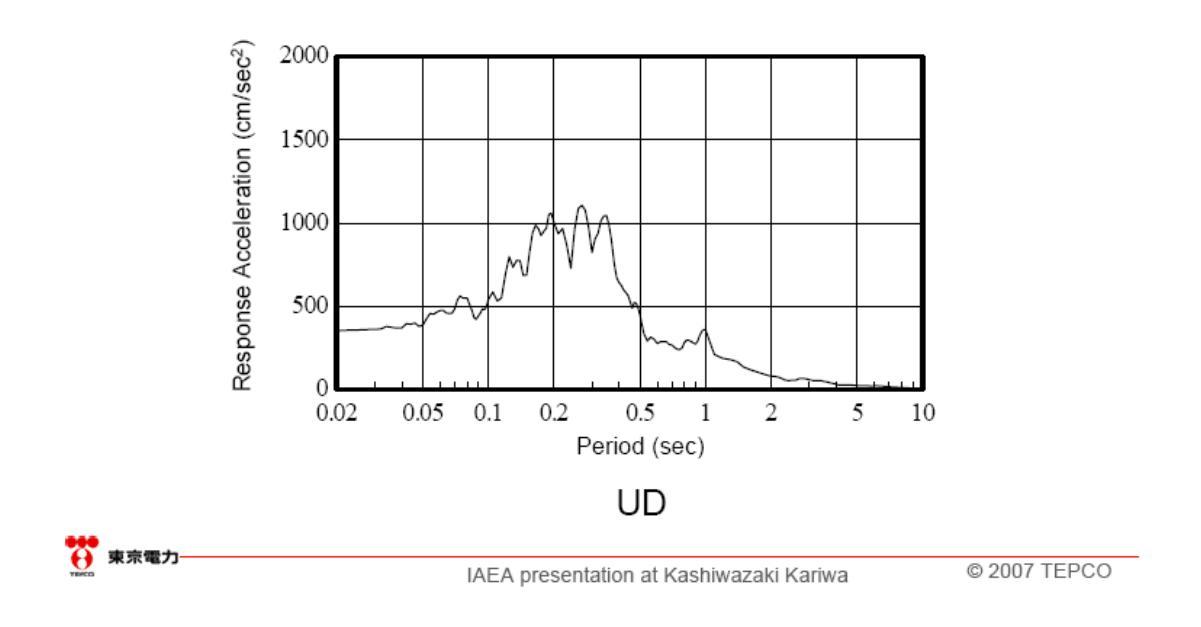
7. Unit 7:

Response Spectra (acc.) Base mat (B3F) R/B #7 7-R2

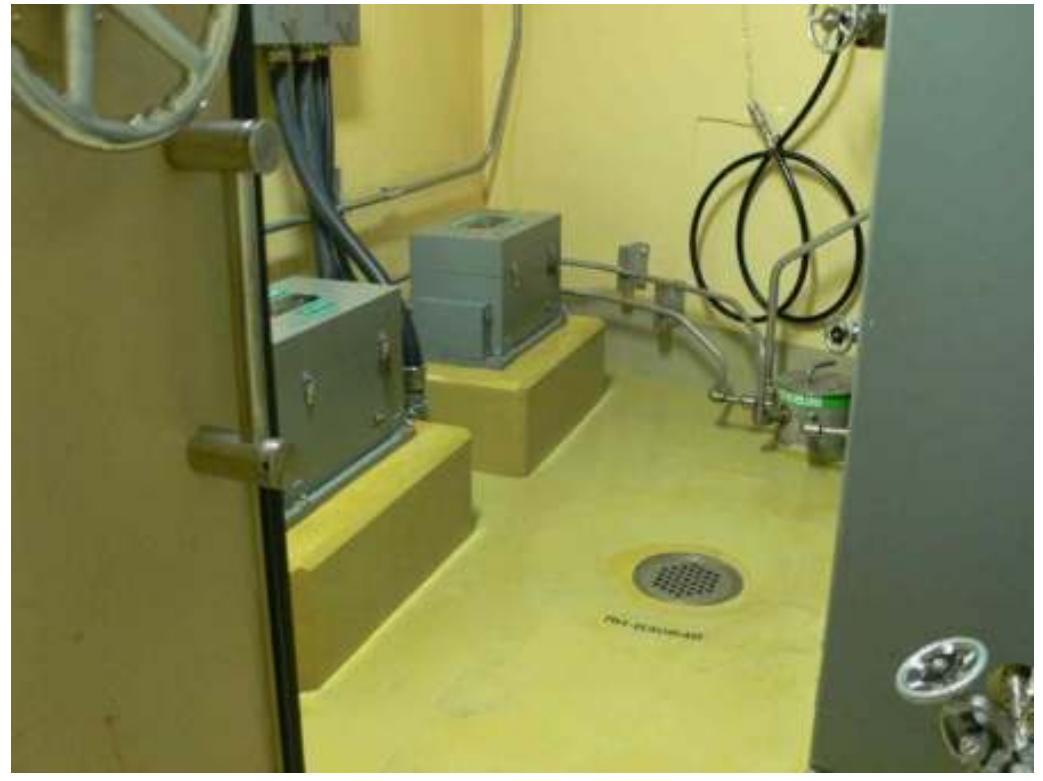
Photo 2: One of the seismic instruments used for automatic scram

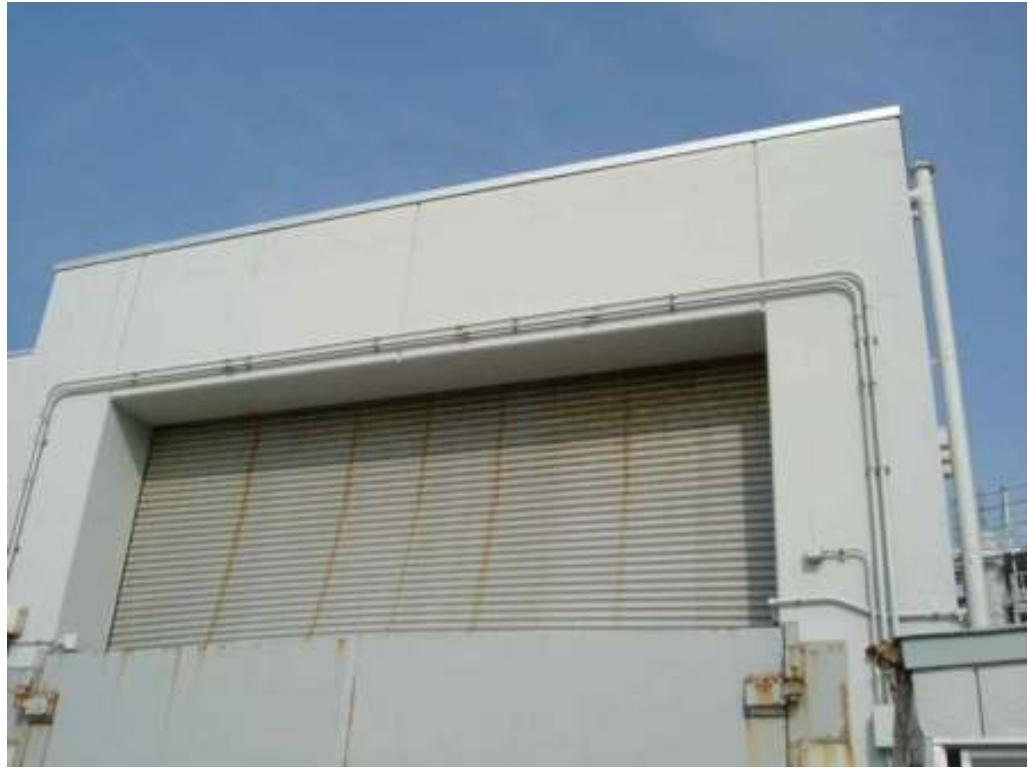
Photo 9: Colour difference at the top, showing differential settlement of building. (A.2-2)

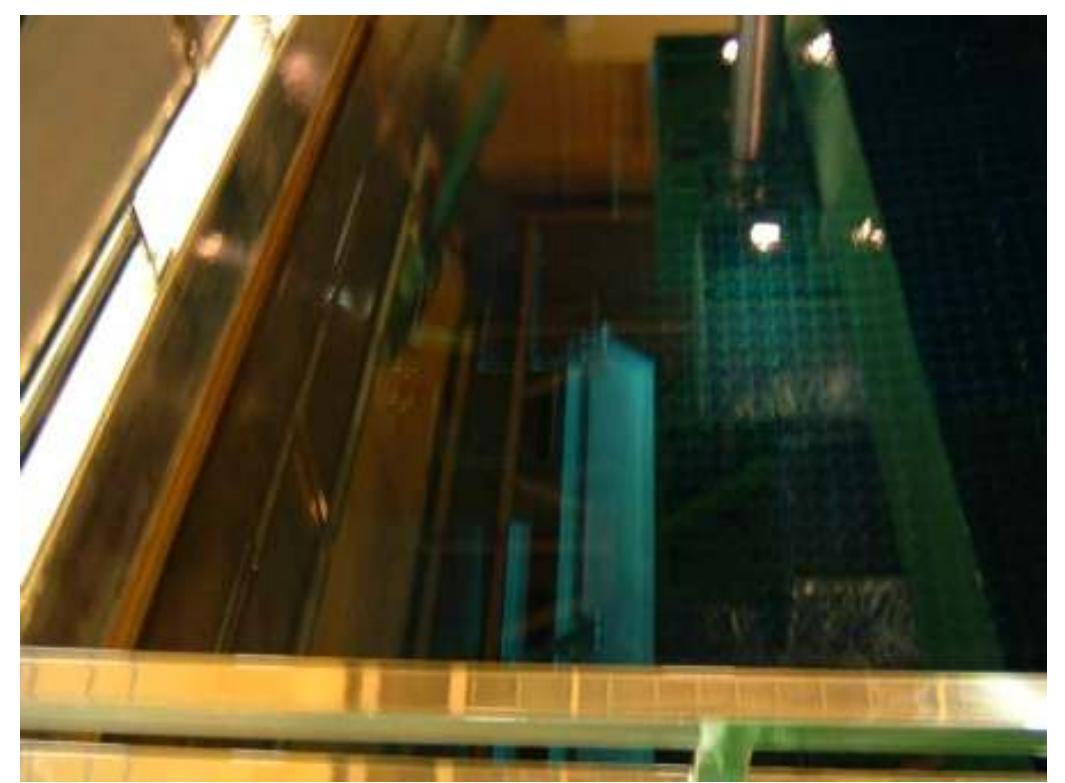
Photo 14: Unit 6 - Falling of temporary service platform into the spent fuel pool (A.2-2)

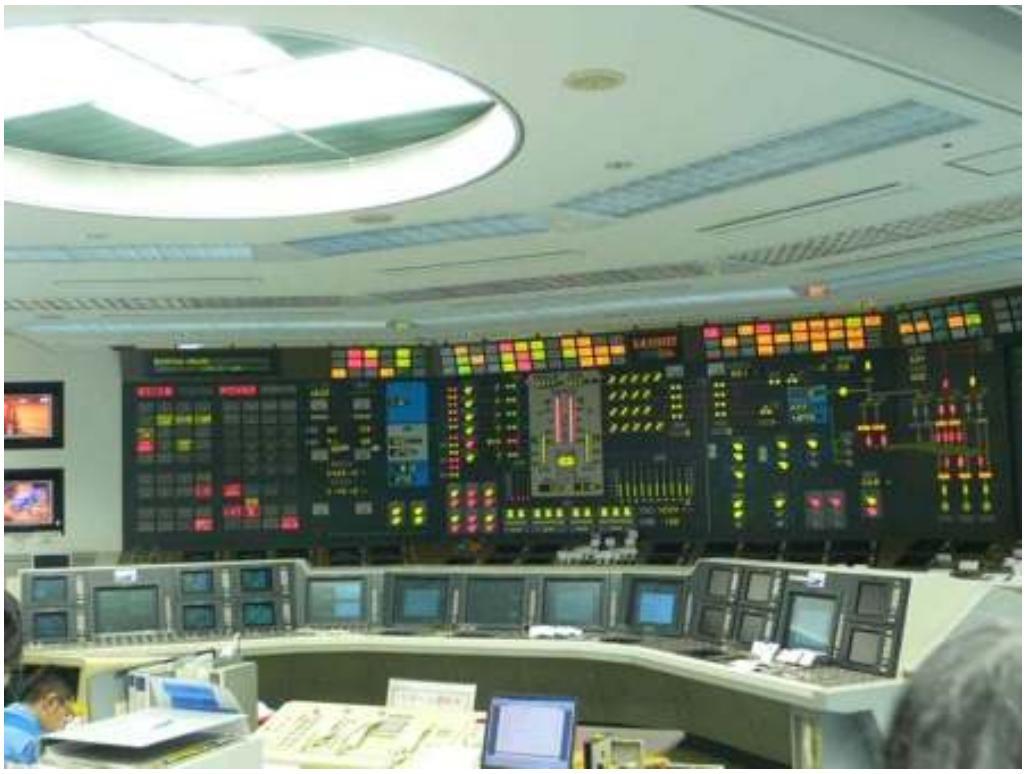
Photo 17: Control room: Ceiling panels that fell due to the earthquake (A.2-2)

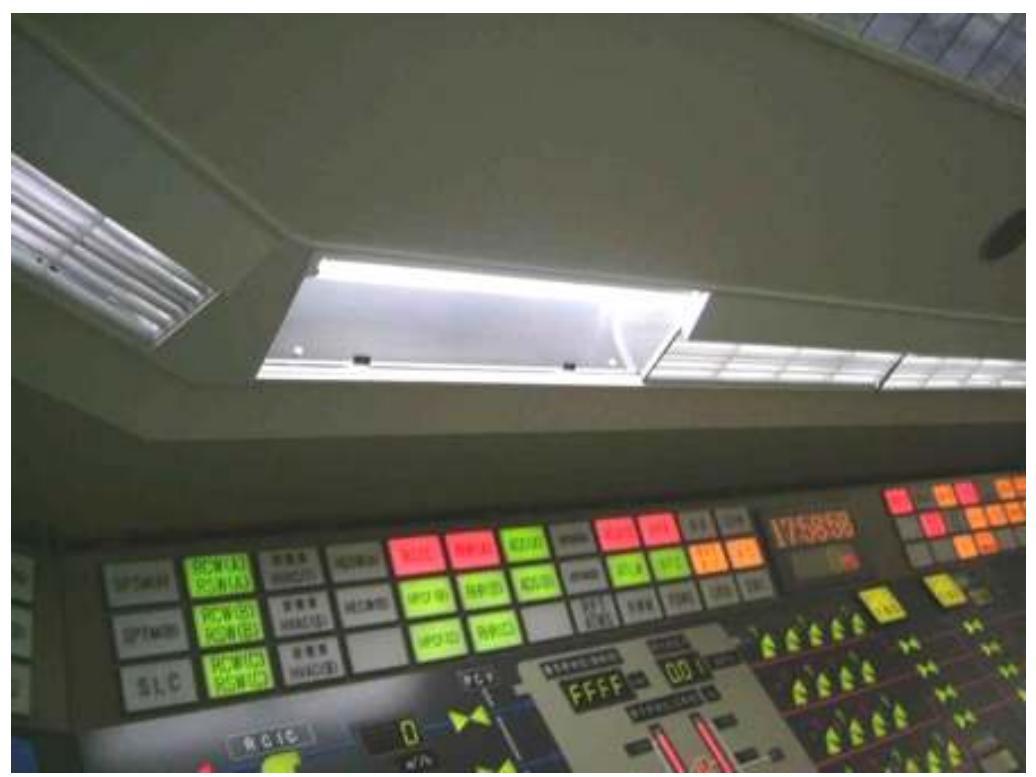
Photo 18: Ceiling panel that fell into the control room floor and panels (A.2-2)

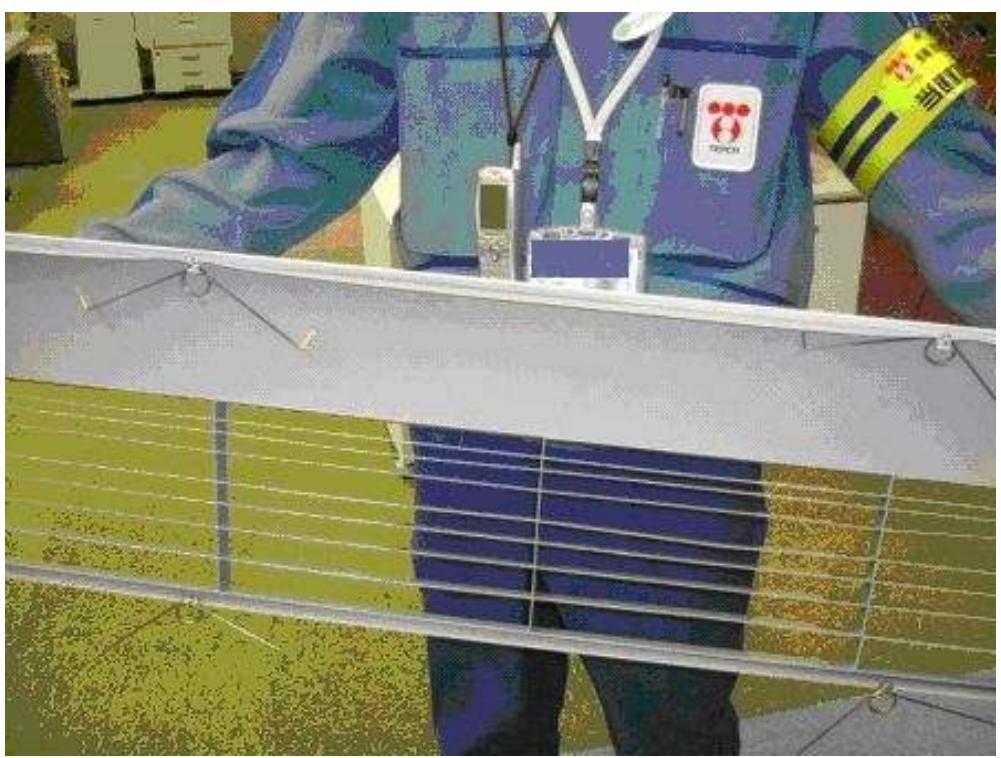
Photo 19: A ceiling panel that fell, reflecting a weak connection, a maintenance problem, etc. (A.2-2)

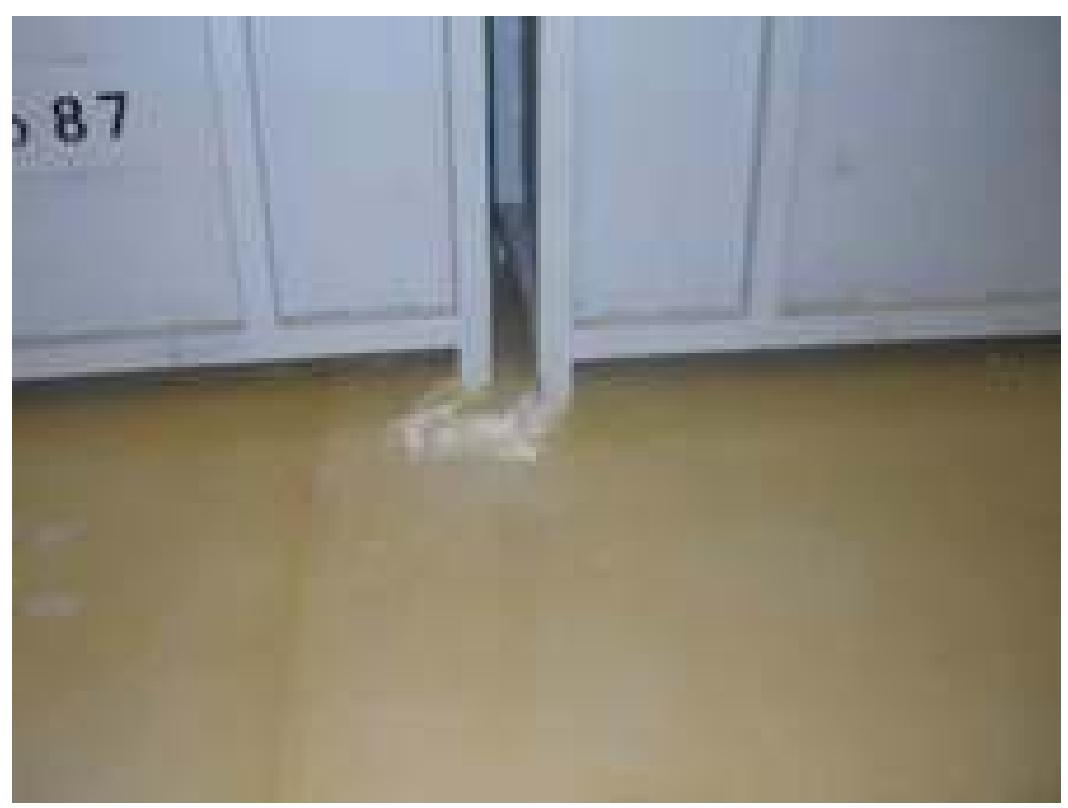
Photo 33: Lateral movement of unanchored cabinet

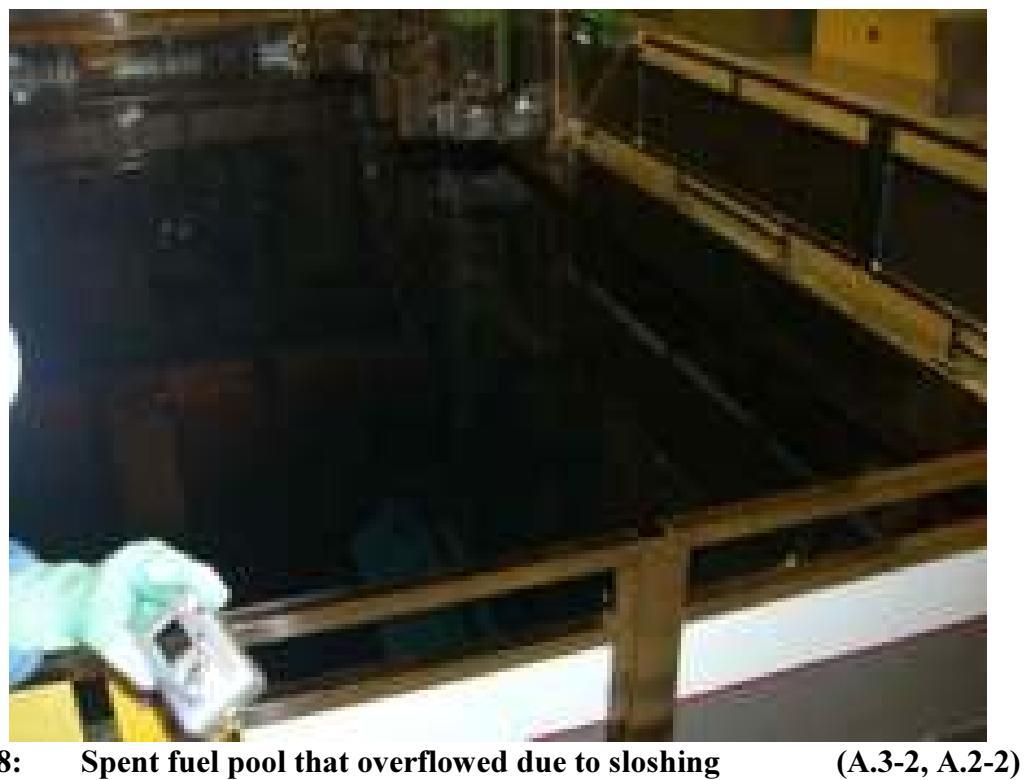
Spent fuel pool that overflowed due to sloshing Photo 38:

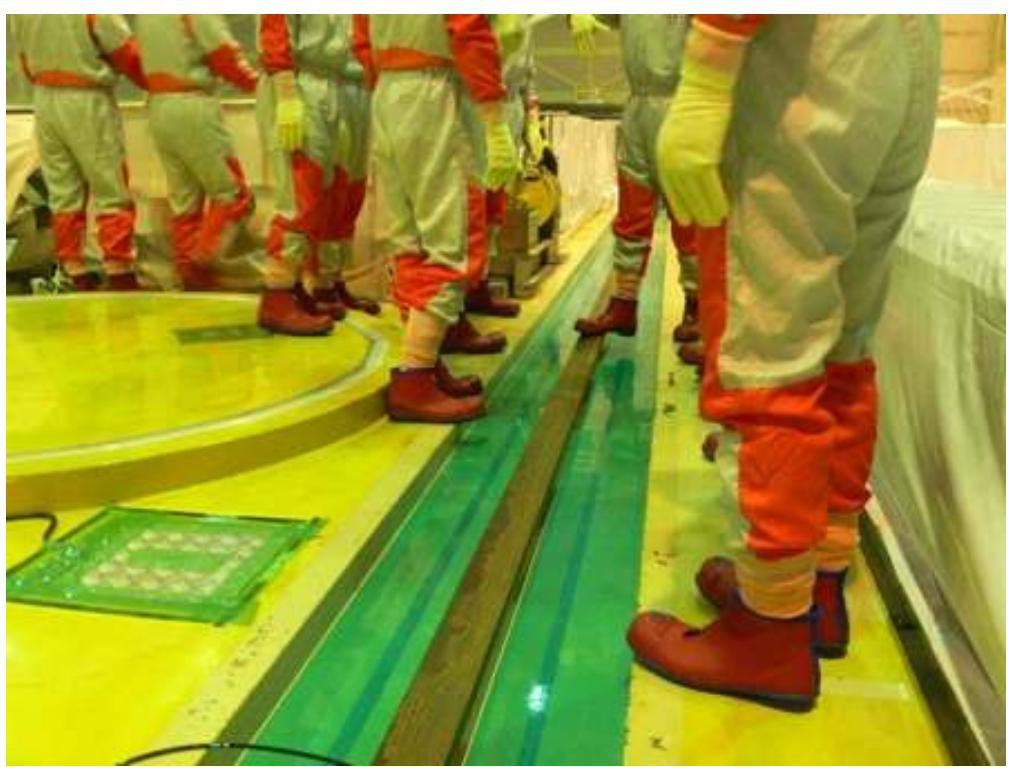
Photo 39: Spent fuel area, floor channel from which the water flowed through cable penetrations. (A.3-2, A.2.2)

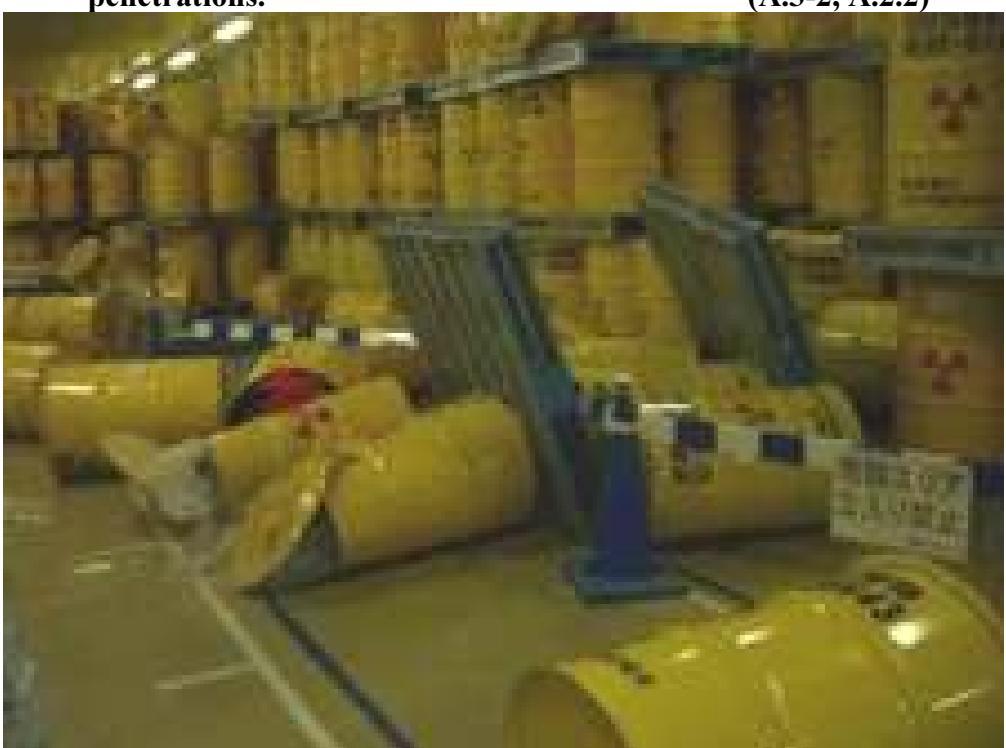
Photo 40: Falling of barrels containing low level radioactive waste – there was no release related to this incident (A.3-2, A.2-2)

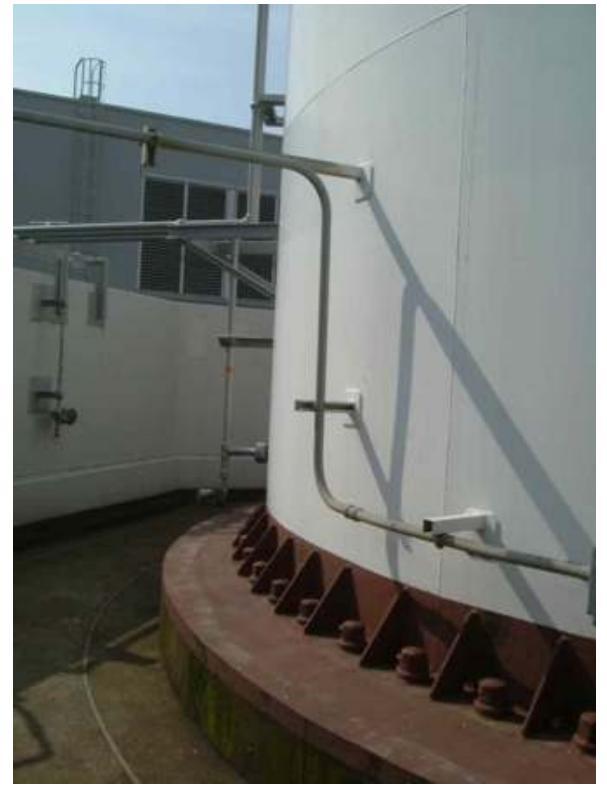
Photo 41: The diesel generator fuel tank with undamaged bolts shows the contrast in the performance of components of different seismic design.

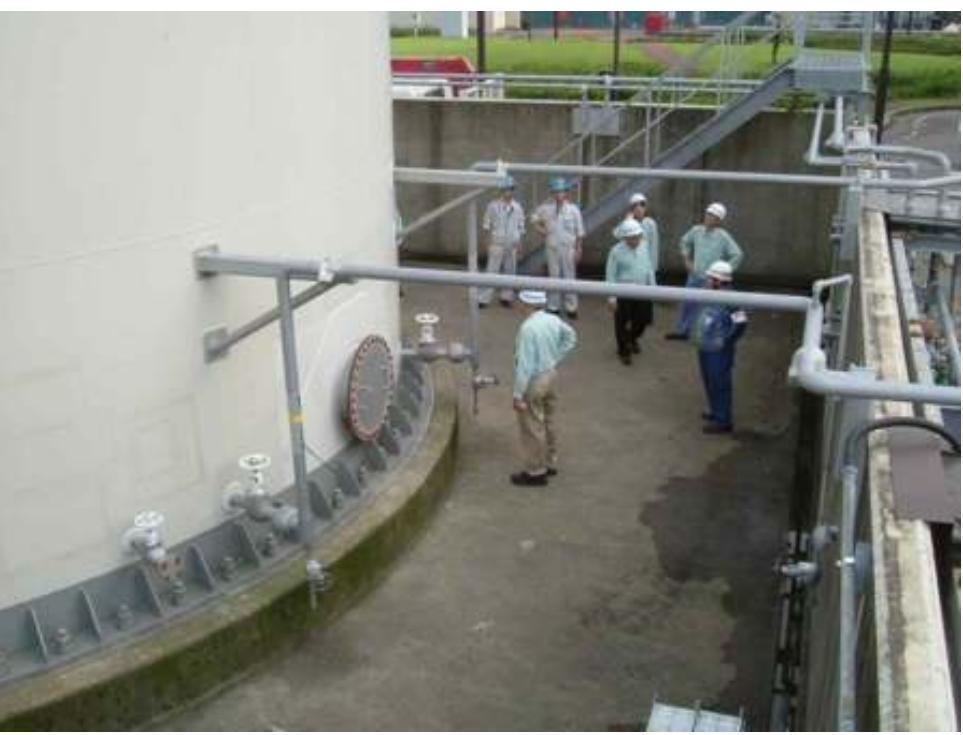
Photo 42: The diesel generator fuel tank with undamaged bolts shows the contrast in the performance of components of different seismic design.
