INTERNATIONAL ATOMIC ENERGY AGENCY

ENGINEERING SAFETY REVIEW SERVICES SEISMIC SAFETY EXPERT MISSION

"PRELIMINARY FINDINGS AND LESSONS LEARNED FROM THE 16 JULY 2007 EARTHQUAKE AT KASHIWAZAKI-KARIWA NPP"

Kashiwazaki-Kariwa NPP and Tokyo, Japan 6 – 10 August 2007

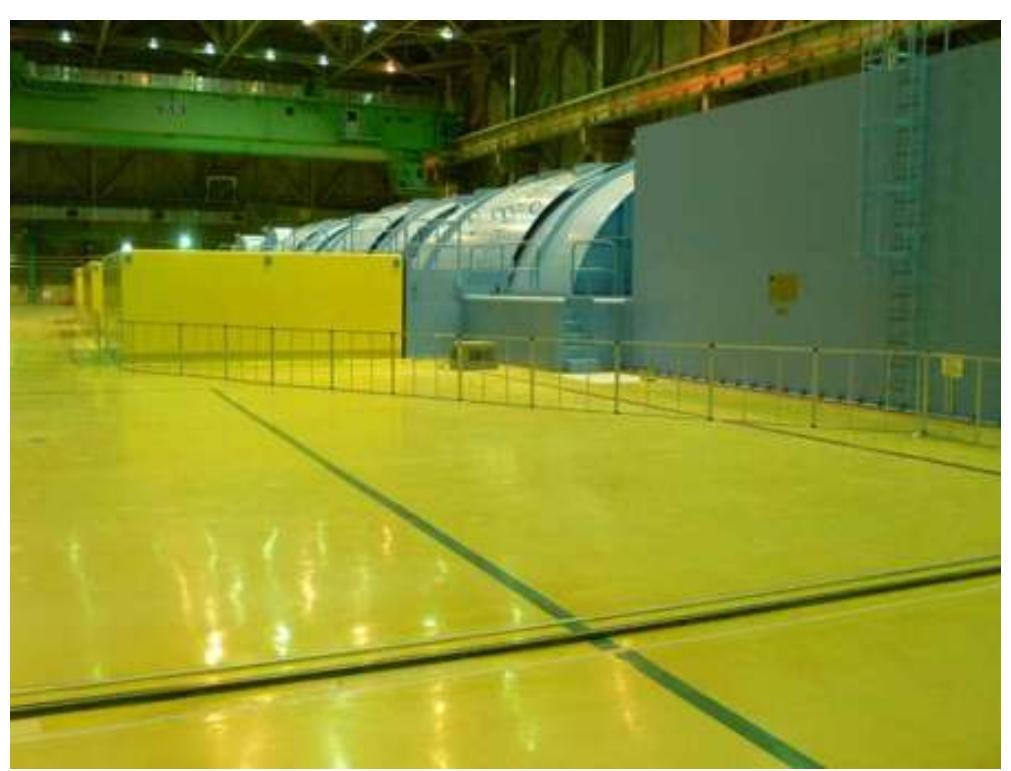
Photo 43: In general, visual inspections did not provide evidence of recent earthquake on safety related SSCs.

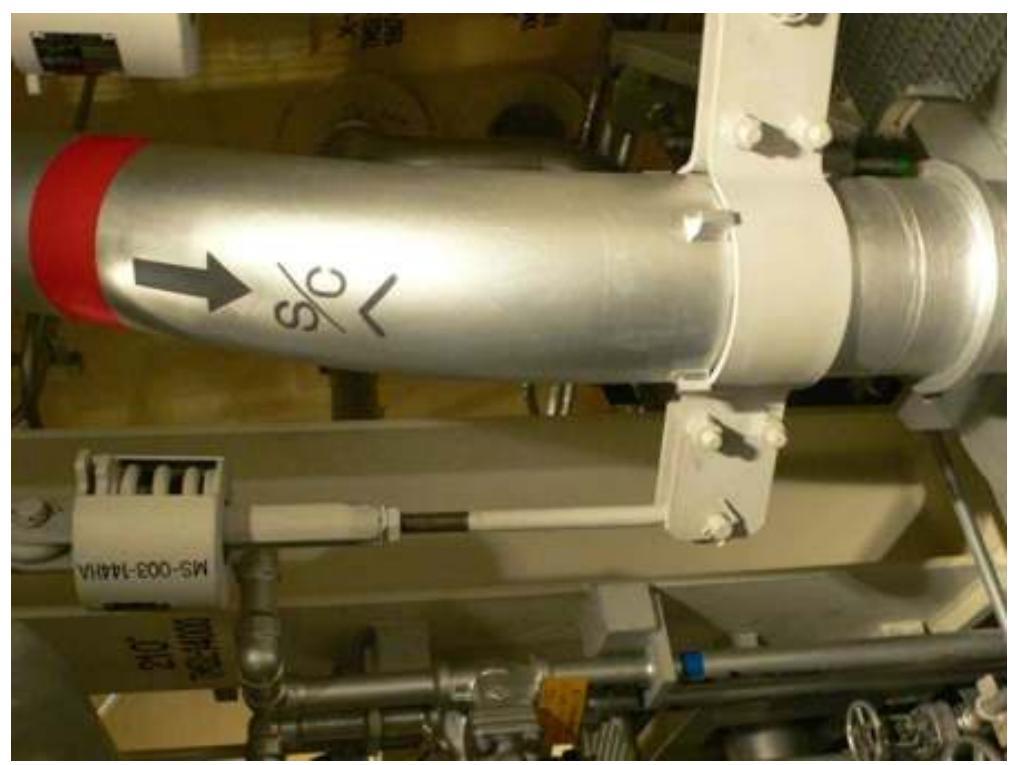
Photo 44: Safety related piping of all sizes generally showed very good performance

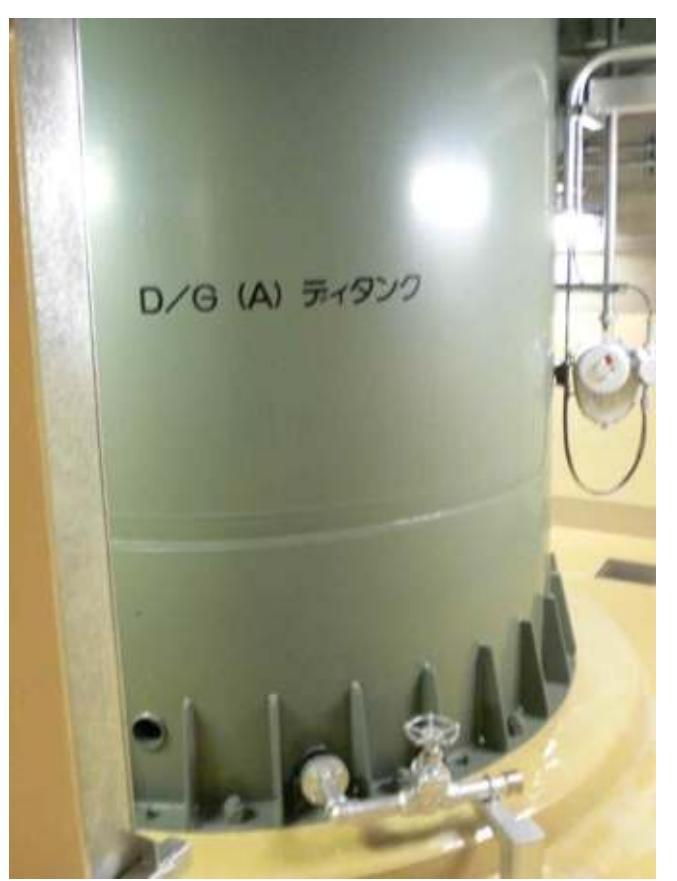
Photo 45: Safety related tanks generally performed very well

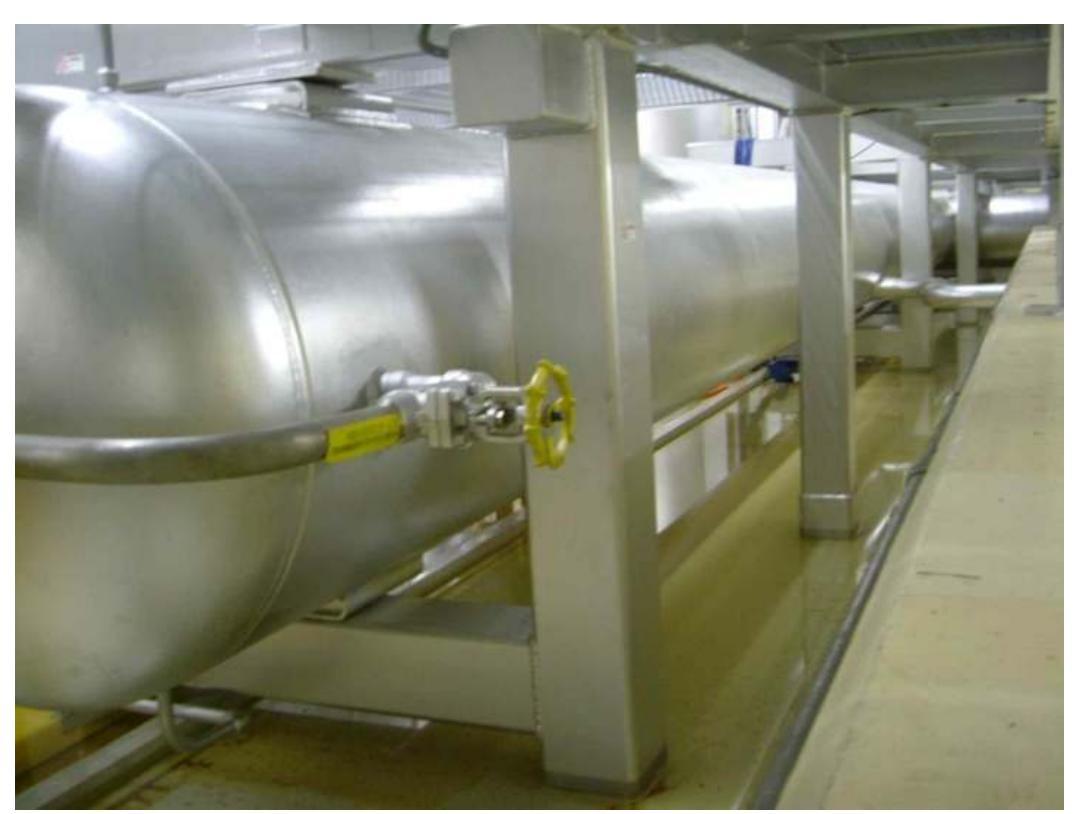
Photo 48: Example of a horizontal vessel (HEx) showing very good performance

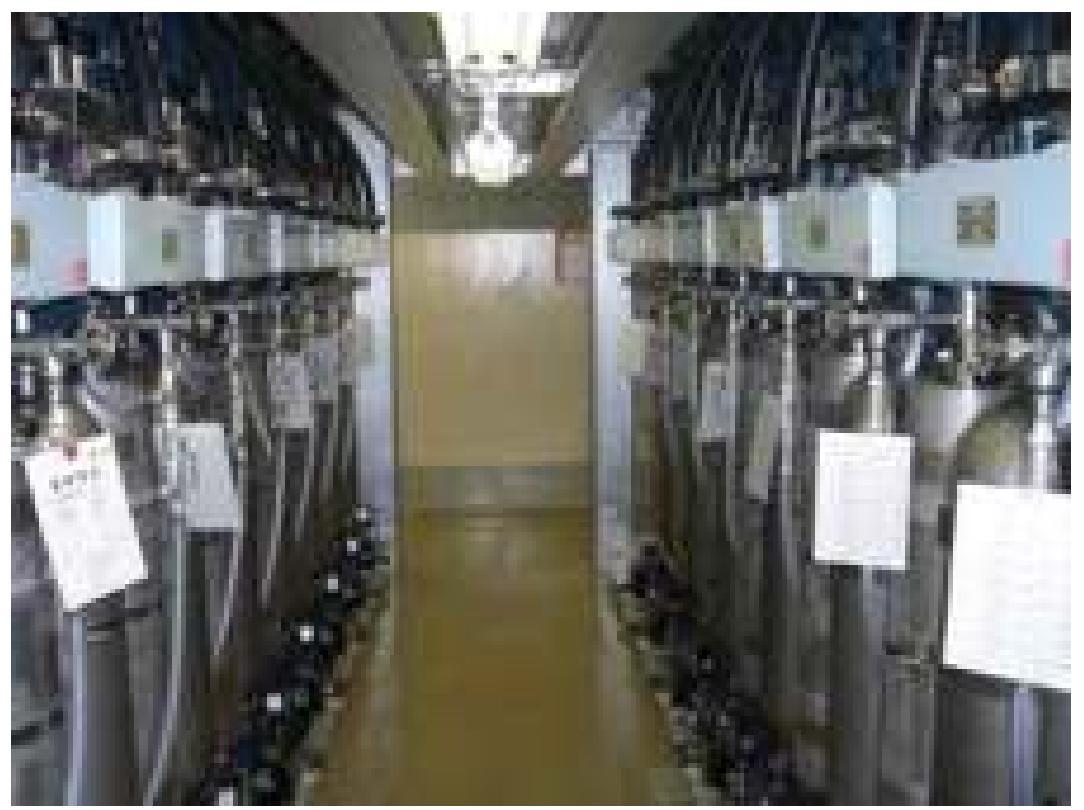
Photo 49: Good performance of well supported Nitrogen tubes of the hydraulic control units for Control Rod Drive System, (Level ~-1.00).

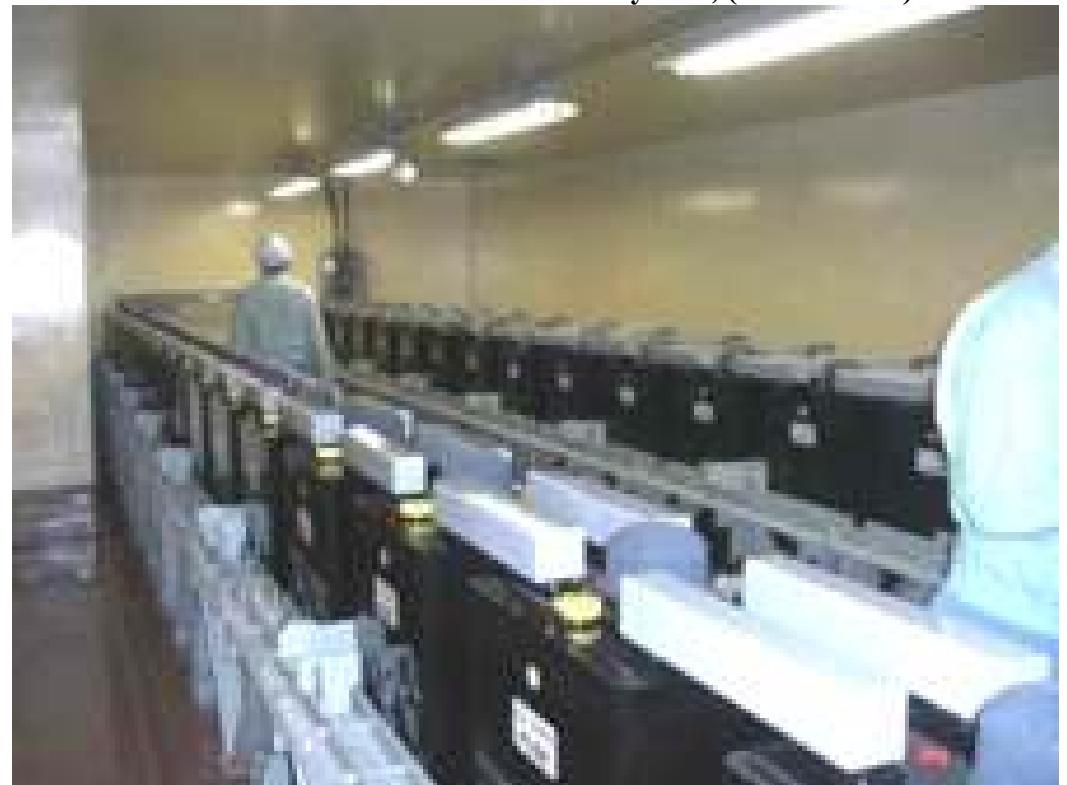
Photo 50: Emergency Batteries in well designed racks showed very good performance.

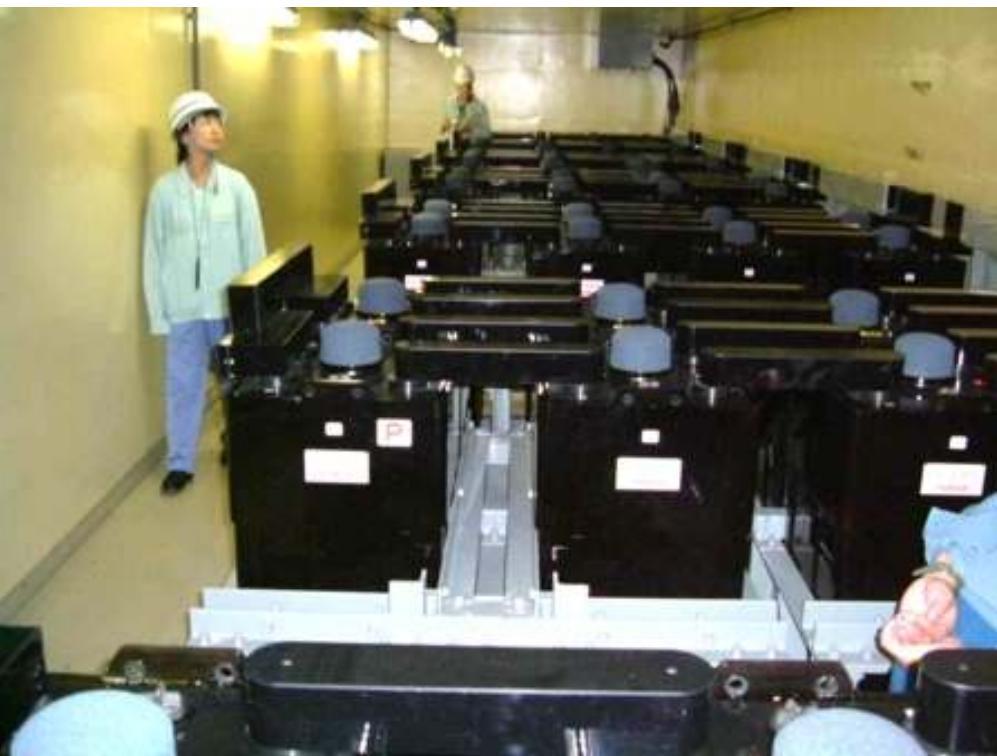
Photo 51: Emergency Batteries in well designed racks showed very good performance

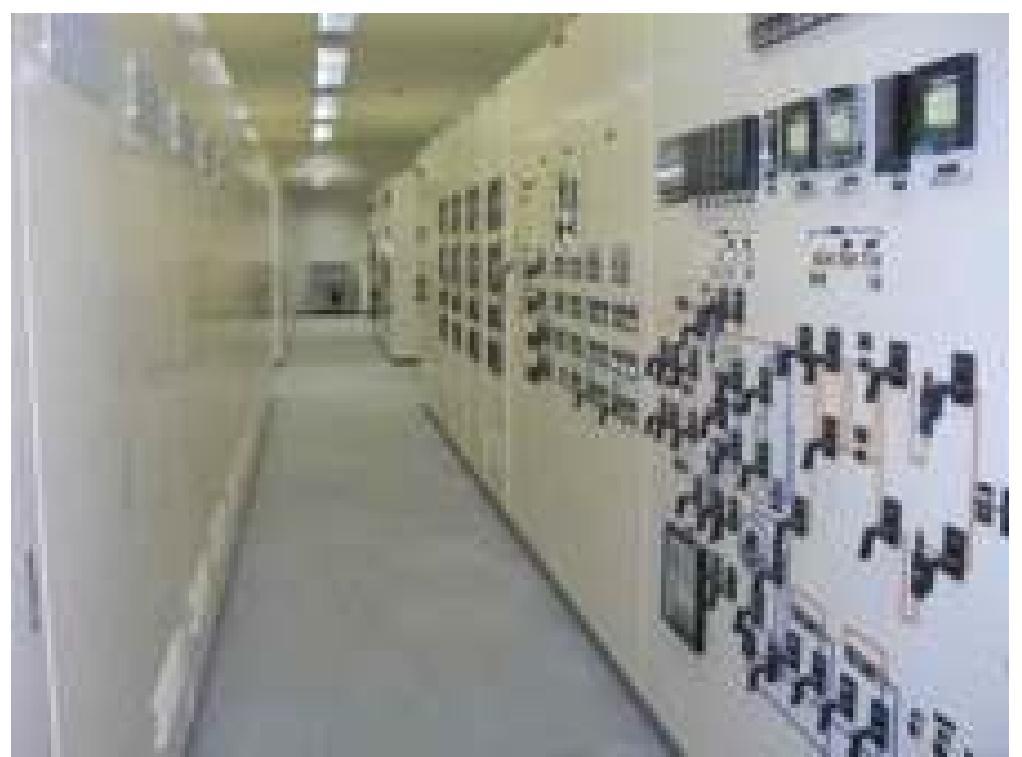
Photo 52: Well braced and supported electrical cabinets in general showed very good performance

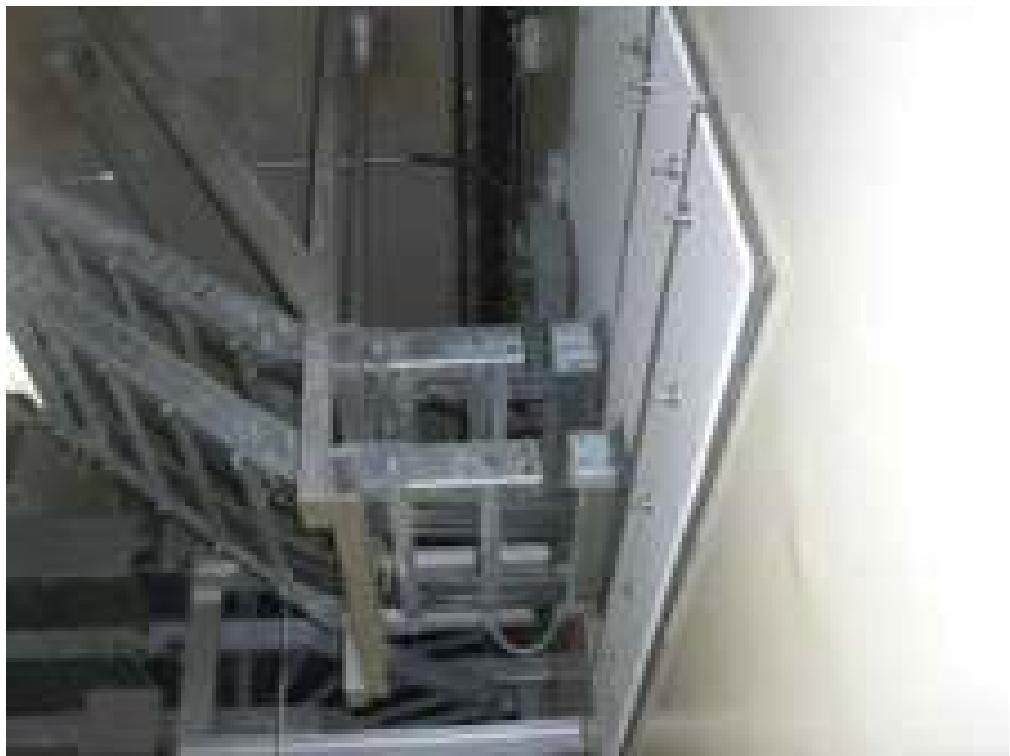
Photo 53: Well braced cable trays in general showed very good performance

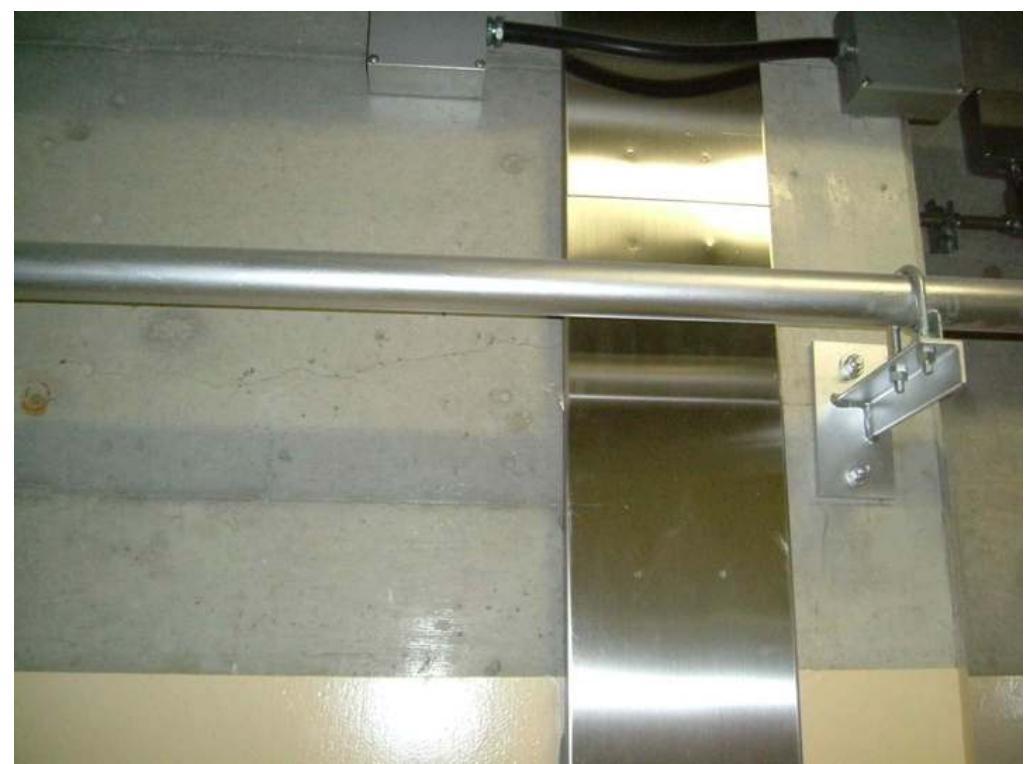
Photo 54:

: Details for cable connection and pipe support that performed very well
